Forest Products
Laboratory

Iowa State
University

Dynamic Field Performance of Timber Bridges

Final Report: Summary and Conclusions

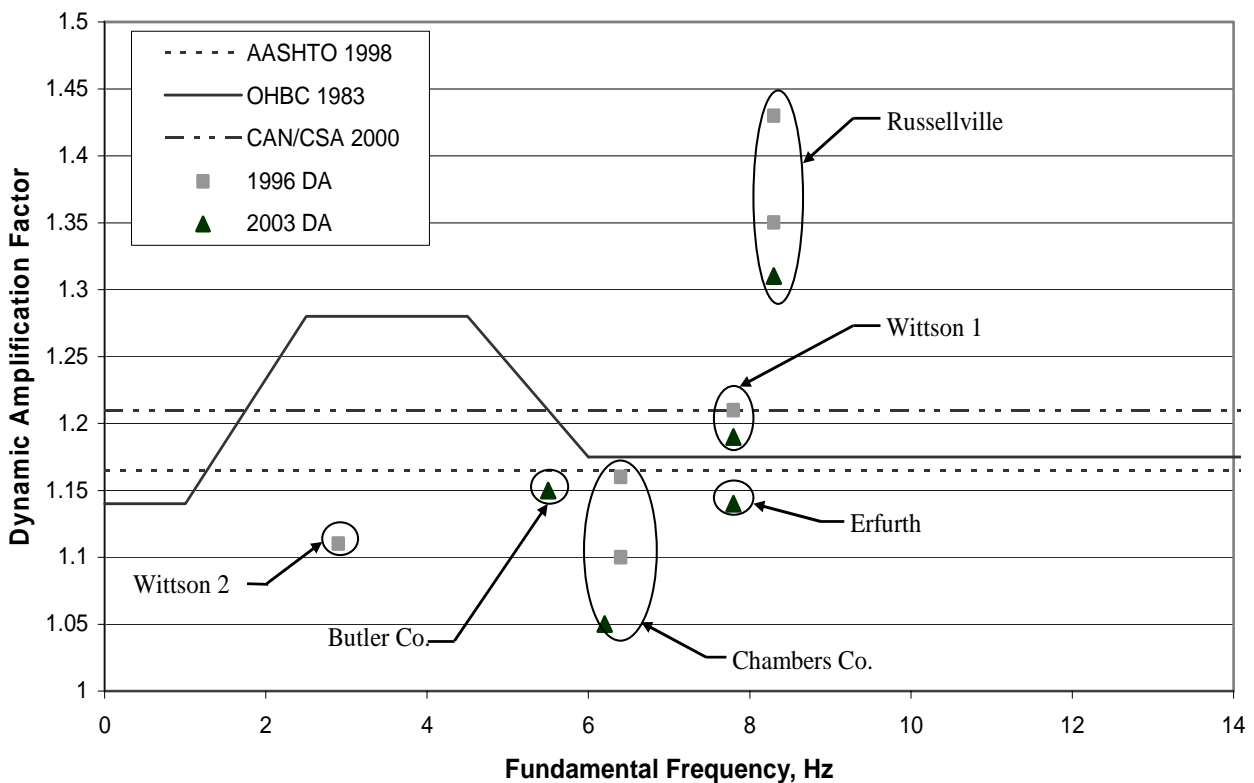
Figure 2. International impact factors for glued-laminated girder bridges.

Four of the five bridges tested were found to have DAF within the code limits presented in Fig. 2. The Russellville Bridge was the only bridge that did not meet the codified requirements. The large DAF values for the Russellville Bridge are attributed to the natural bump at the entrance of the bridge. Tables 2 and 3 summarize the results of the dynamic testing and also list key physical attributes of each bridge.

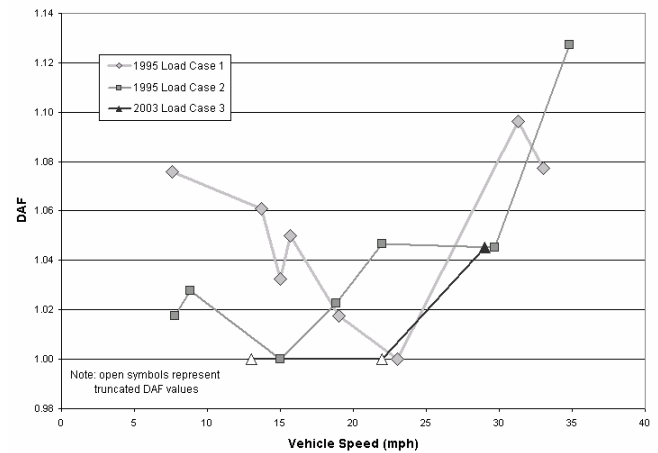
Figure 4. Chambers County Bridge DAF plot.

The Chambers County Bridge was also field tested in 2003 using only Load Case 3. The condition of the structural elements of the bridge at the time of testing was rated as good. The wearing surface, however, was in poor condition with very rough approaches and significant transverse cracking. The bridge deck can be seen in Fig. 3. During the testing, a maximum deflection of 0.588 in. was obtained. This deflection occurred at 29.6 mph and created a DAF of 1.05. Possible higher DAF values could have been obtained from the bridge if higher testing speeds were possible. Figure 4 shows the DAF in relation to velocities for all three load cases and is typical of the collected data. The fundamental frequency from the 2003 testing was found to be 6.2 Hz.

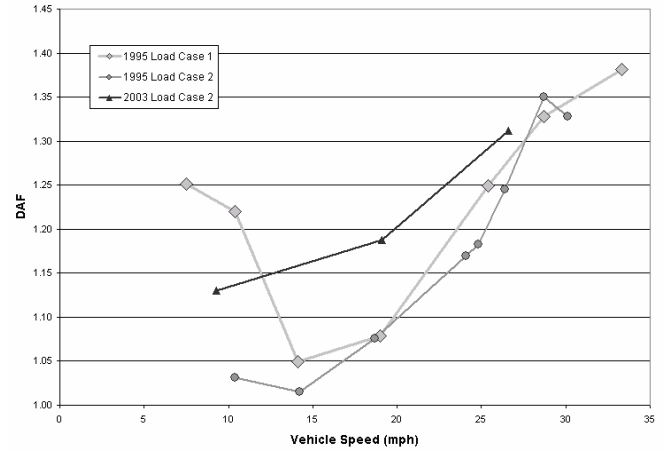
Figure 6. Russellville Bridge DAF plot.

The condition of the bridge during the 2003 test was found to be satisfactory. The natural bump at the entrance of the bridge still existed, although did not appear to have worsened over time. The wearing surface also had prominent transverse cracking typically aligning with the deck joints. The structural condition of bridge generally appeared to be in good condition.

The bridge was tested using Load Case 2 in 2003. The maximum DAF occurred as the truck crossed the bridge at 26.6 mph. The resulting deflection and DAF was 0.477 in. and 1.31, respectively. Once again, the high DAF is attributed to the natural bump at the entrance of the bridge. The natural frequency matched very closely to the frequency found in 1995- a range of 7.8 Hz to 8.6 Hz. A plot of the DAF results from both 1995 and 2003 is shown in Fig. 6.

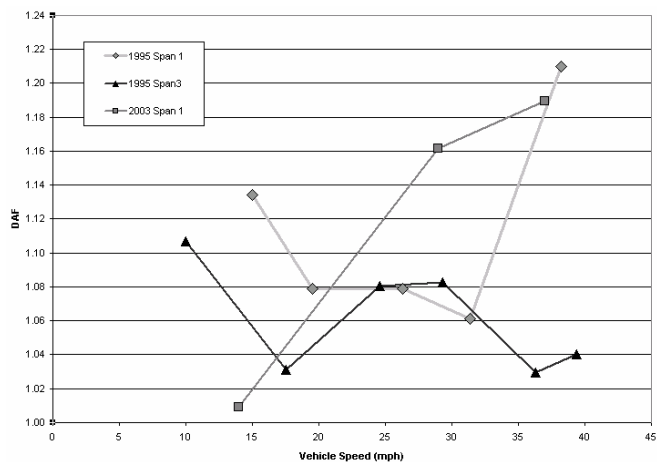
Figure 7. Wittson Bridge DAF plot.

The maximum dynamic response of Span 1 from the 2003 testing was found to be very similar to the testing in 1995. The maximum DAF was found to be 1.19 at 37 mph. Figure 7 shows the DAF for the Wittson Bridge in both 1995 and 2003. The frequency was found to be 7.8 Hz, which is similar to the range found in 1995. The Span 3 frequency was found to be 2.9 Hz, which is also close to 1995 results.

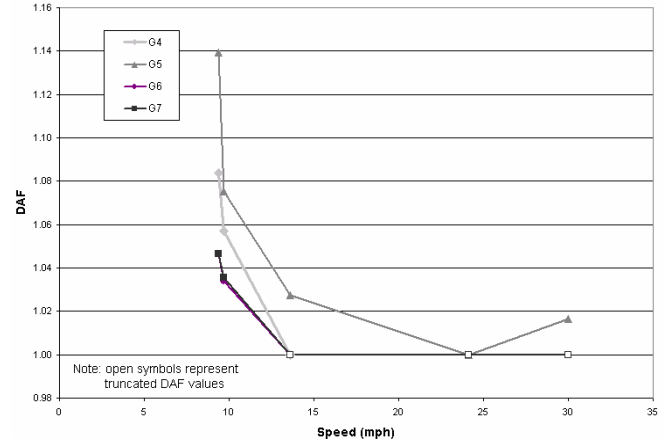
Figure 10. Erfurth Bridge DAF plot.

Testing took place in 2003 using Load Case 3 only. A maximum deflection of 0.903 in. was measured on one girder. This deflection, however, was twice as large as the adjacent girders. The reason for the large deflection could not be determined; however possible sources include varying gaps between deck panels and girders, differences in support conditions, and possible non-visible deterioration on the girder. The maximum DAF for the bridge occurred at 9.4 mph and was 1.14. Figure 10 shows the DAF for four of the girders in the zone of direct influence of the truck.

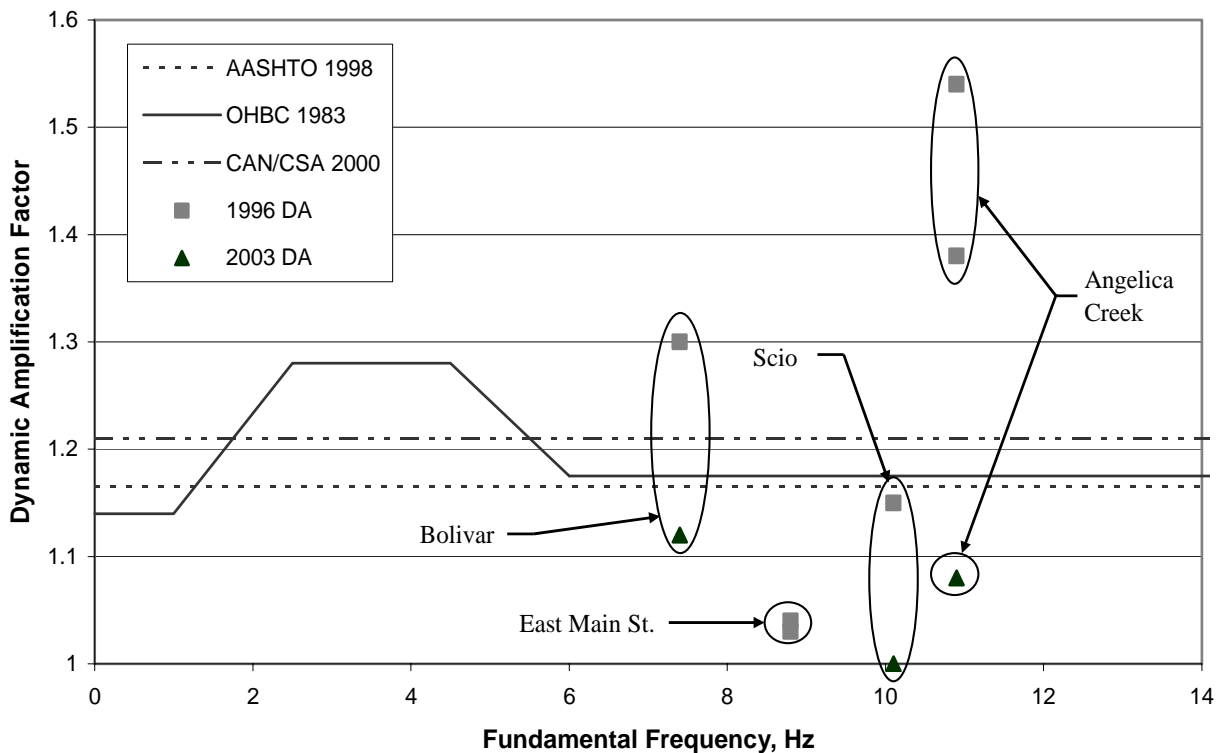
Figure 12. International impact factors for longitudinal glued-laminated panel bridges.

Figure 12 shows the dynamic load allowances from various design codes with respect to the experimental bridge amplifications found in both 1996 and 2003. As can be seen from Fig. 12, only three measured DAFs were above the various code requirements. Interestingly, all DAFs established in 2003 were below the established codes values and were seen to be less than the 1996 tests results.

Two of the four panel bridges tested had all DAF values within code limits. Of the nine dynamic tests performed on the bridges, 66% of the DAF values obtained were within code limits. The Angelica Creek Bridge and Bolivar Bridge had DAF values that were above the specified code limits as was shown in Fig. 12. The large DAF values for both of these bridges are attributed to bumps at the entrances of the bridge during the 1996 testing. These values, however, were seen to decrease below the code recommendations in 2003. This decrease is attributed to the change in the approach conditions, the properties of the different testing vehicles, changes in the weight of the bridge due to increase in moisture levels, and changes in load distribution due to swelling of components. Similar to the girder bridges, the entrance and approach roughness heavily influenced the DAF values obtained for the four panel bridges. A summary of the results along with key physical characteristics is shown in Tables 5 and 6.

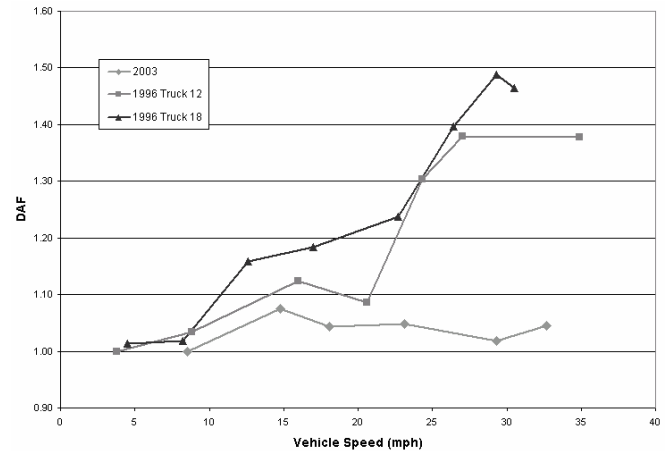
Figure 13. Angelica Creek Bridge DAF plot.

The testing that took place in 2003 also traversed Load Case 2. The maximum dynamic deflection that occurred during the testing was 0.56 in. at 14.8 mph. The resulting DAF was 1.08. This was also the maximum DAF that occurred for the bridge. Figure 13 shows the DAF history with respect to vehicle speed for both the 1995 and 2003 testing. Similar to that found in 1996 the fundamental frequency was found to be 10.9 Hz.

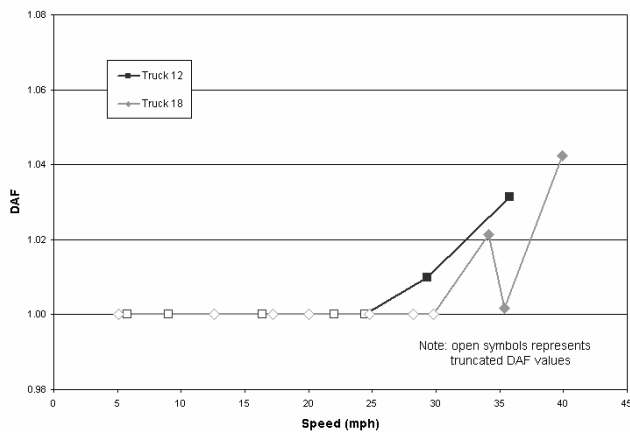
Figure 15. East Main Street Bridge DAF plot.

In 1996 the East Main Street Bridge was dynamically tested with both Truck 12 and Truck 18 on Load Case 3. The results from the Truck 12 testing found the maximum displacement to be 0.414 in. This deflection occurred at a speed of 35.8 mph and also created the maximum DAF of 1.03. Truck 18, which weighed 5600 lb less than Truck 12, had a maximum deflection of 0.390 in. This created a maximum DAF of 1.04. The fundamental frequency of the bridge was found to be 8.8 Hz. Figure 15 shows the DAF history with respect to vehicle speed for both Truck 12 and Truck 18 testing.

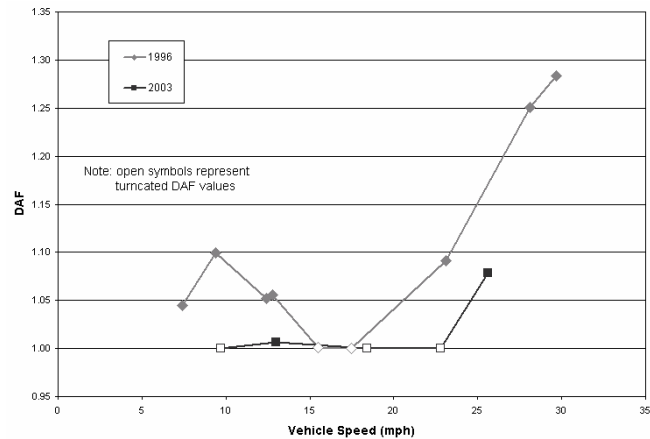
Figure 17. Bolivar Bridge DAF plot.

The maximum 2003 deflection for the Bolivar Bridge was 0.536 in. The maximum DAF was found at an adjacent location resulting in a DAF of 1.12 and occurred at the maximum test speed. As can be seen from Fig. 17, if larger speeds were attained during the 2003 testing, a higher DAF could have possibly been obtained. The natural frequency was found to be 7.4 Hz, which was the same frequency found in 1996.

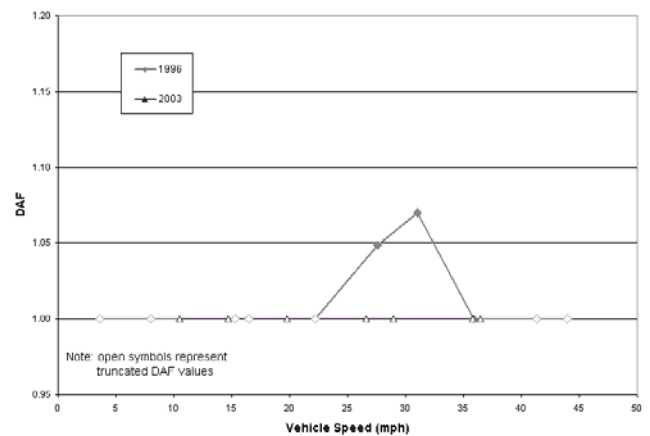
Figure 19. Scio Bridge DAF plot.

During the 2003 testing of the Scio Bridge, seven truck passes were conducted for the same load position used in the 1996 testing. All seven dynamic truck passes yielded DAF values of 1.00. Figure 19 shows the DAF results for both the 1996 and the 2003 testing. Only one vibration mode was found for the Scio Bridge during the 2003 testing. The fundamental frequency was 10.1 Hz, which is the same frequency as was found in 1996.

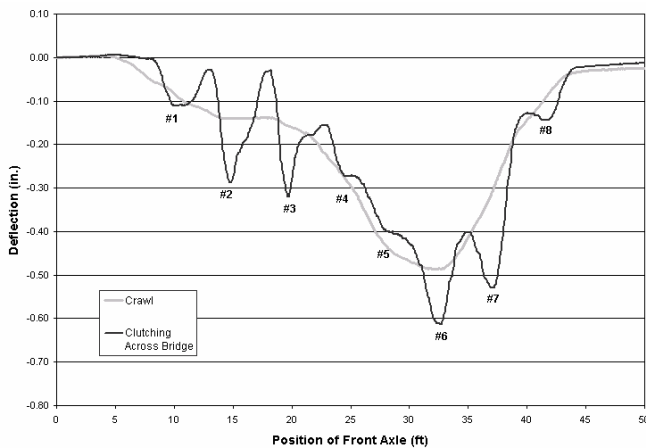
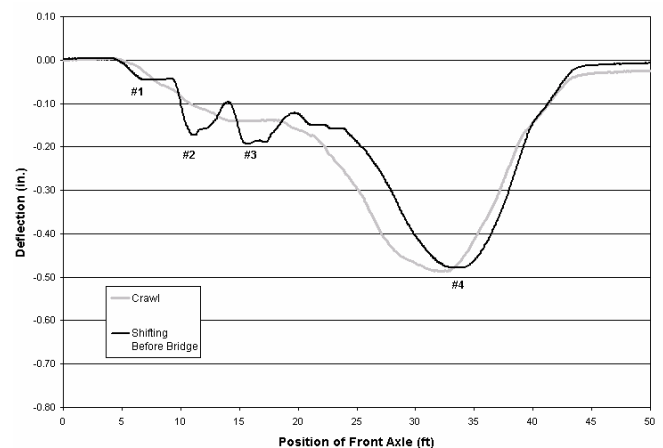
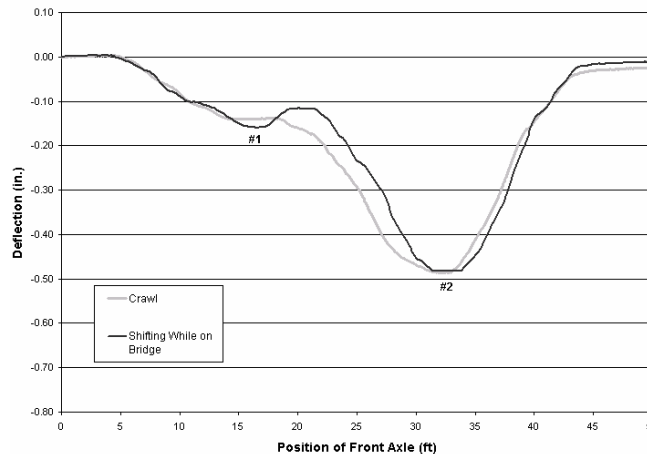
Figure 20. Scio Bridge dynamic deflections for non-conventional loading.

bouncing of the truck as it traversed the bridge. The deflection plot of the truck pass can be seen in Fig. 20. A localized maximum DAF of 2.0 was achieved at points 2 and 3.

The second non-conventional truck pass consisted of the truck shifting gears just prior to entering the bridge. The truck was traveling approximately 5 mph and the shifting caused the truck to bounce just prior to entering the bridge. Figure 20 shows the deflection of the truck pass. A localized maximum DAF was found to be 1.7. The third truck pass was similar to truck pass two; however, the shifting took place while on the bridge. The deflection history of this loading is also shown in Fig. 20. It was seen that shifting while on the bridge had less of an impact than the other non-conventional truck passes; however, a localized maximum DAF was found to be 1.14 (as compared

a. Jamming clutch across bridge.

b. Shifting prior to entering bridge.

c. Shifting while on bridge.
