Research
Paper
FPL-RP-570

Field Performance of Timber Bridges

16. North Siwell Road Stress-Laminated Bridge

James A. Kainz

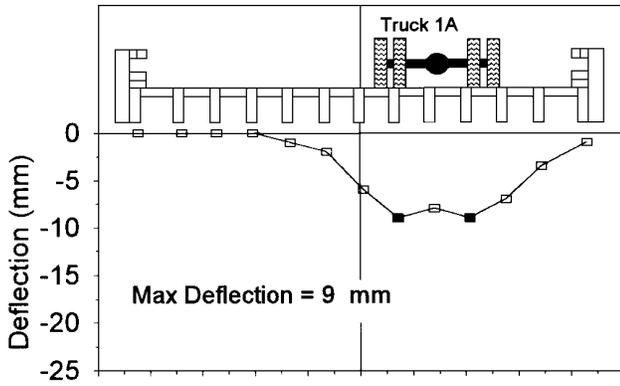
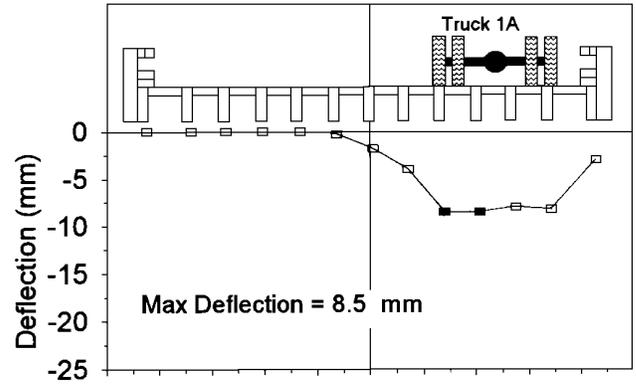
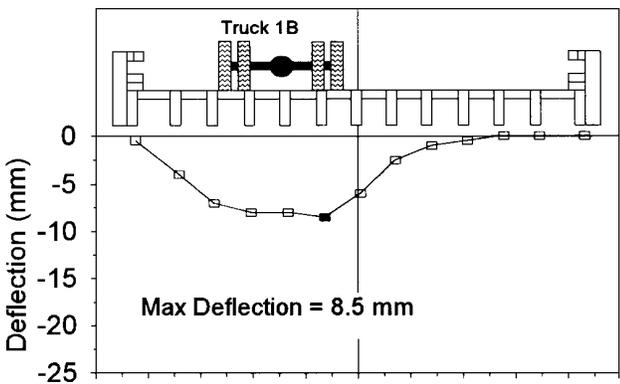
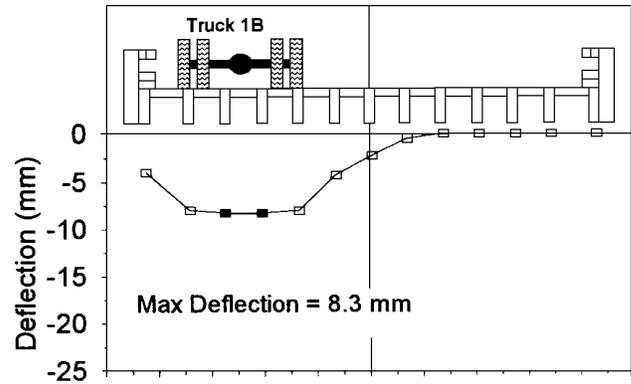
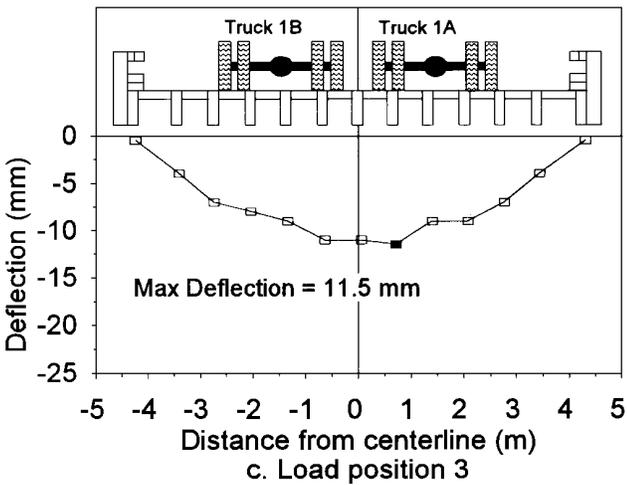
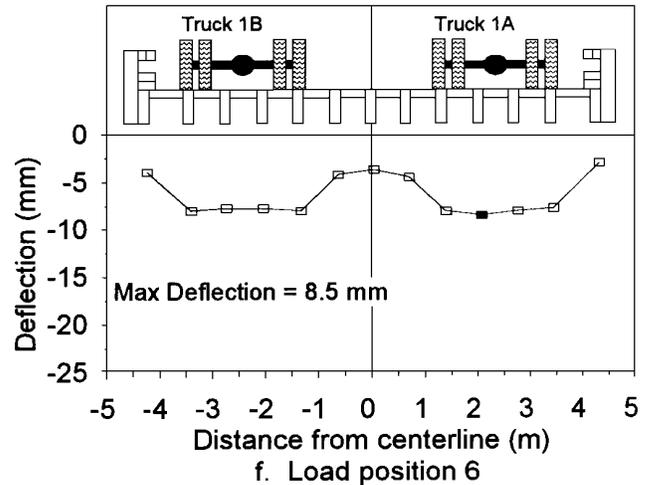
Transverse deflections for load test 1 with the locations and magnitudes of the maximum measured deflections are shown in Figure 17. The maximum measured deflection was 9 mm (0.35 in.) for load position 1, 8.5 mm (0.34 in.) for load position 2, and 11.5 mm (0.45 in.) for load position 3. For the eccentric load positions, the maximum measured deflection was 8.5 mm (0.34 in.) for load positions 4 and 6 and 8.3 mm (0.33 in.) for load position 5. As shown in Figure 17, the maximum measured deflections occurred near the wheel lines of the test vehicles. These maximum measured deflections are symmetrical between similar load positions, such as load positions 1 and 2 and load positions 4 and 5. For the load positions with two vehicles, the deflection from load position 3 was greater than all other measured deflections, and the smaller deflection from load position 6 was similar to load positions 1, 2, 4, and 5. This was due to the transverse stiffness of the deck that was created by the interlaminar compression stress.

Figure 17—Transverse deflections measured at mid-span (looking north) for load test 1. Bridge cross-sections and vehicle positions are presented to aid interpretation and are not to scale.

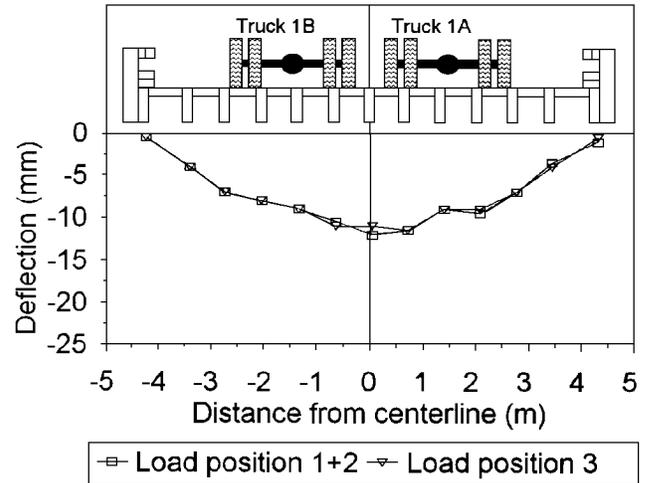
Assuming uniform material properties, symmetric loading, and accurate deflection measurements, the summation of bridge deflections from two single-truck load positions should equal the deflections from the load position with both trucks. Figure 18 displays the summation of load positions 1 and 2 overlaid on load position 3. As shown, there are slight deflection variations near the longitudinal centerline, but the deflections are essentially the same.

Figure 18—Comparison of measured deflections for load test 1, showing the actual deflection of load position 3 and the sum of load positions 1 and 2 (looking north).

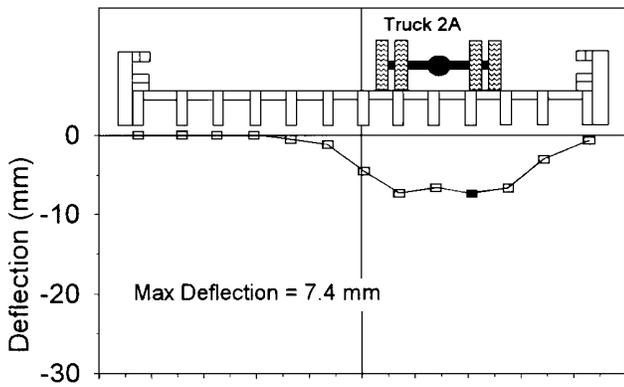
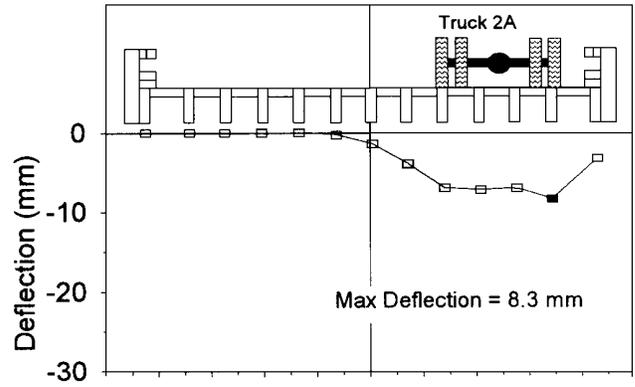
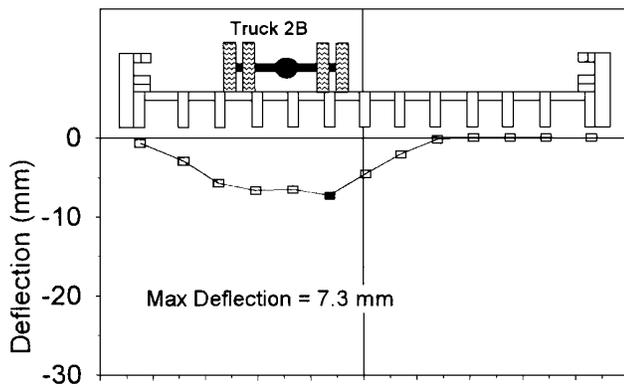
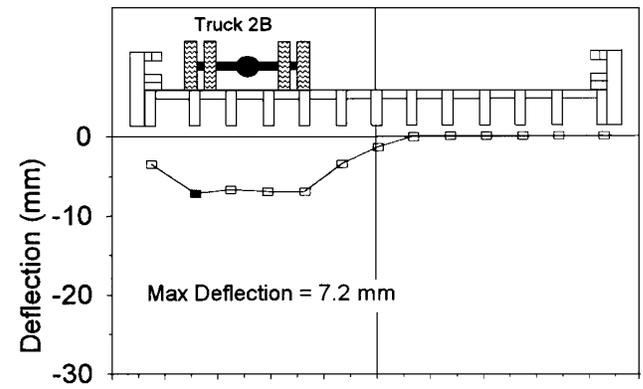
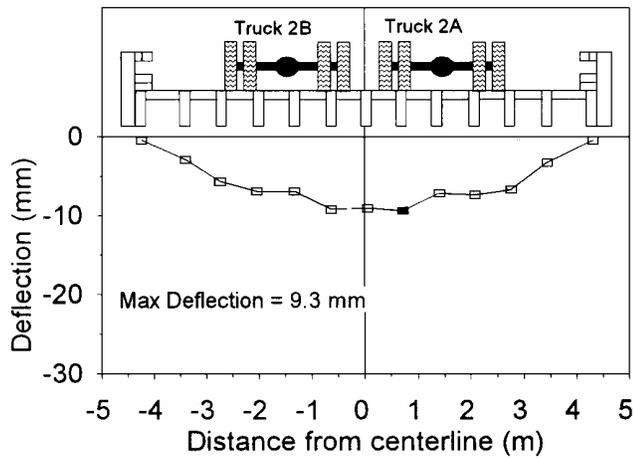
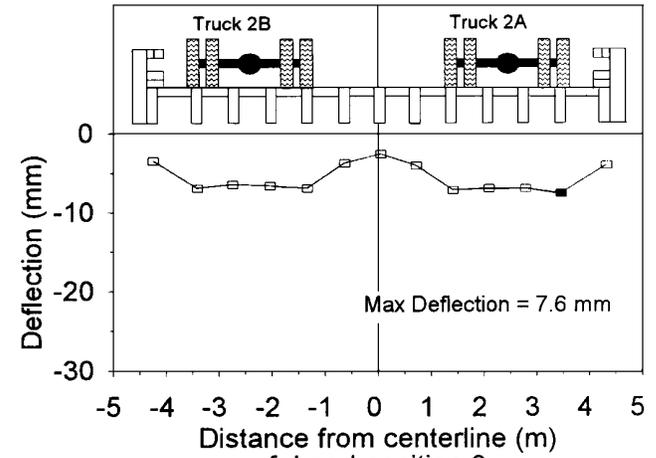
Load test 2 transverse deflections are shown in Figure 19. The maximum measured deflection was 7.4 mm (0.29 in.) for load position 1, 7.3 mm (0.29 in.) for load position 2, and 9.3 mm (0.37 in.) for load position 3. The maximum measured deflections for load positions 4 through 6 were 8.3 mm (0.33 in.) for load position 4, 7.2 mm (0.28 in.) for load position 5, and 7.6 mm (0.30 in.) for load position 6. Observations from load test 1 were also made for load test 2. The maximum measured deflections occurred near the wheel lines of the test vehicles. These maximum measured deflections were symmetrical between similar load positions, such as load positions 1 and 2 and load positions 4 and 5. For the load positions with two vehicles, the deflection from load position 3 was greater than all other measured deflections, and the smaller deflection from load position 6 was similar to load positions 1, 2, 4, and 5. Again, this was due to the transverse stiffness of the deck that was created by the interlaminar compression stress.

Figure 19—Transverse deflection measured at mid-span (looking north) for load test 2. Bridge cross-sections and vehicle positions are presented to aid interpretation and are not to scale.

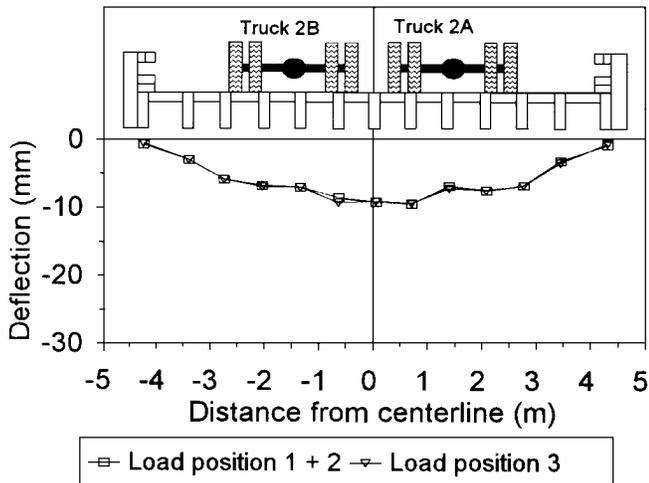
As for load test 1, the summation of bridge deflections for two single truck load positions should equal the deflections from the load position with both trucks. Figure 20 displays the summation of load positions 1 and 2 overlaid on load position 3 for load test 2. Aside from slight deflection variations, the deflections are essentially the same.

Figure 20—Comparison of measured deflections for load test 2, showing the actual deflection of load position 3 and the sum of load positions 1 and 2 (looking north).

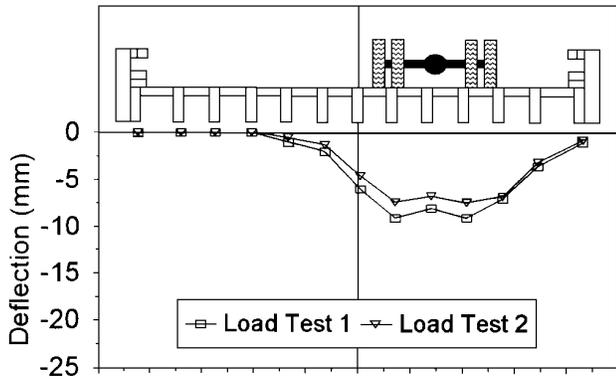
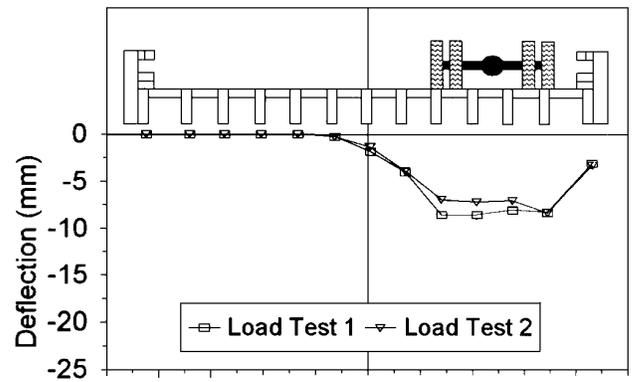
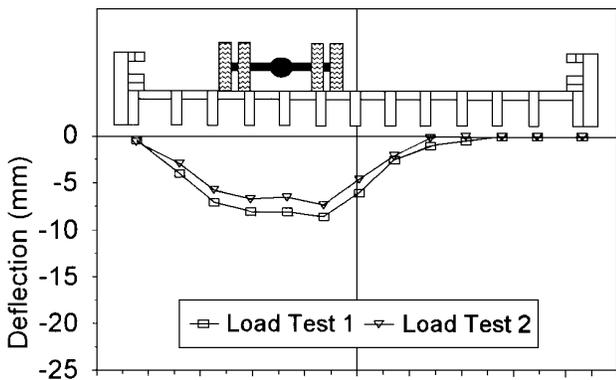
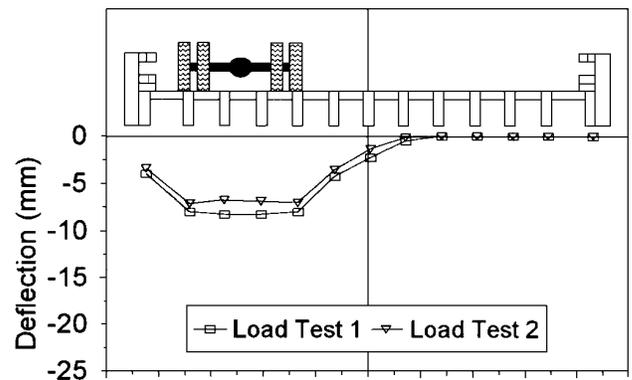
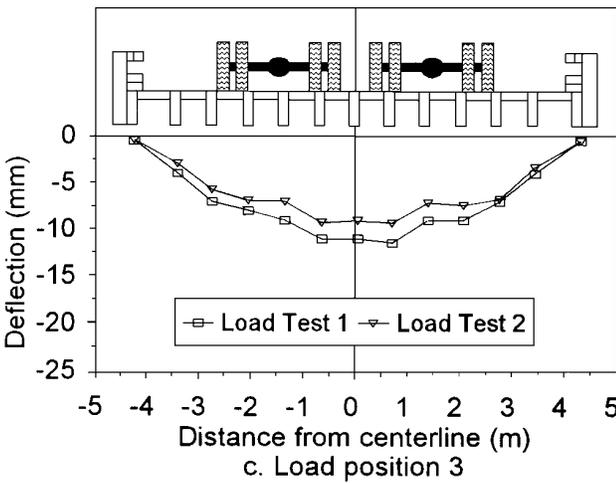
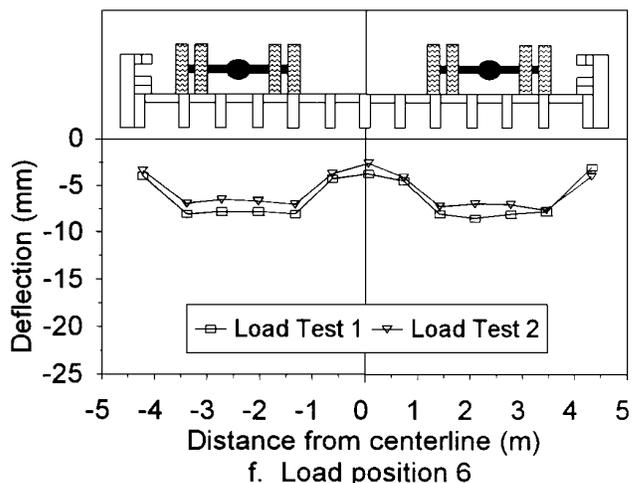
Figure 21—Comparison of load tests 1 and 2 at all load positions.

An examination of the results from load tests 1 and 2 revealed similar maximum deflection locations for each load position (Fig. 21). As shown, the second load test exhibited smaller deflections than the first load test. The decreased deflections were due to 15% lighter loading on the second load test. If the deflections for load test 2 were factored to account for the 15% load reduction, they would appear very similar to the deflections for load test 1.
