Exploration of Ultrasound for the Evaluation and Preservation of Structures

**Final Report
January 2021**

Sponsored by
Iowa Highway Research Board
(IHRB Project TR-757)
Iowa Department of Transportation
(InTrans Project 18-671)

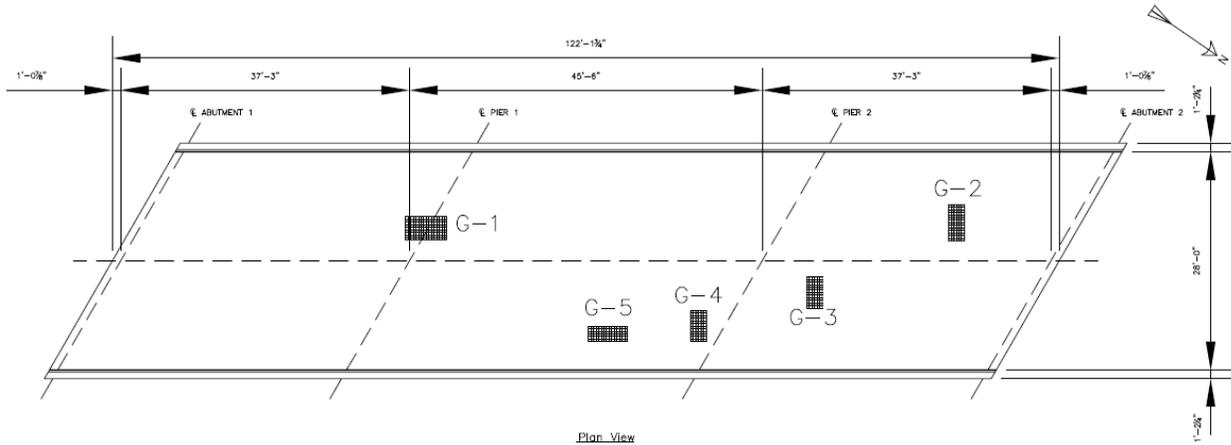
Figure 8. Mingo Bridge layout with testing locations identified

These locations were selected to obtain a wide variety of results, in that two areas with major cracking (G-1 and G-3), two areas with no cracking (G-2 and G-4), and one area with minor cracking (G-5) were selected.

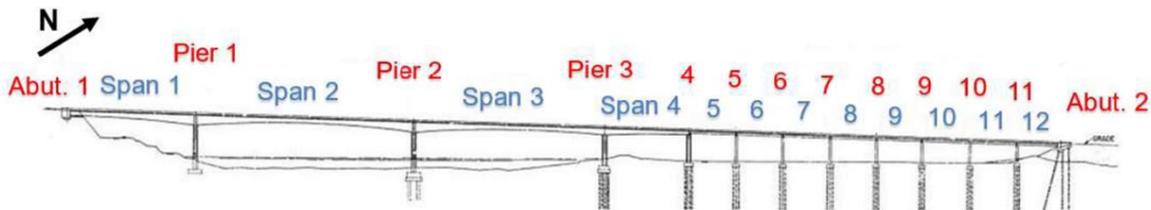
Figure 14. Bridge layout

The second deployment of MIRA was conducted on the Highway 2 Bridge over the Missouri River connecting Iowa and Nebraska. The objective of this round of MIRA testing was to assess the condition of the post-tensioning ducts in areas where voids had previously been found using an alternate NDT method. This bridge was constructed in 1983 with 12 spans, as shown in Figure 14.

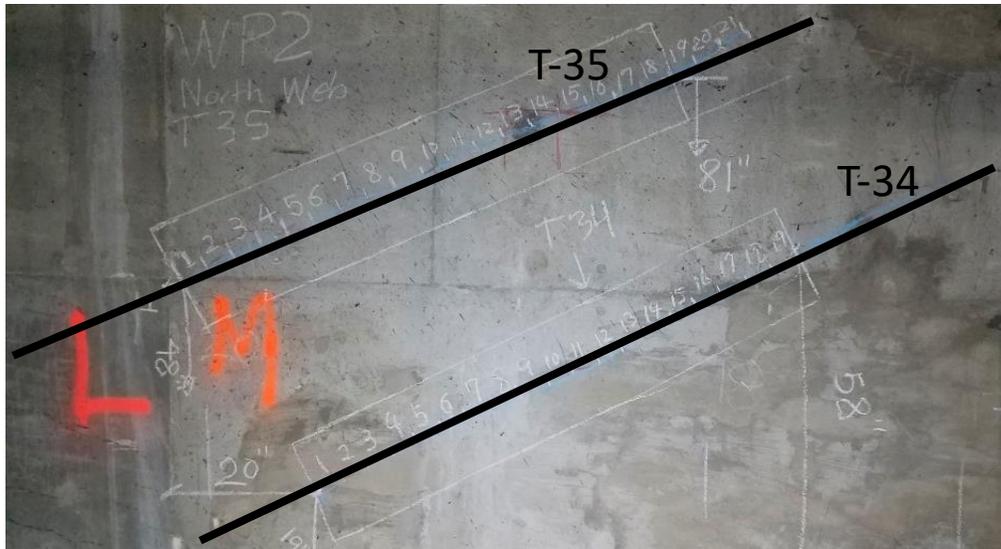
Figure 16. MIRA testing layout for T-34 and T-35

Two tendons (T-34 and T-35) were located west of Pier 2 (Span 2) in the north web. The two web tendons tested are shown in Figure 15 and Figure 16.

VCS identified potential defects in T-35 using impact echo. The area of the defects is depicted in Figure 15 by the blue line. Moreover, to confirm that there was, in fact, a void at the identified location, a borescope inspection was conducted at the location shown by the black dot in Figure 15. In the results, a void was indeed identified. The impact echo testing did not identify defects in T-34.

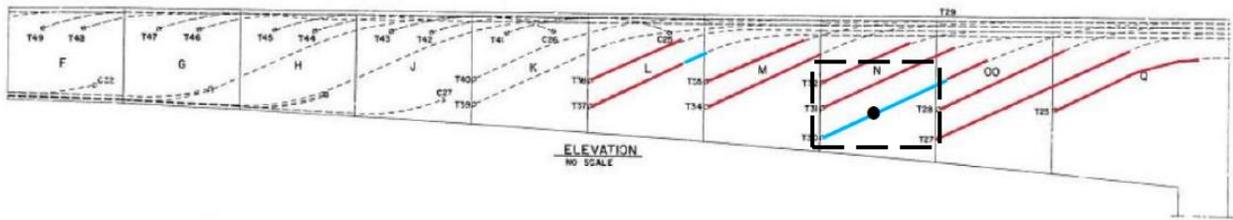
Figure 20. Detailed tendon layout for T-30

One tendon (T-30) west of Pier 2 (Span 2) in the south web was also tested. The web tendon tested is shown in Figure 20 and Figure 21.

T-30 was the second void location determined by VCS. Figure 22, Figure 23, and Figure 24 show the C-scan, B-scan, and 3D image for T30, respectively.
