**ICTB 2013**  
**Las Vegas, Nevada**

# **Inspection of Timber Bridges in the Pacific West**

**Tom Williamson, P.E.**  
**Lola Coombe, P.E.**  
**David Strahl, P.E.**

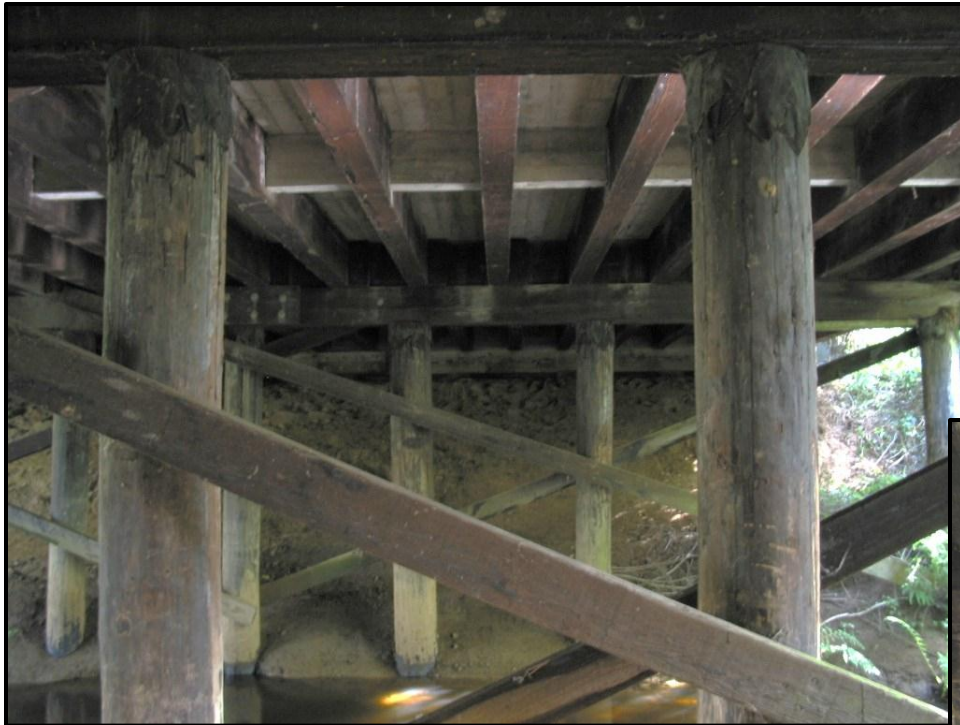
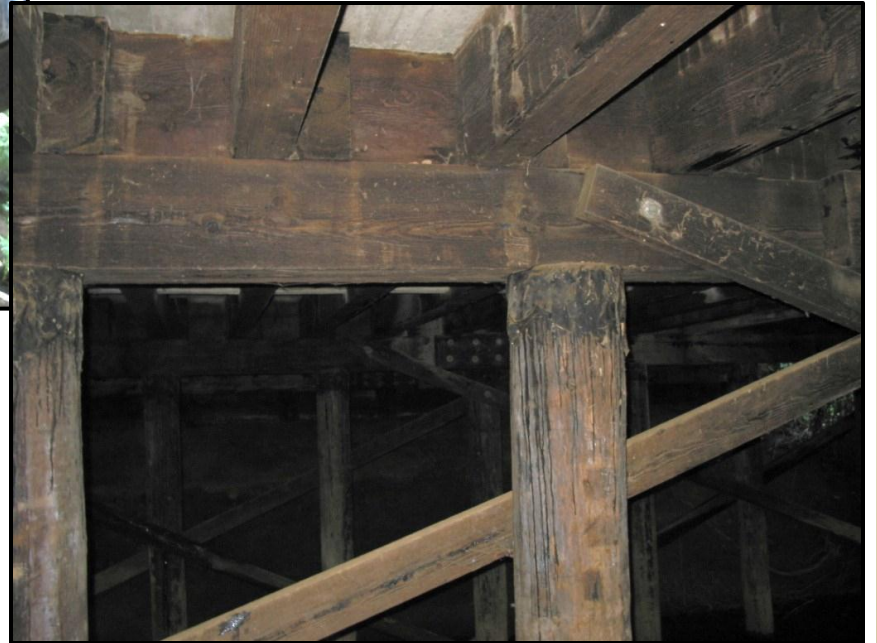
## Sylvia Creek Bridge

- Erected in 1935 - in continuous service for 78 years
- Carries an ADT of over 4000 vehicles
- 3 spans with a total of 169 sawn timber girders - no signs of significant decay or deterioration
- NBI rating of 7 for the sawn timber girders

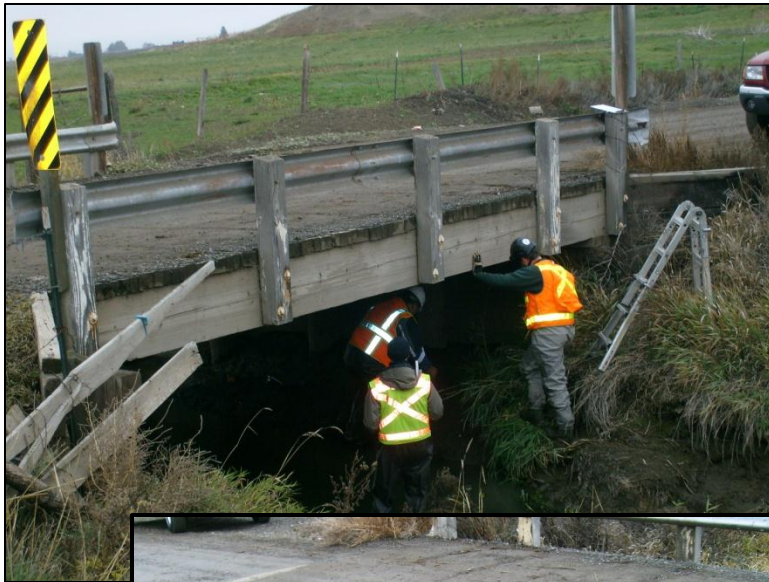
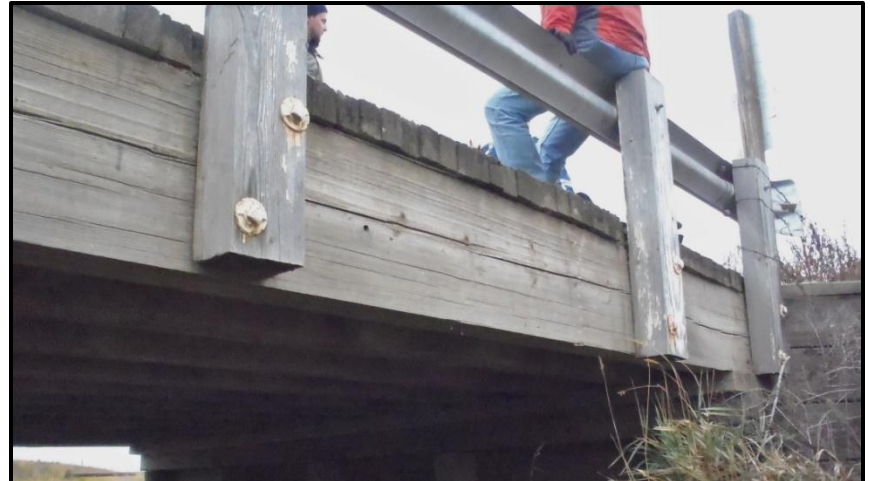
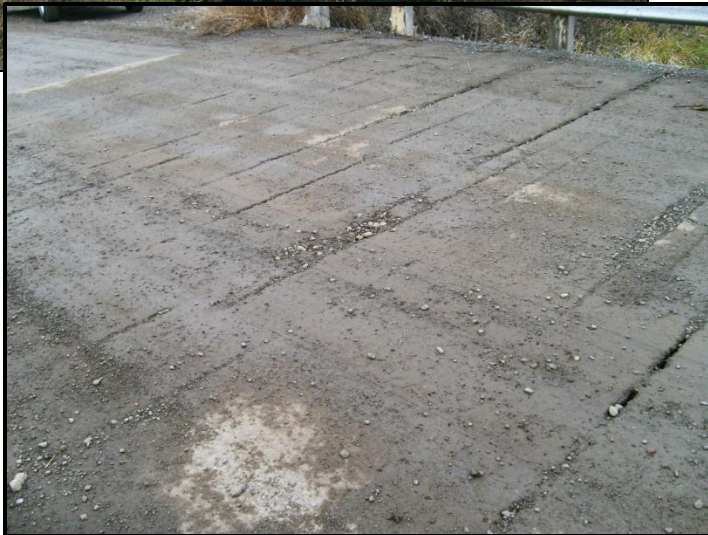
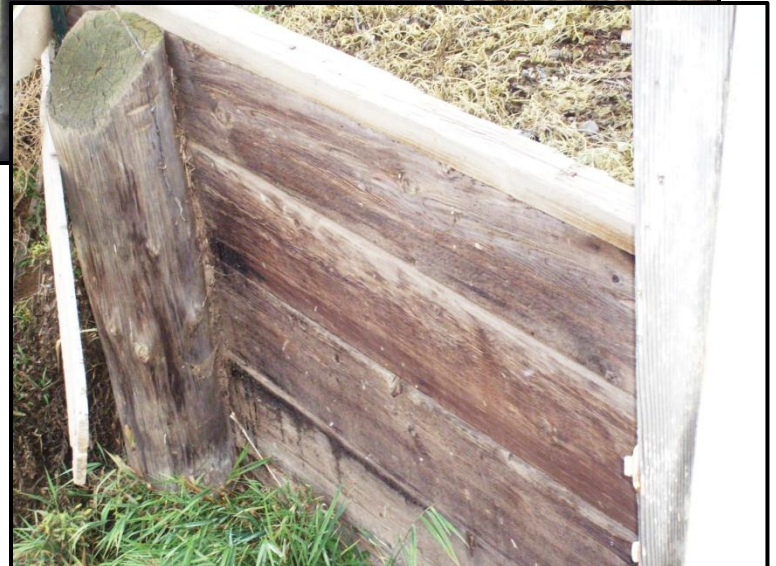
## Bridge 724

- Erected in 1959 – in service for 54 years
- **Untreated** DF girders and deck
- No asphalt wearing surface
- Lowest recorded NBI ratings of all bridges inspected in this region

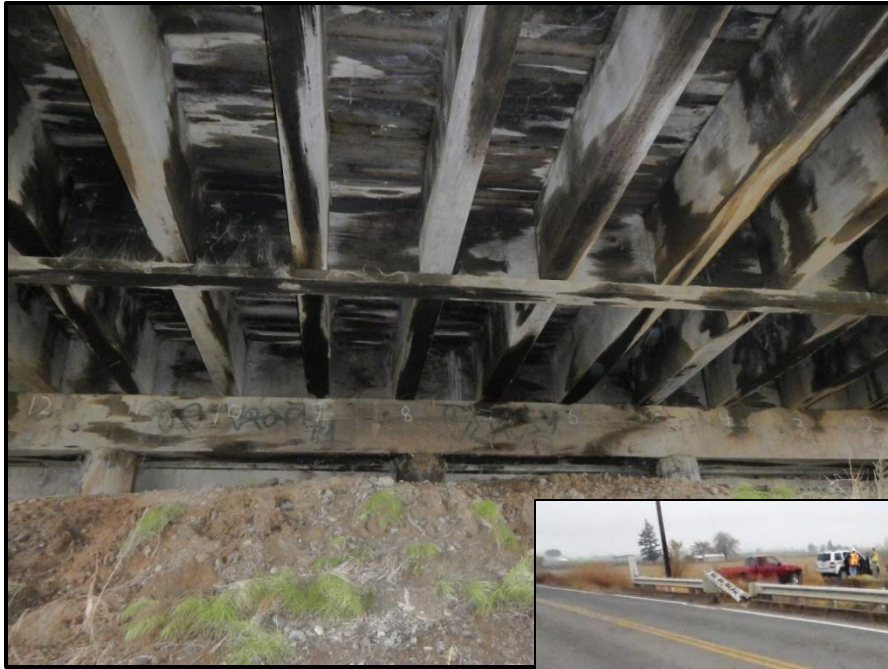
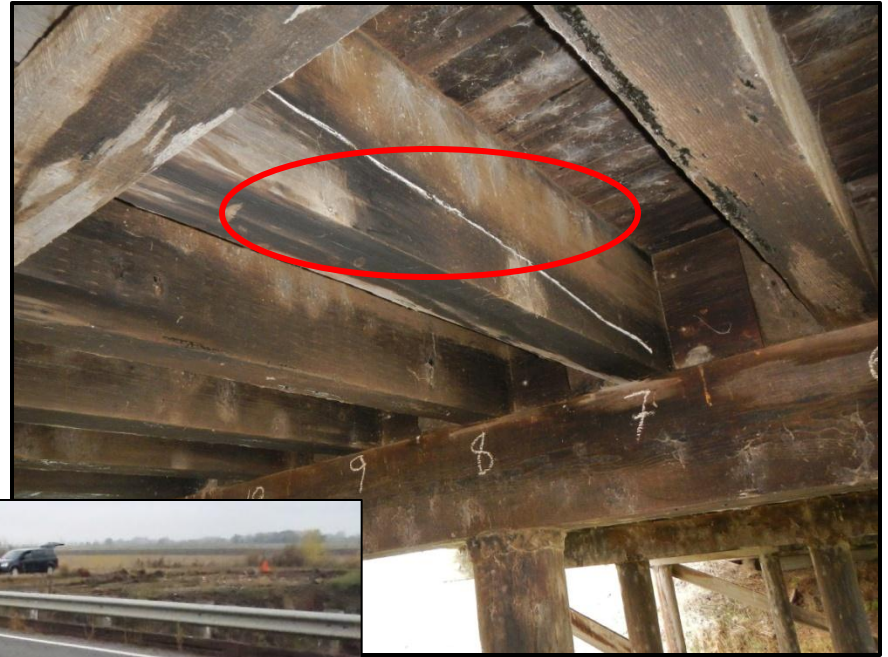
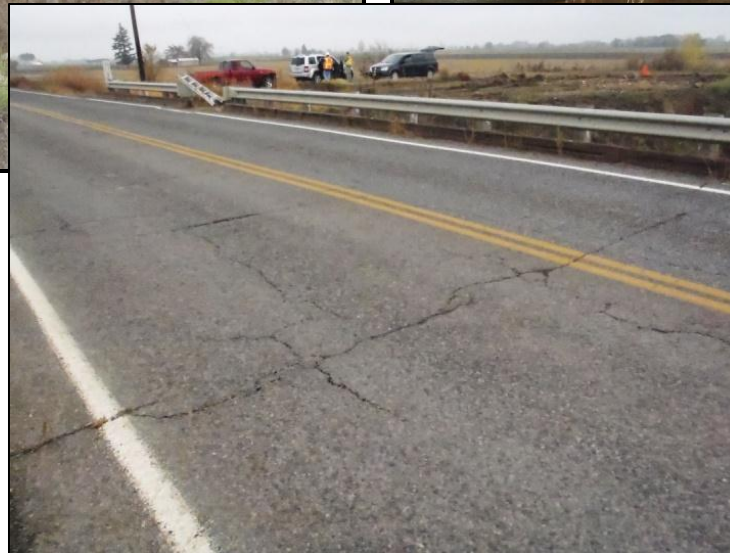
## Bridge 739

- Erected in 1939 – in service for 74 years
- 4 spans with total length of 22 m or 75 ft.
- Carries an ADT of over 1600 vehicles
- NBI ratings of 6 for deck and girders

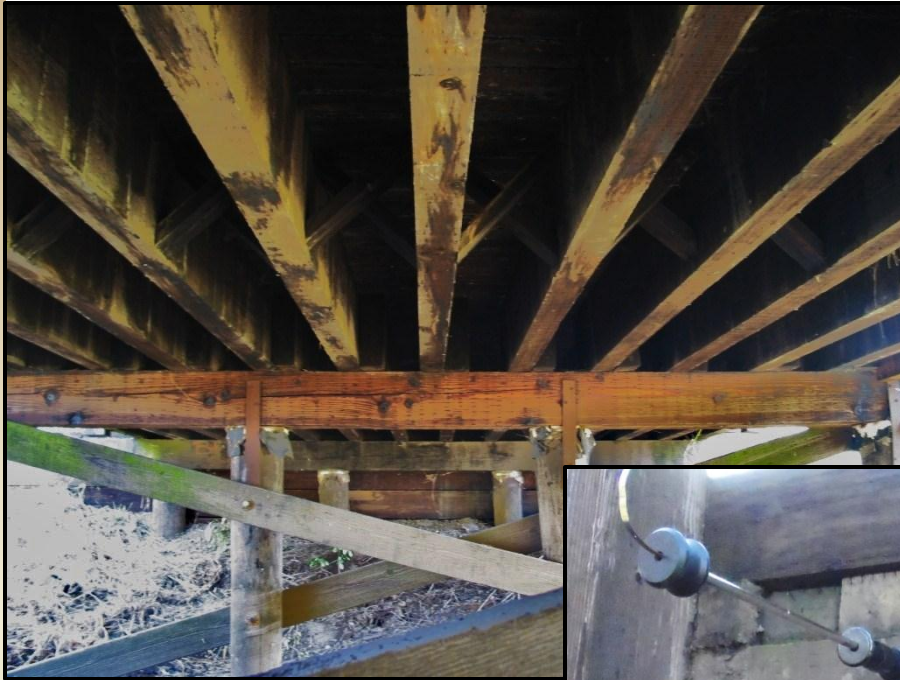
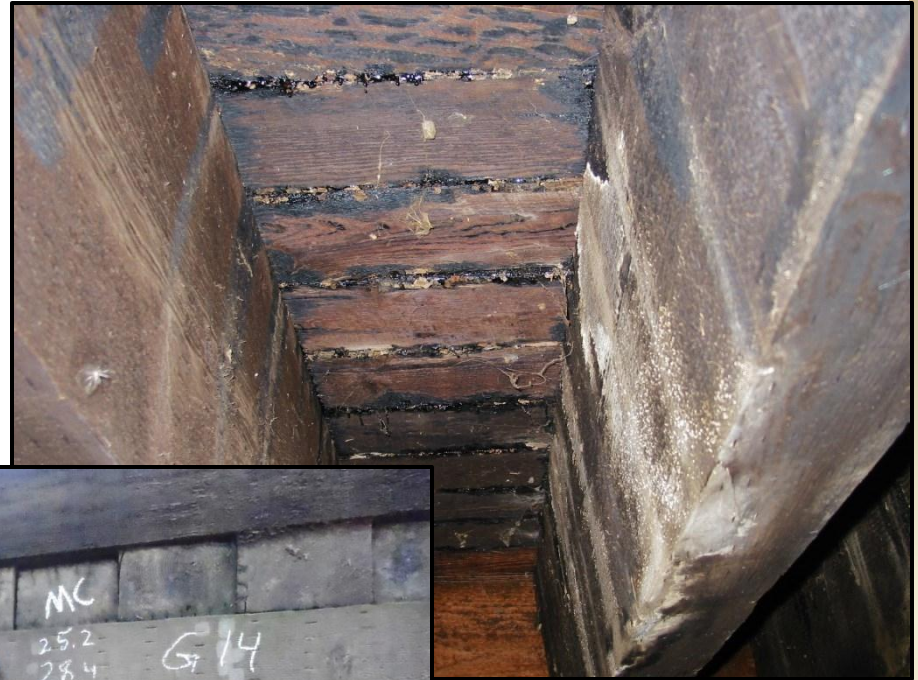
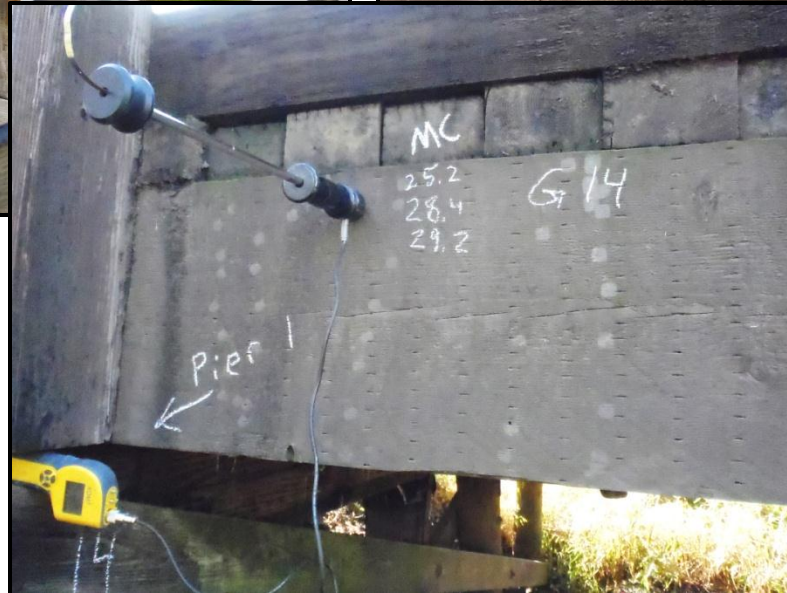
## Bridge 1298

- Erected in 1960 – in service for 53 years
- 3 spans with total length of 14 m or 48 ft.
- NBI ratings of 7 for sawn timber deck and girders
- One outside girder replaced in 2010
- Carries an ADT of over 1100 vehicles

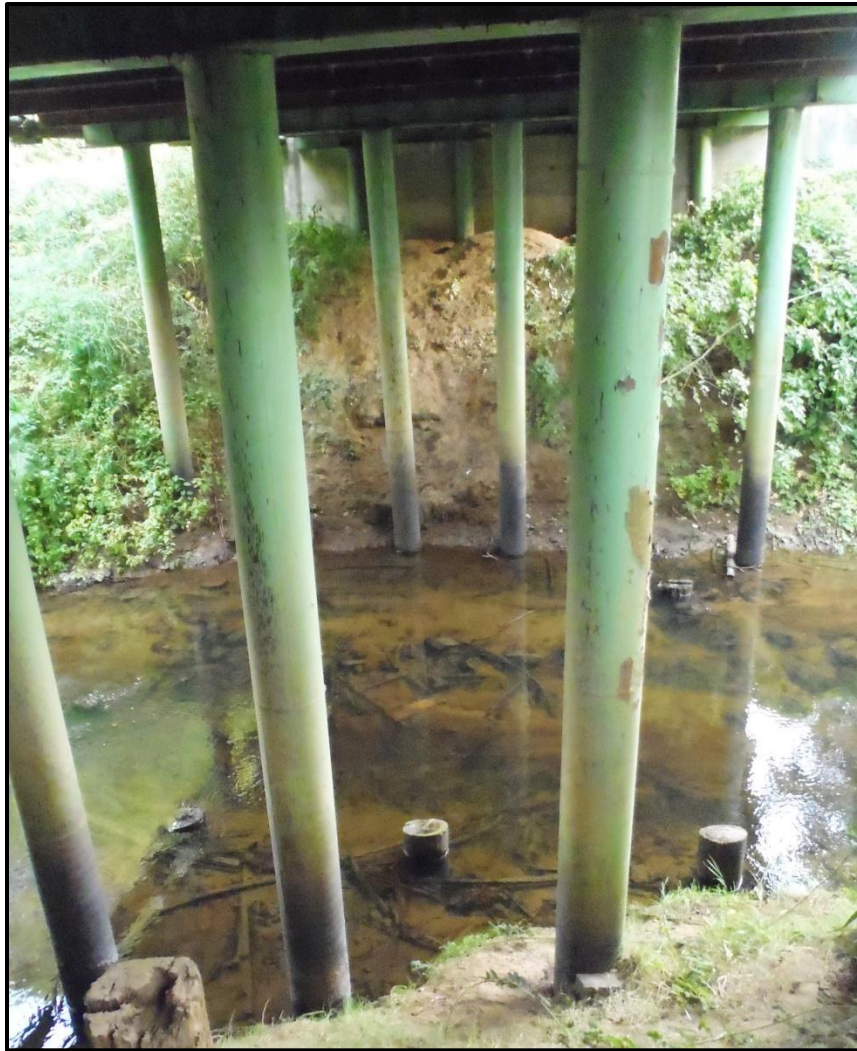
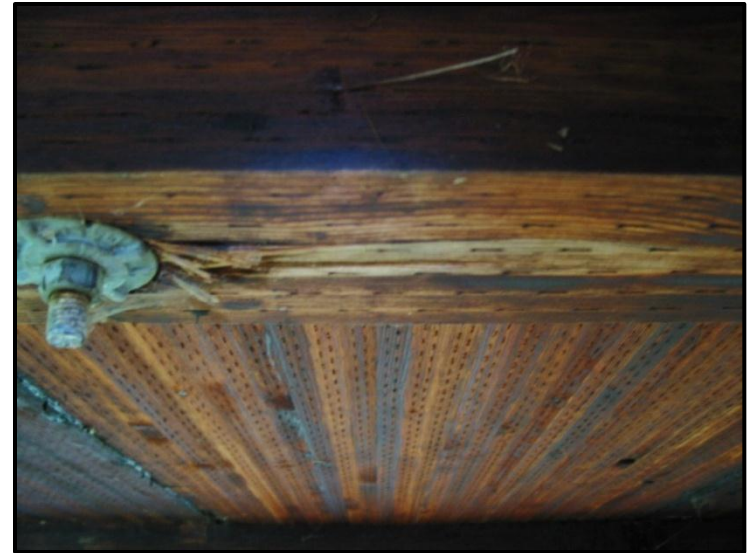
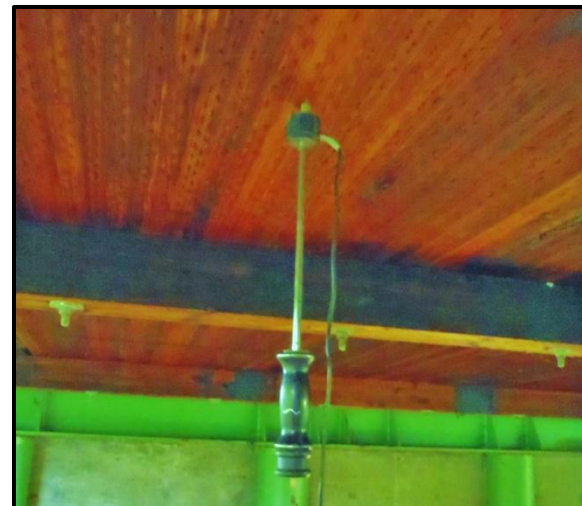
## Bridge 1358

- Erected in 1992 – in service for 21 years
- 3 spans with total length of 22 m or 75 ft.
- Longitudinal glulam deck with NBI rating of 8
- Carries an ADT of over 1500 vehicles

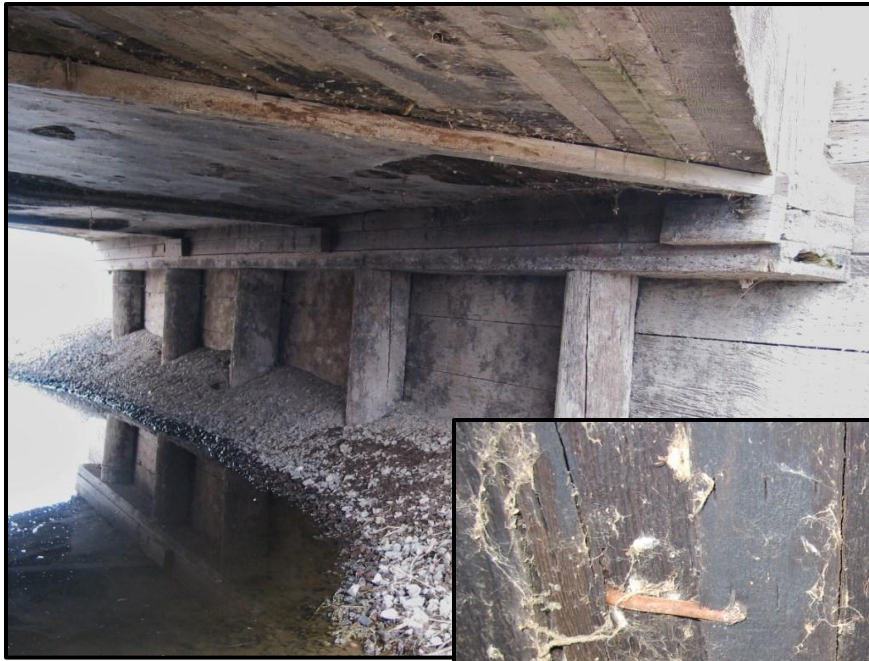
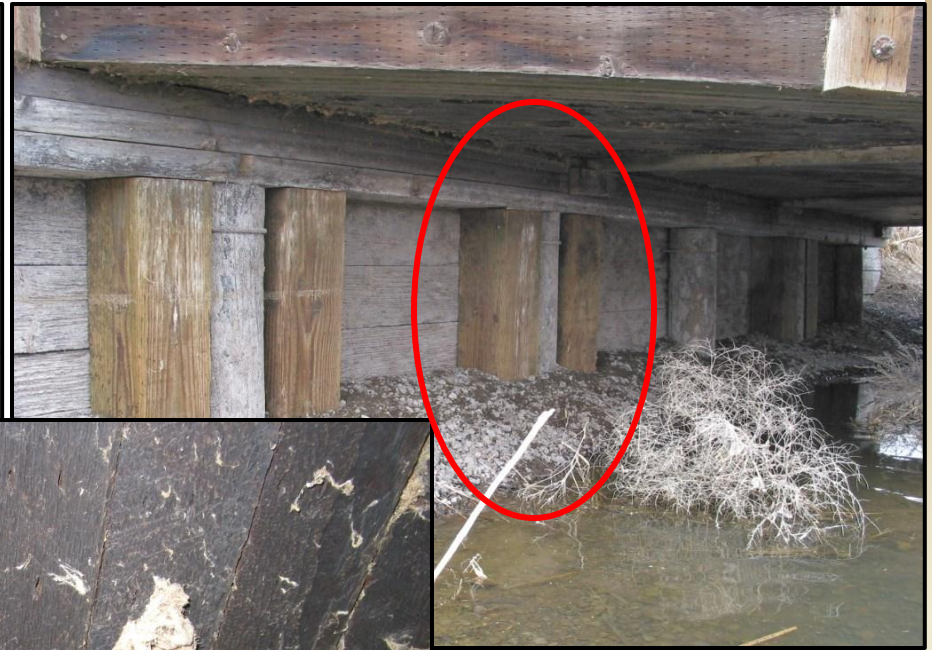
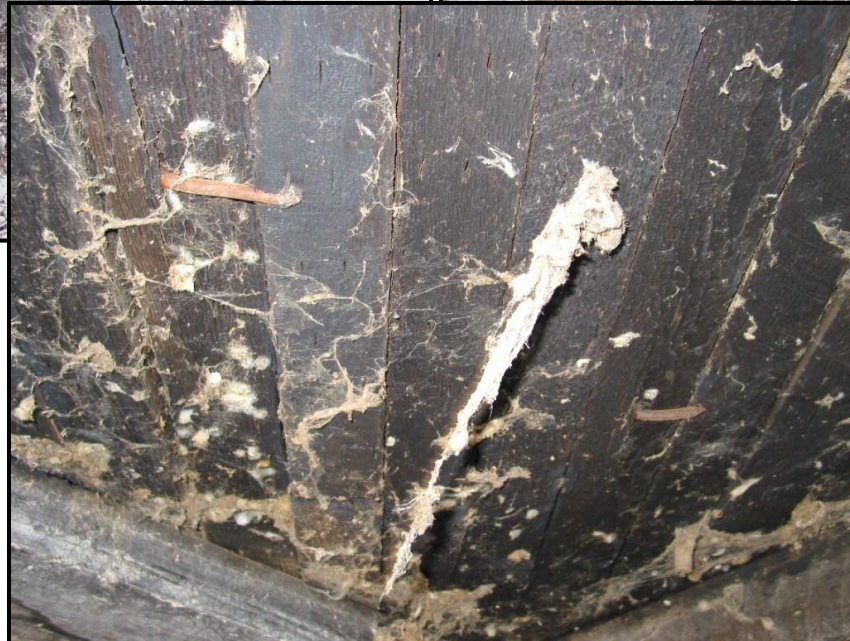
# Klamath County, OR Homedale Road Bridge

- Erected in 1963 – in service for 50 years
- 2 spans with total length of 13.5 m or 46 ft.
- Longitudinal sawn lumber slab deck with NBI rating of 7
- Carries an ADT of over 300 vehicles

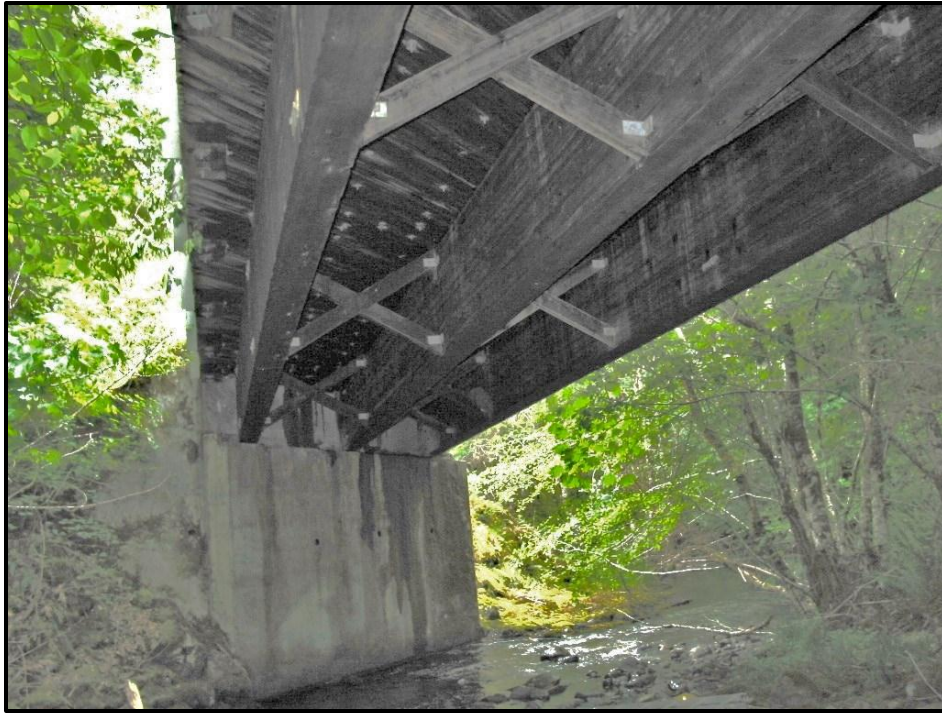
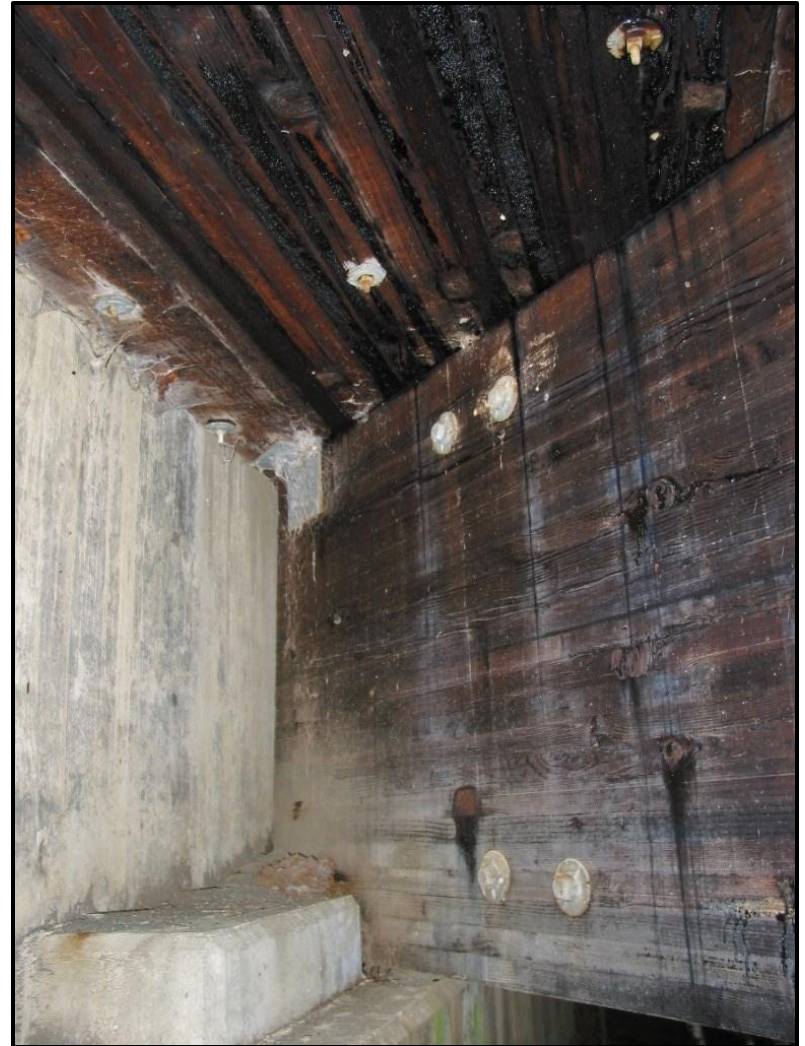
## Knopki Creek Bridge

- Erected in 1967 – in service for 46 years
- Glulam girders with transverse sawn timber deck
- Simple span with length of 14 m or 48 ft.
- NBI ratings of 7 for girders and 8 for deck

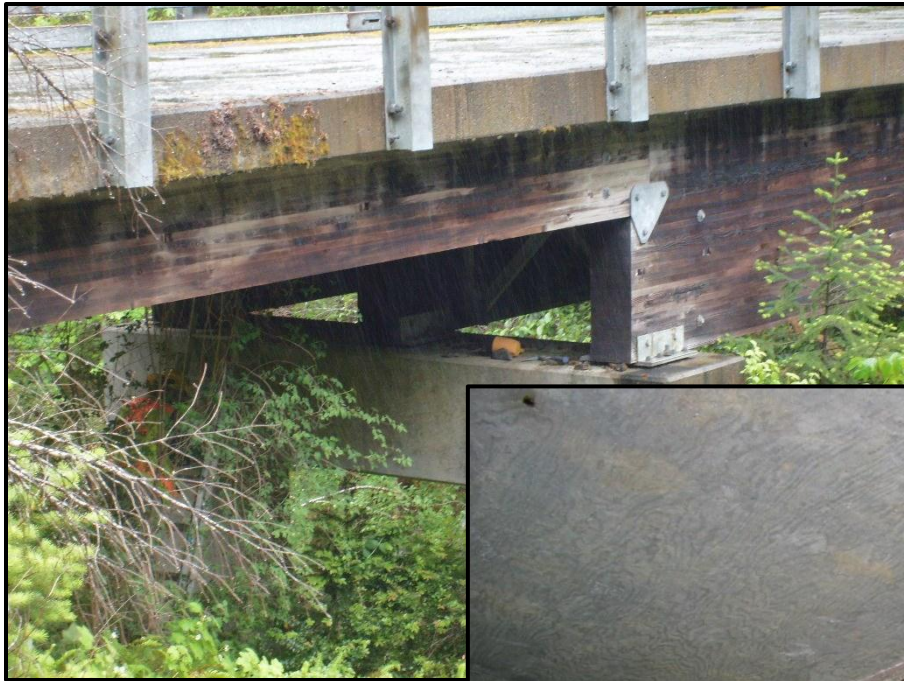
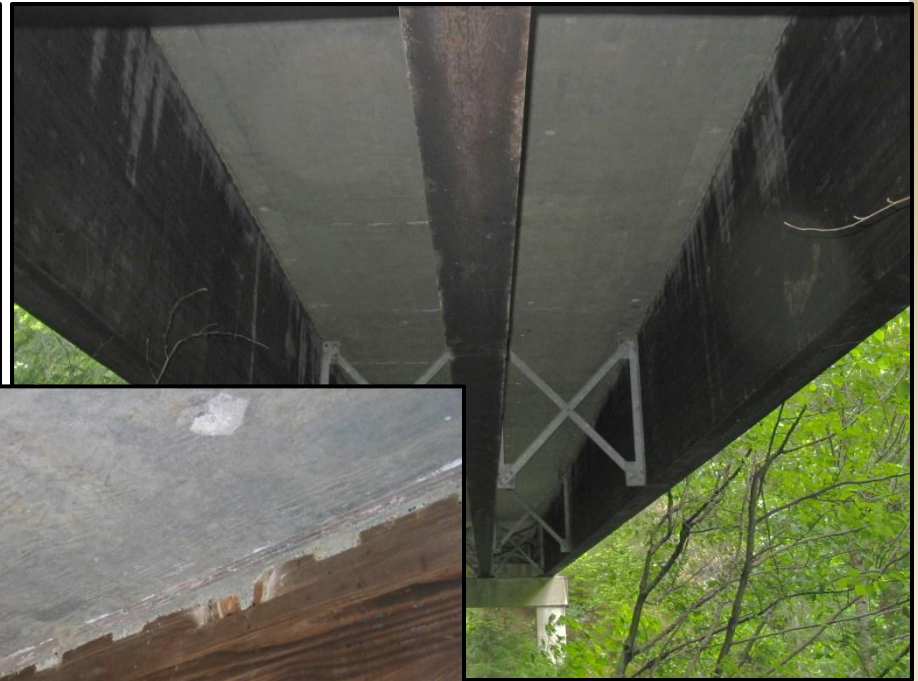
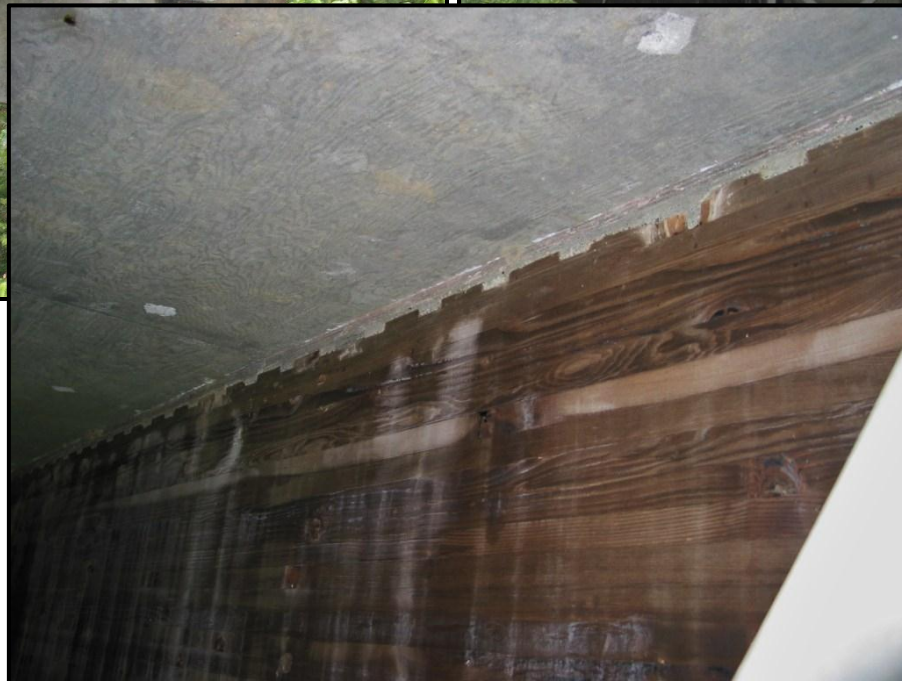
# Del Norte County, CA Middle Fork #2 Bridge

- Erected in 1973 – in service for 40 years
- Glulam girders with cast in place concrete deck
- Three spans with total length of 38.5 m or 130 ft.
- NBI ratings of 7 for girders and deck
