# Road Safety Audit for the US 61/ Harrison Street and West Locust Street Intersection in Davenport- Scott County, Iowa

**Final Report**  
**October 2008**

**Sponsored by**  
the Iowa Department of Transportation

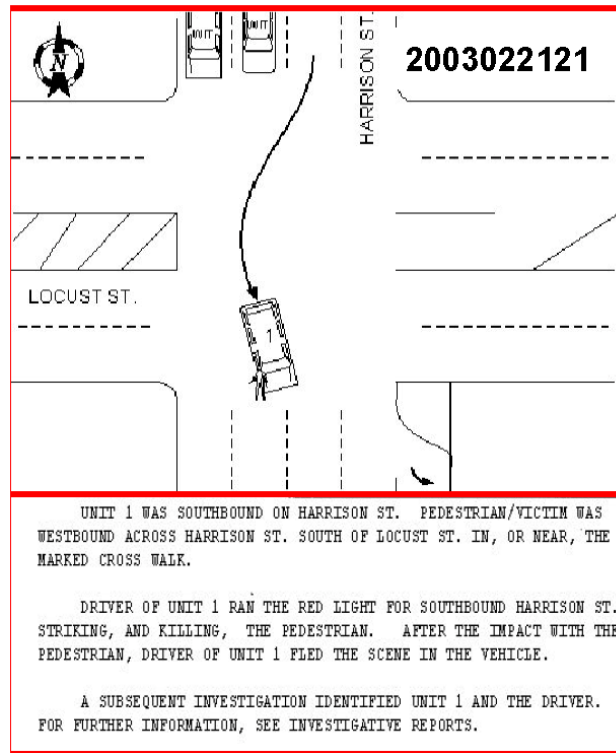
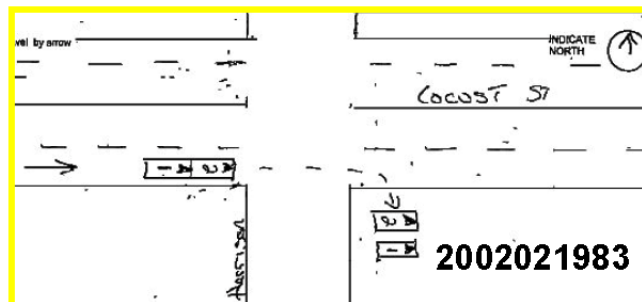
Figure B.3. Crash reports for the intersection

Describe what happened (refer to vehicles by number) UNIT 2 was stopped at the intersection of Locust & Harrison waiting for the light to turn green. UNIT 1 also heading southbound on Harrison St. UNIT 1 attempted to stop but was unable to & struck UNIT 2 in the rear.
