Cost-Effective Timber Bridge Repairs: Manual for Repairs of Timber Bridges in Minnesota

Minnesota
Department of
Transportation

Research Project
Final Report 2015-45B

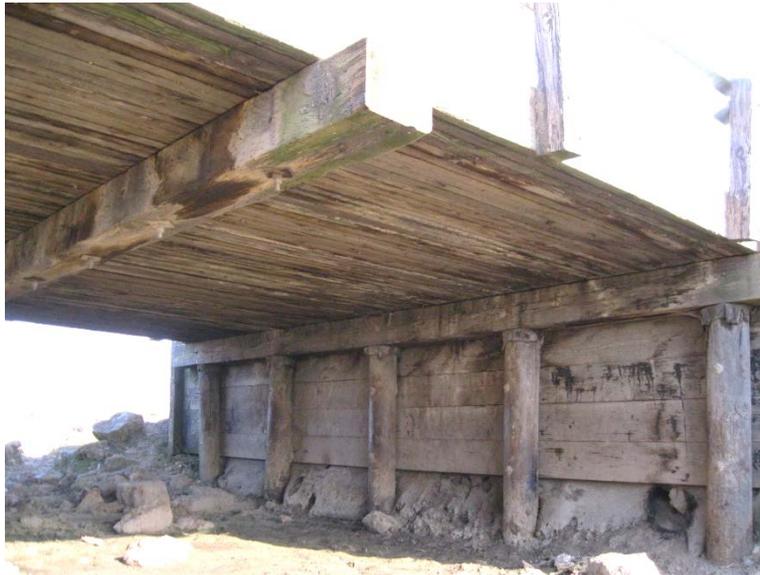
Figure 2-1 Common slab bridge underside

Slab bridges can be identified by the closely spaced, nail-, spike-, or dowel-laminated dimension or glued-laminated (glulam) lumber placed in the longitudinal direction of the bridge. Figure 2-1 and Figure 2-2 provide examples showing a slab bridge underside and topside, respectively.

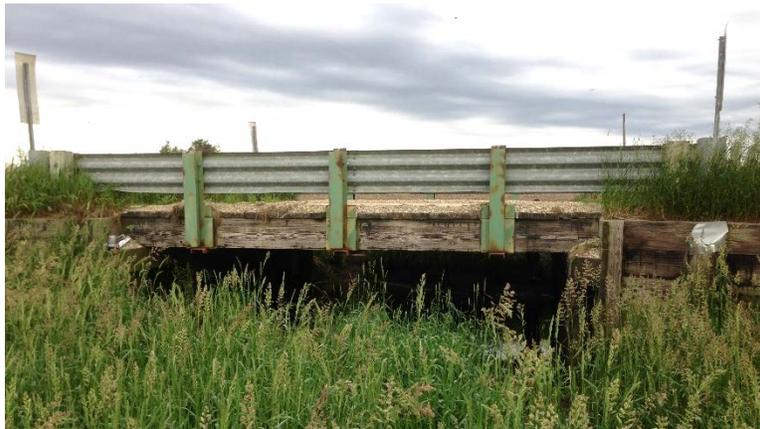
Figure 2-3 Timber girder bridge profile

Stringer bridges, like those shown in Figure 2-3 and Figure 2-4, can be identified by the full-sawn timber (sometimes glulam) stringers or girders placed in the longitudinal direction of the bridge with a transverse timber deck laid and attached to the top of the stringers.

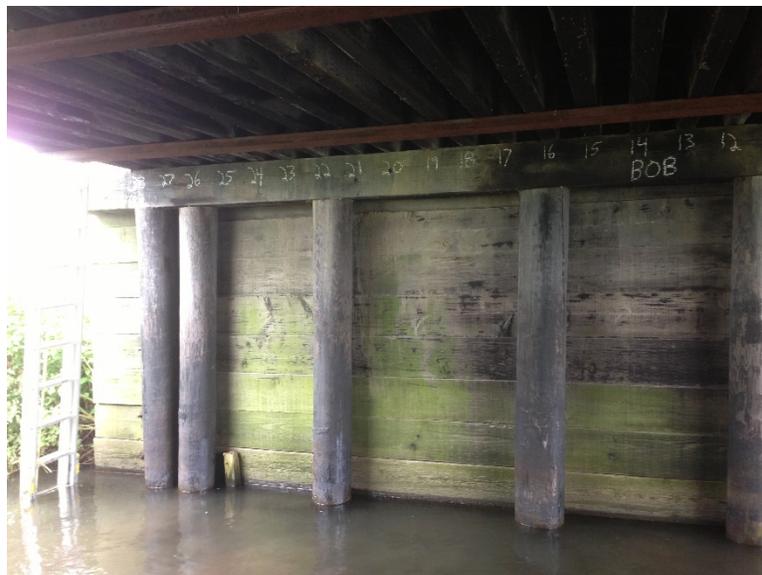
Figure 2-5 Timber substructure

Substructures can take on many forms. However, for timber slab and girder bridges, one of the more common configurations is made up of timber piles, timber pile caps, and timber backwalls and wingwalls. The pilings are typically Douglas fir or southern yellow pine, treated with creosote. Examples are shown in Figure 2-5 and Figure 2-6.

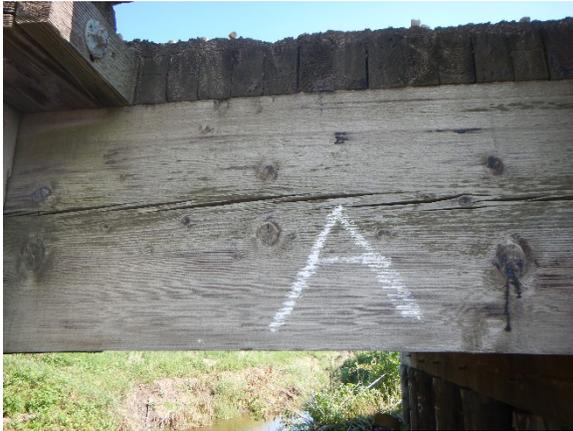
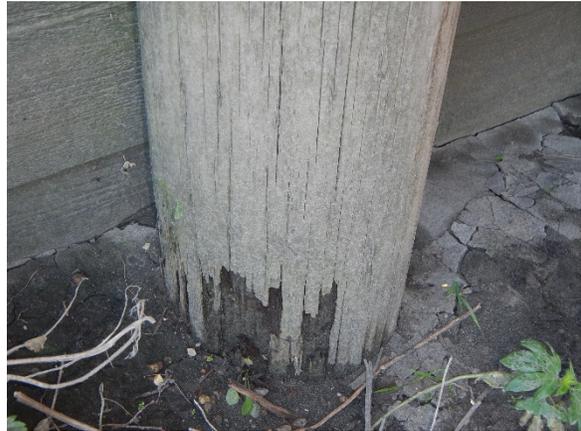
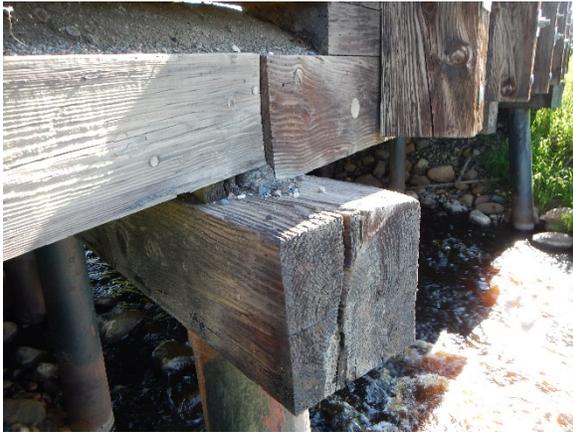
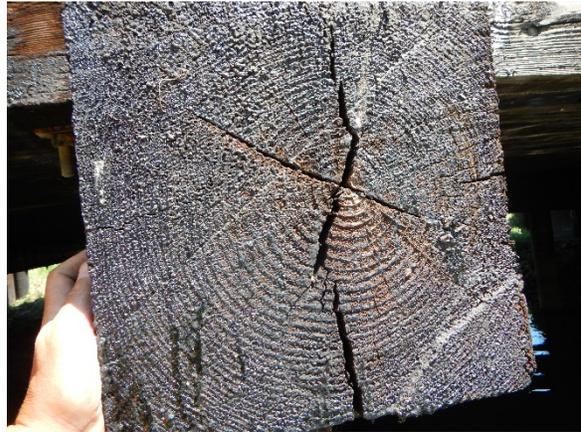
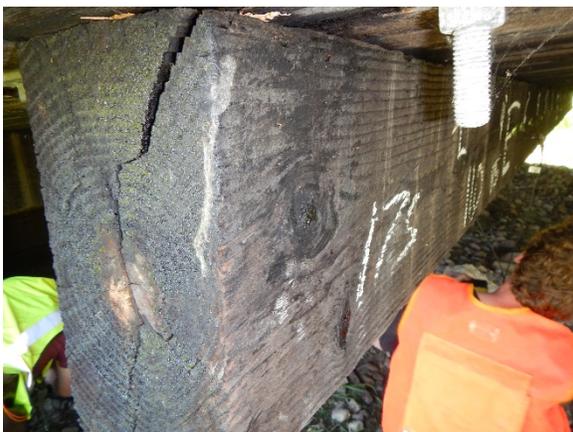
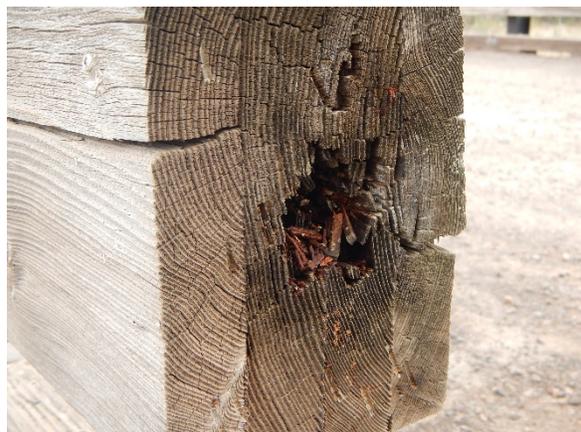
Figure 3-1 Examples of timber deterioration

Following are physical properties and defects that can be visually seen as indications of protective performance and degradation or may suggest areas of future concern (Bigelow et al. 2007). Several examples are shown in Figure 3-1.

Surface check

Surface decay

End grain split

End grain split and check

End grain decay

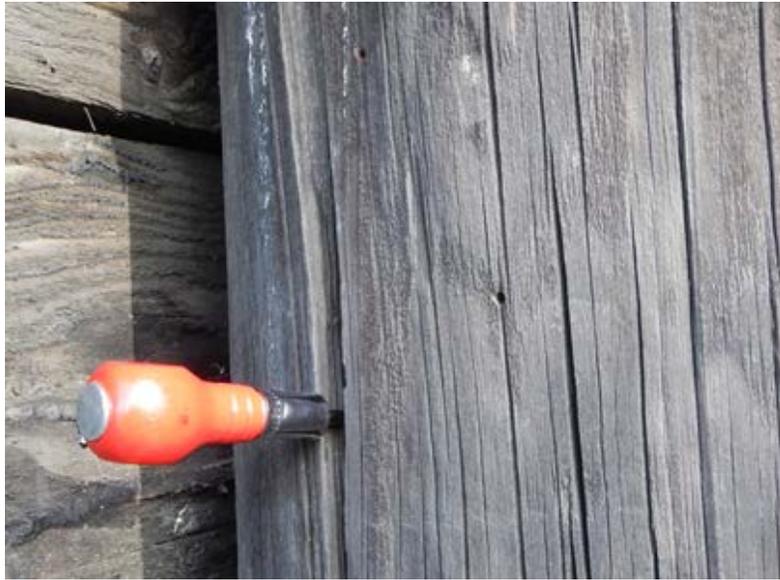
Figure 3-2 Probing and pick tests

Use of an awl or other sharp pointed tool like that shown in Figure 3-2 can be used to detect soft spots created by decay fungi or insect damage (Bigelow et al. 2007).

Probing can locate pockets of decay near the surface of the wood member or can be used to test the splinter pattern of a piece of wood. Non-decayed wood is dense and difficult to penetrate with the probe and results in a fibrous or splintering break (Wilcox 1983).

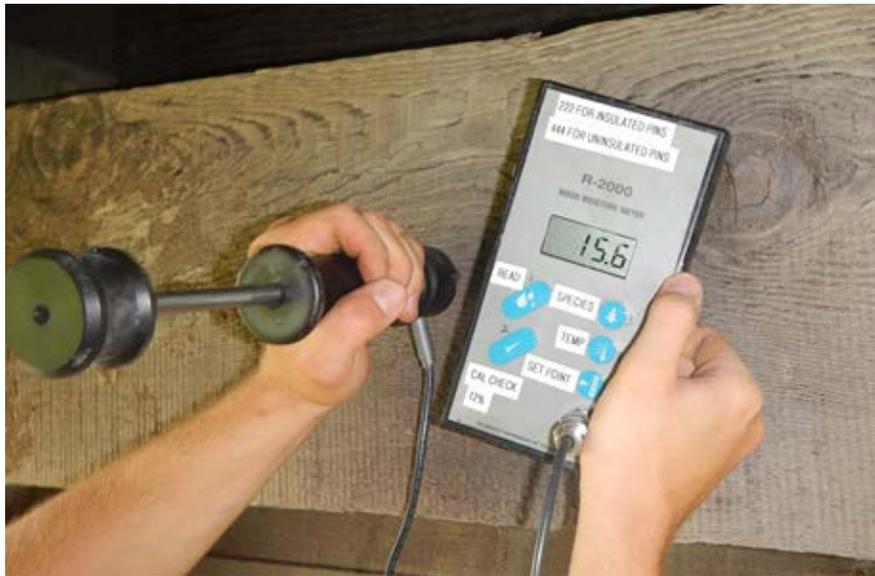
Figure 3-3 Moisture measurement

Moisture measurements are taken with an electronic hand-held moisture meter (Bigelow et al. 2007) like that shown in Figure 3-3.

The moisture meter consists of two metal pins that are driven into the wood. The meter displays the measurement of electrical resistance (moisture content) between the pins.

Moisture content greater than 20 percent indicates that enough moisture is present for decay to begin. Moisture measurements provide information on areas where water is being trapped, such as joints, and serves as an indicator that a more thorough assessment of an area with high moisture content is necessary.

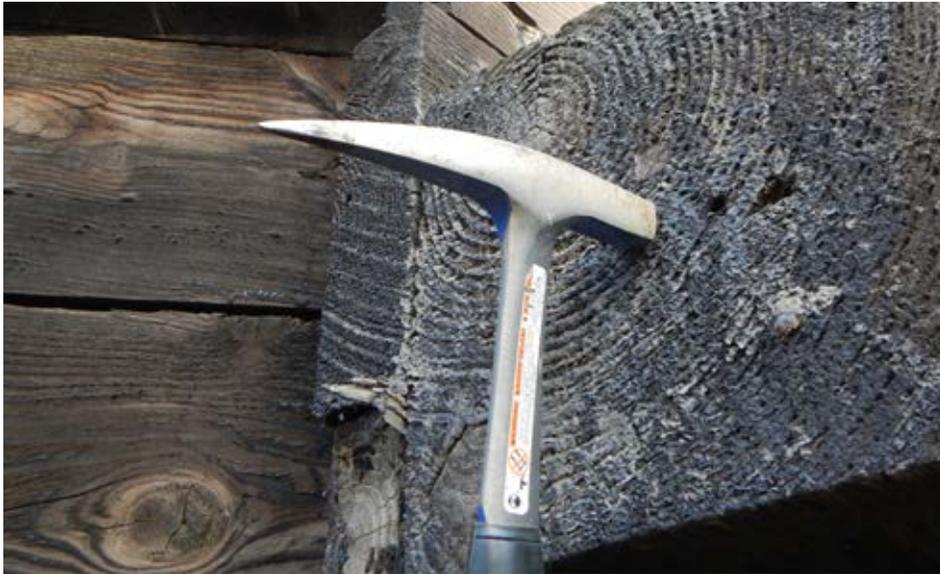
Figure 3-4 Hammer sounding

With the sounding method, shown in Figure 3-4, a hammer is used to strike the wood surface (Bigelow et al. 2007).

Based on the tone, the inspector might be able to differentiate a hollow sound created by a void or pocket of decay from the tone created by striking solid wood. Some experience is necessary for reliable interpretation of sounding given that many conditions can contribute to variations in sound quality. Sounding is best used in conjunction with other inspection methods (Ross et al. 1999).

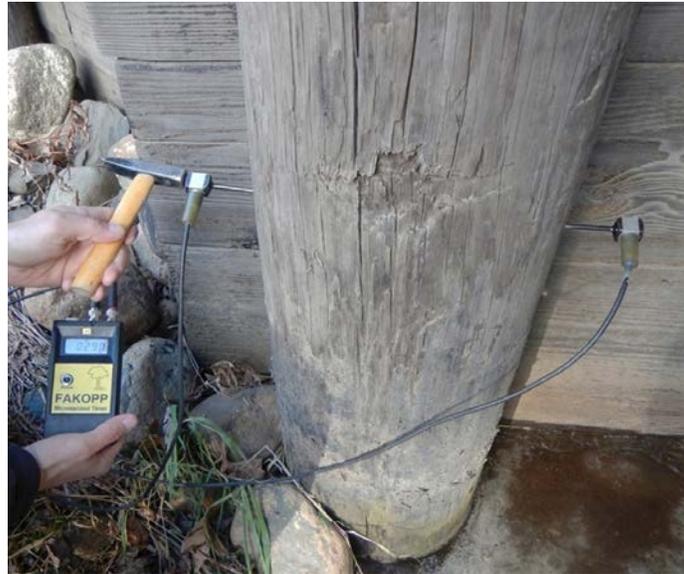
Figure 3-5 Stress wave timing

Stress wave devices like that shown in Figure 3-5 measure the speed (transmission time) at which stress waves travel through a wood member.

Stress wave measurements locate voids in wood caused by insects, decay fungi, or other physical defects. Stress wave signals are slowed significantly in areas containing deterioration. Because stress wave signals do not distinguish between active decay, voids, ring shakes or other defects, this method should be used with other inspection methods (Clausen et al. 2001).

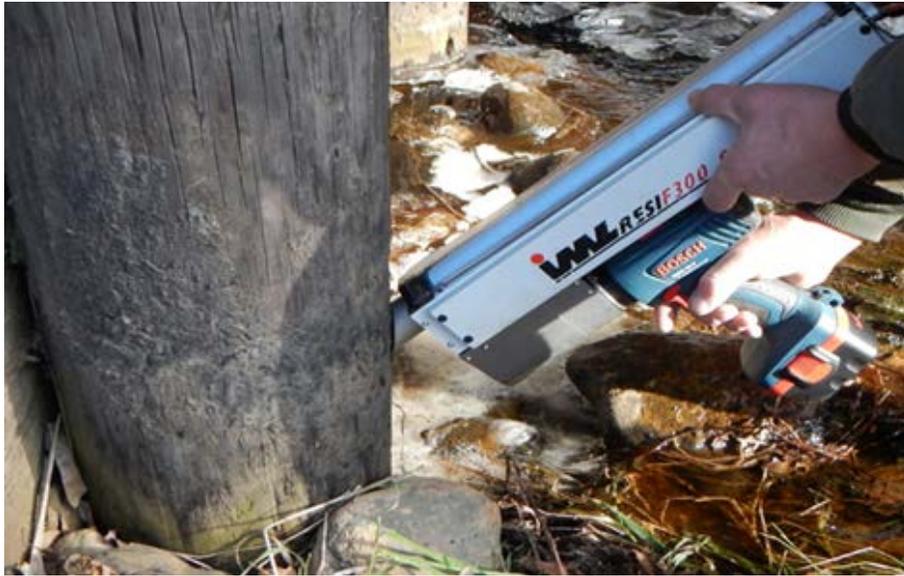
Figure 3-6 Drill resistance measurements

Drill resistance devices like that shown in Figure 3-6 record the resistance required to drill through a piece of wood.

The amount of resistance is related to the density of the wood in that particular area and can be used to determine if deterioration exists. This method should be used with other inspection tools (Emerson et al. 1998). The advantage of using drill resistance devices is that the cross-section of the location of drilling can be very accurately defined. Furthermore, the procedure is minimally invasive and non-destructive due to the small size of the drill bits.

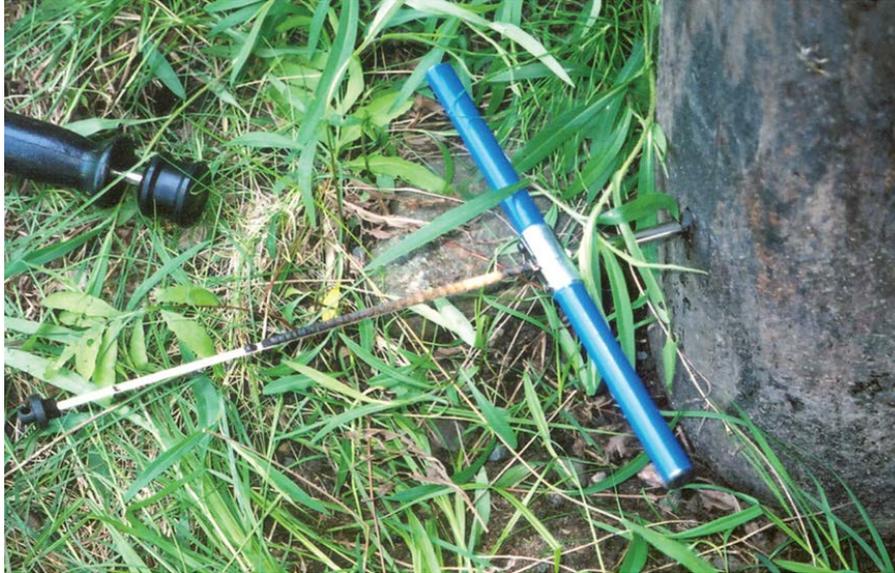
Figure 3-7 Core boring

Increment core borings are taken using the device shown in Figure 3-7.

Representative areas should be taken perpendicular to the face of the member being sampled (Bigelow et al. 2007). All test holes must be plugged immediately after extracting the increment core with a tight-fitting wood plug treated with a preservative similar in performance to the member being sampled. Increment cores can be visually examined for signs of deterioration and may be submitted to a laboratory for biological and/or chemical analysis.

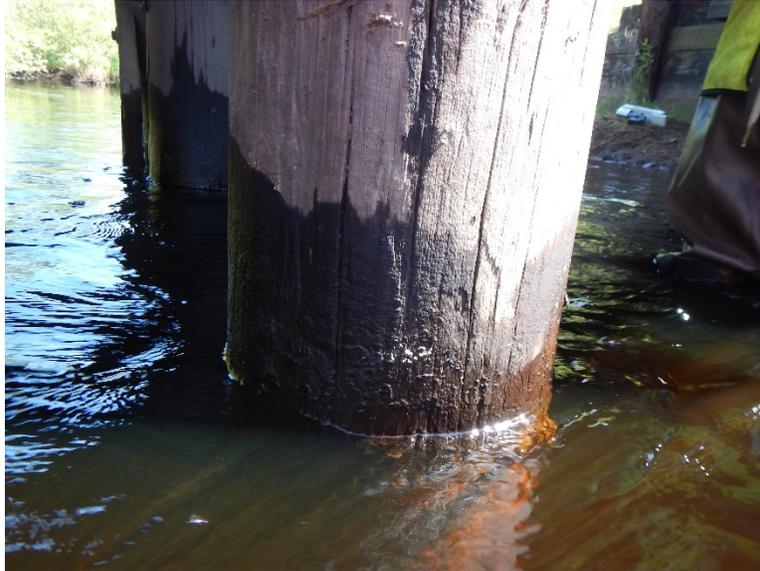
Figure 4-1 Moisture control

The best preventive maintenance method for timber is moisture control (White et al. 2007). Moisture control can be used as an effective technique to extend the service life of many timber piles, stringers, or other elements. For example, when exposure to moisture is reduced, timber piles will dry to moisture contents below that required for fungus and insect growth (Ritter 1992 and Seavey and Larson 2002). Timber abutments placed up and away from stream banks will have an extended service life compared to elements near the stream that are repeatedly going through wet and dry cycles. Given it is highly unlikely that pile locations will be moved on existing bridges, it is paramount to take note of particular piles that are apt to see wet and dry cycling like that shown in Figure 4-1 so special attention may be paid to these piles.

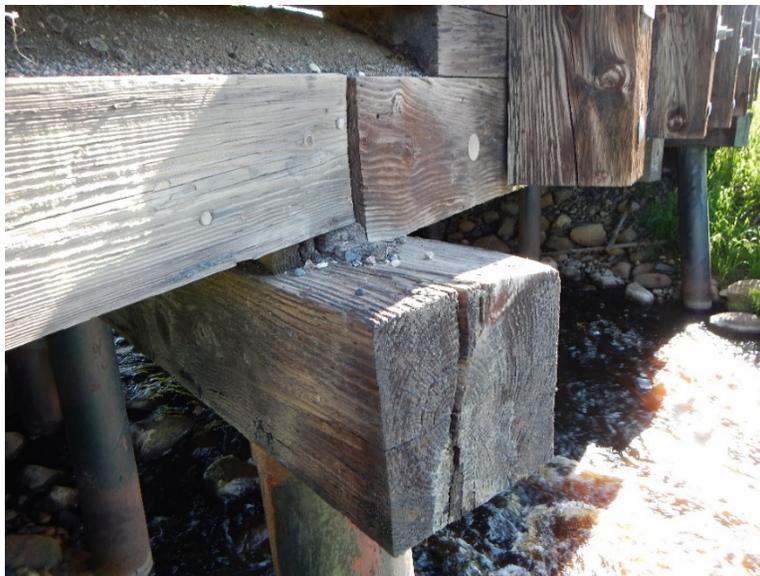
Figure 4-2 End grain treatment

Without preventive measures, the ends of timber members like that shown in Figure 4-2 are more susceptible to draw in water than other portions of the pile.

If the end has been cut, a timber treatment should be brushed on and, where exposed, capped with flashing (tin, aluminum, or similar material) with minimization of water exposure being the goal.

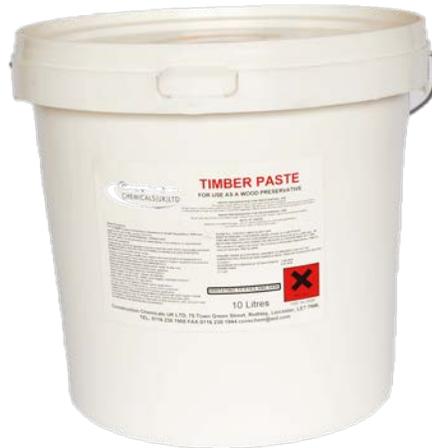
Figure 4-3 In-place treatments

In-place treatments are another common preventive maintenance technique applied to timber piles. Surface treatments, paste (Figure 4-3), and fumigants are three types of in-place treatment that are frequently used.

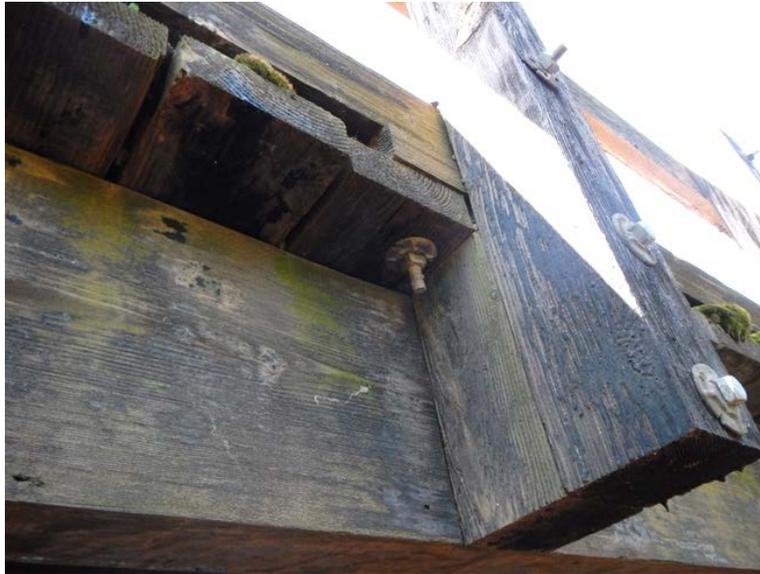
Figure 4-4 Fastener maintenance

The condition of all structural fasteners, like those shown in Figure 4-4, should be checked for corrosion and tightness.

Fasteners should be retightened to a snug-tight condition if loose. Where significant corrosion is present, fasteners should be replaced altogether.

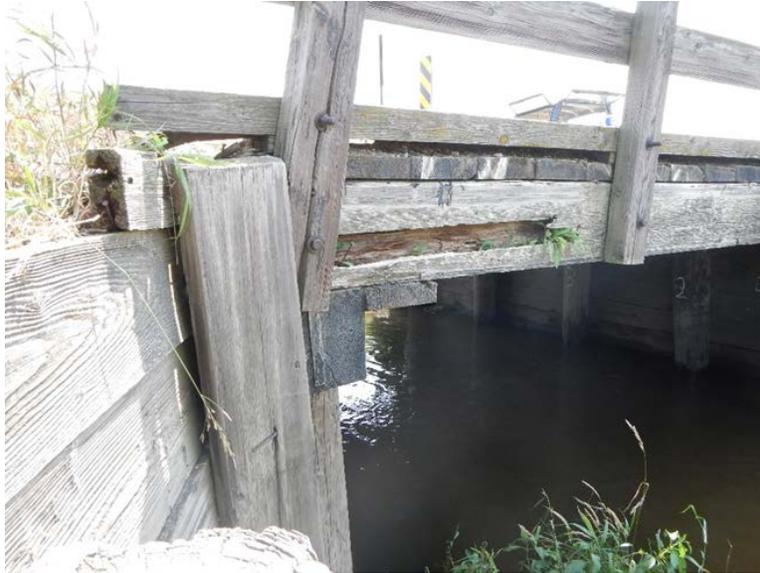
Figure 4-5 Outside stringer maintenance

The outside stringer on a timber bridge is more susceptible to deterioration due to its increased exposure to the elements, including rain, sunlight, and debris flow. An example is shown in Figure 4-5.

All dirt and loose decayed material should be removed and consideration given to adding flashing to prevent excessive wetting and further repairs if checks or splits are present.

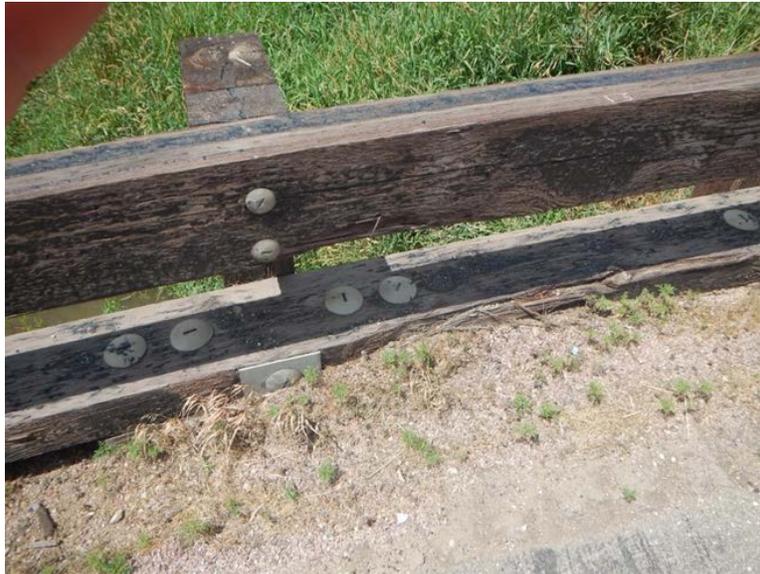
Figure 4-6 Deck drainage

Proper drainage on timber bridges is often impeded by the collection of road debris, gravel, and sand like that shown in Figure 4-6.

The inability for water to quickly exit the bridge deck could promote undue deterioration. It is common for debris to collect at the bridge deck edges; this debris should be removed. Some bridges may have scuppers that become filled. Likewise, the scuppers should be cleared of all debris to allow proper water passage.

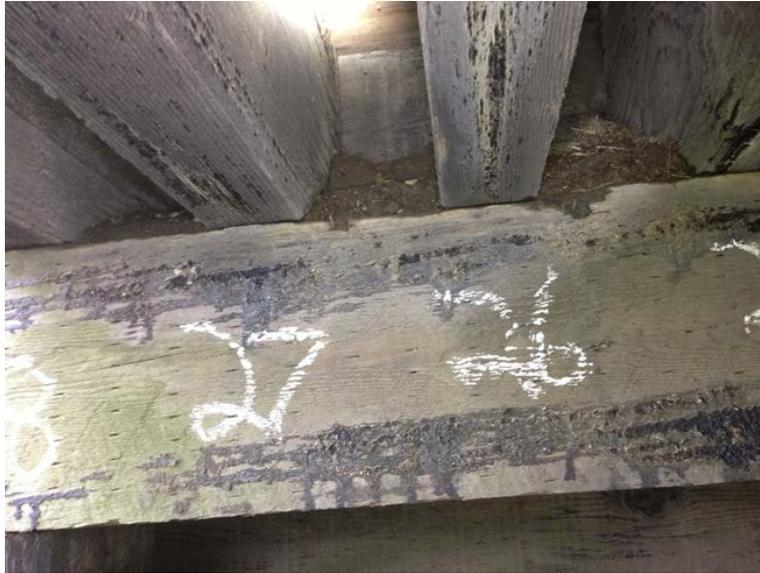
Figure 4-7 Debris removal from pile caps

Commonly, gaps between deck boards on timber bridge decks form and allow at least a nominal amount of debris to pass through. The debris is able to collect on top of pile caps, as shown in Figure 4-7, which can trap water against the pile cap.

Due to the retained moisture, deterioration of the pile cap advances at a quicker rate than would otherwise occur. If left alone, the pile cap could deteriorate to a point where sufficient support of the superstructure is compromised and complete replacement of the pile cap is necessary. Debris should be cleared or washed from the top side of pile caps to reduce chances of water retention.

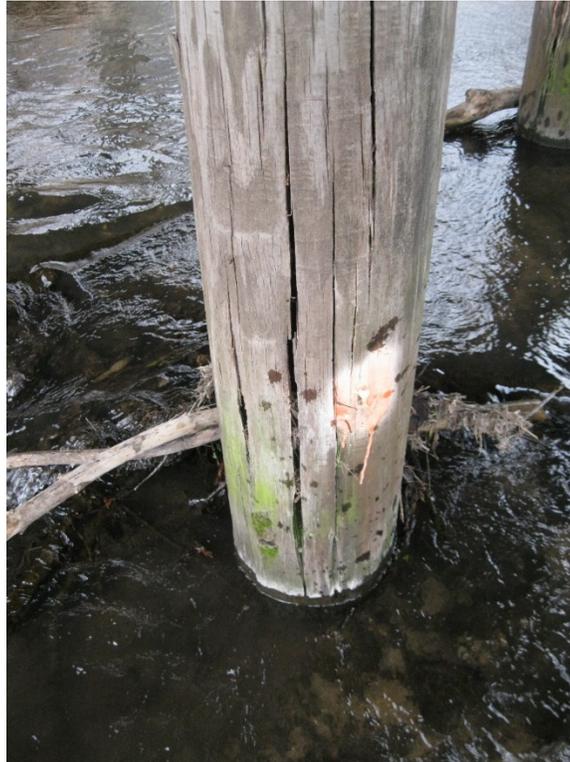
Figure 4-8 Crack repair

Small to medium cracks and splits caused by weathering or shrinkage similar to those shown in Figure 4-8 create pathways for decay fungi to enter the untreated wood at the core of the timber pile (White et al. 2007).

Therefore, cracks and splits must be repaired regularly. Epoxy grout can be injected under pressure to fill checks and splits. The epoxy seals the affected area, preventing water and other debris from entering. It can also restore the bond between separated sections, increase shear capacity, and reduce further splitting. Low viscosity epoxy is injected to fill the void, which is then sealed using a sealing epoxy (US Army Corps of Engineers 2001 and Ritter 1992).

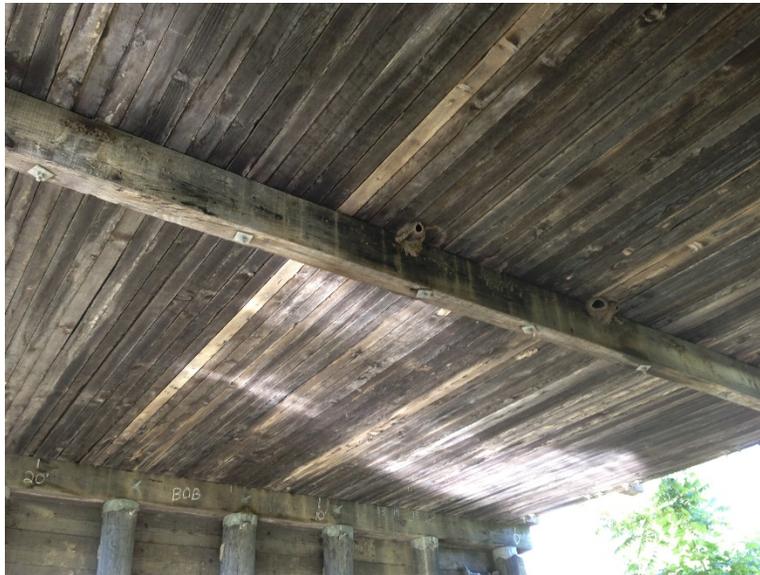
Figure 5-1 Repair of laminated decks

This method is used to repair a dowel-laminated deck (which is also known as a Wheeler deck), as shown in Figure 5-1, that has an area or areas of deterioration extending to either partial depth or full depth.

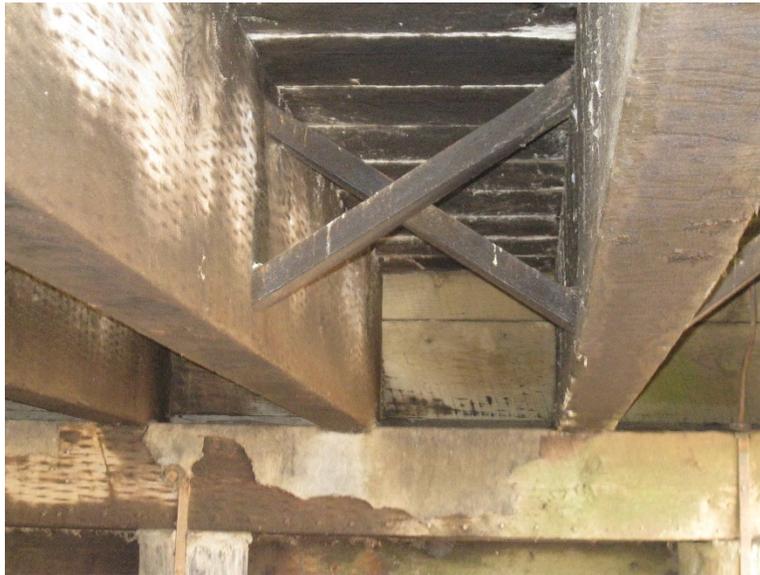
Figure 5-9 Strengthening of individual timber stringers

This method is used to strengthen timber stringers or girders that have localized minor to moderate deterioration that has weakened the overall strength of the member at the ends or along the span. See Figure 5-9.

Attach steel members to timber stringer or girder using through bolts or lag bolts.

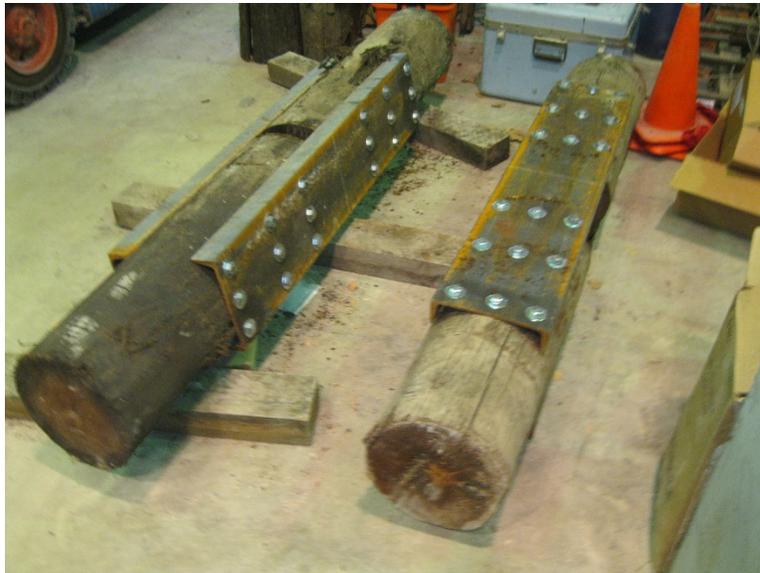
Figure 5-14 Addition of steel sisters for pile reinforcement

Attach steel channels to timber piles using through bolts or lag bolts as shown in Figure 5-14.

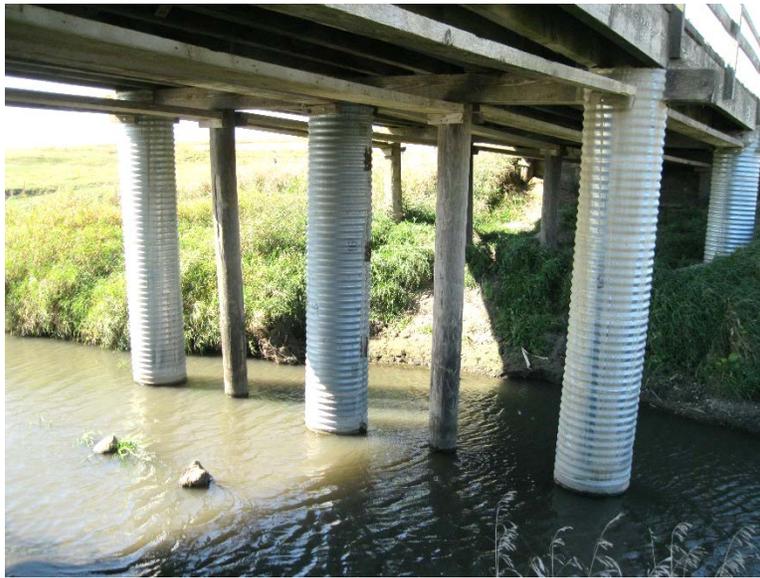
Figure 5-16 Addition of pile jackets

Timber piles are partially encased within a concrete-filled steel shell as shown in Figure 5-16.

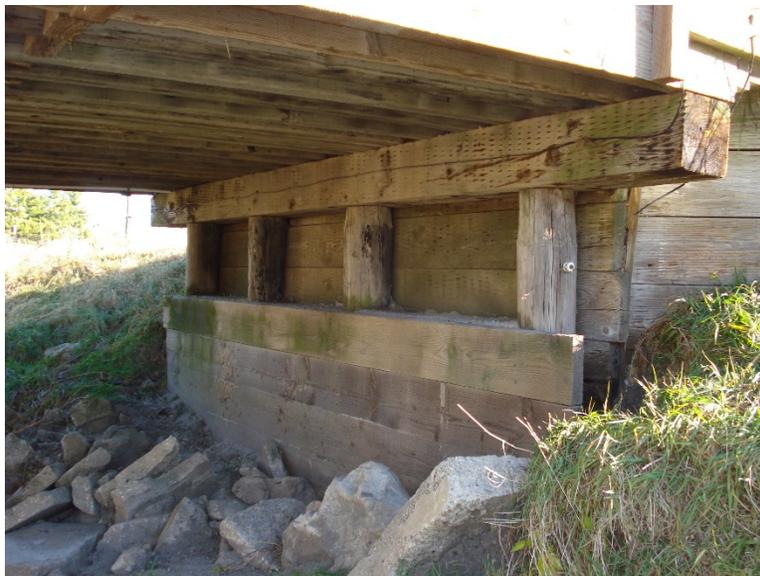
Figure 5-18 Pile encapsulation at abutment

A group of piles, within which deterioration/damage is present on multiple piles, is encapsulated in a reinforced concrete grade beam, tying each pile together and strengthening the overall pile group as shown in Figure 5-18.

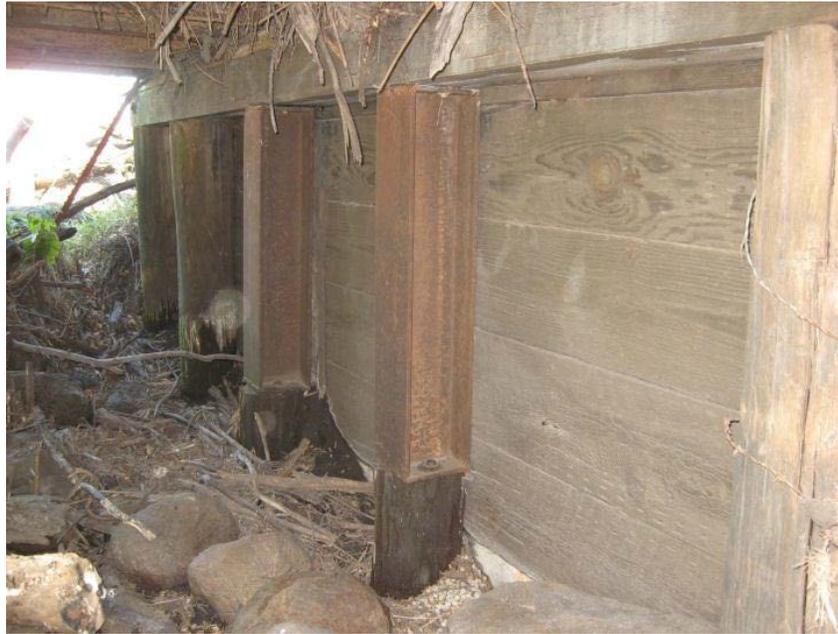
Figure 7-2 Posted piles using steel W shapes

A method of posting used in Iowa is shown in Figure 7-2 (Dahlberg et al. 2012).

Here, W shapes take the place of deteriorated portions of the pile. The method requires that the pile be cut below the area of deterioration at a sound, non-deteriorated location. It is at this location where a steel member is placed between the top of the remaining pile and the pile cap above and then lagged into place at both the top and bottom.

This posting method requires precision that may not always be achievable in the field. The steel must be fabricated to exactly fit the area between the remaining pile portion and pile cap. Moreover, full bearing between the pile and post or post and pile cap is rarely seen. One method to help alleviate the problem of non-fitting steel members was introduced by researchers at Iowa State University (Dahlberg et al. 2012). The method created the ability to vertically adjust the steel member to fit in a desired location using leveling nuts and a threaded rod, which are attached to angles that are lagged to the pile (see Figure 7-3).
