CROSSINGS

NEWSLETTER OF THE WOOD IN TRANSPORTATION PROGRAM

Issue 29

De-icing Salts, Timber Decks, and Steel Beams

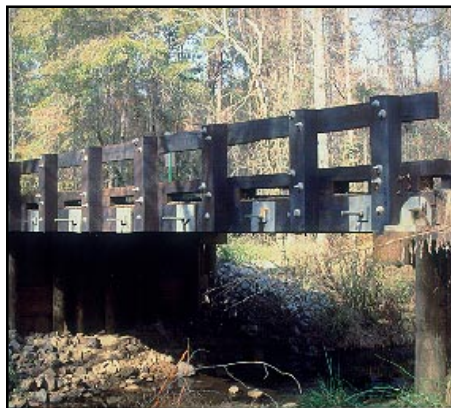
This timber bridge located in Putnam County has a stress-laminated deck, 30-feet long by 16-feet wide, constructed from southern yellow pine and treated with Pentachlorophenol.
