Optimized Joint Spacing for Concrete Overlays with and without Structural Fiber Reinforcement

Final Report
May 2019

National Concrete Pavement
Technology Center

Sponsored by
Iowa Highway Research Board
(IHRB Project TR-698)
Iowa Department of Transportation
(InTrans Project 15-559)

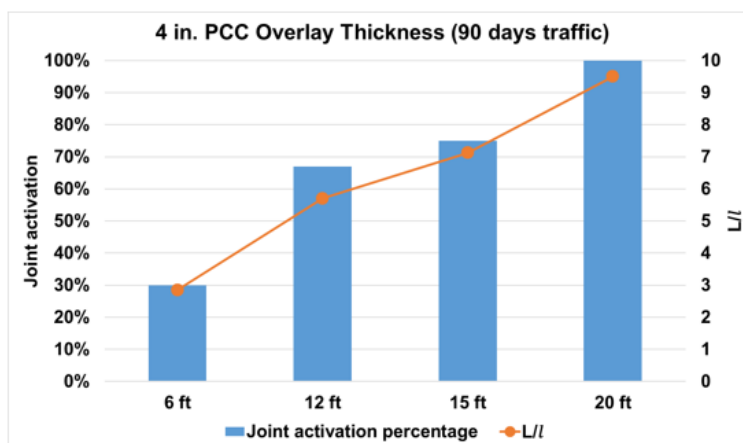
Joint activation vs. L/ℓ and joint spacing for Mitchell County concrete overlay test sections

- Designing joint spacing to achieve L/ℓ between 4 and 7 may provide the desired balance between maximum, timely joint activation and good overlay performance.

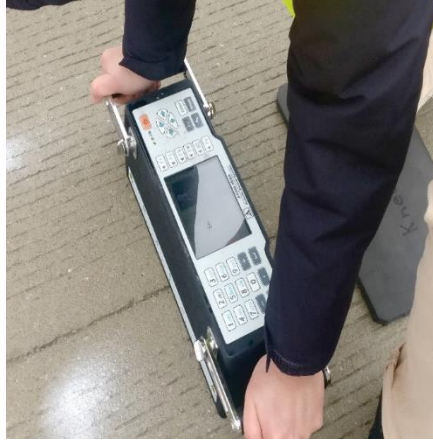
Figure 3. MIRA device used to gather joint activation data

Field information gathered on existing overlays supplemented the software analysis. A non-destructive testing procedure was utilized to determine the amount of joint activation (see Figure 3).

Joint activation data were collected using a MIRA device with an antenna composed of a 4×12 array of point transducers. Interpretation of the data collected by the device to assess joint activation was developed at the University of Illinois (Tran and Roesler 2019). The system uses an ultrasonic pitch-catch method to evaluate internal defects in a concrete element. In the pitch-catch method, one transducer sends a stress-wave pulse at 35 kHz, and a second transducer receives the reflected pulse.

Data from the MIRA device can be used to determine whether a sawn joint in the concrete is activated based on whether or not the crack is deployed given the fact that an air gap in a crack will reflect the pulse, while an uncracked section will permit the pulse to pass through relatively unchanged. The device is placed over the sawcut so that half the transducers are on each side of the cut.

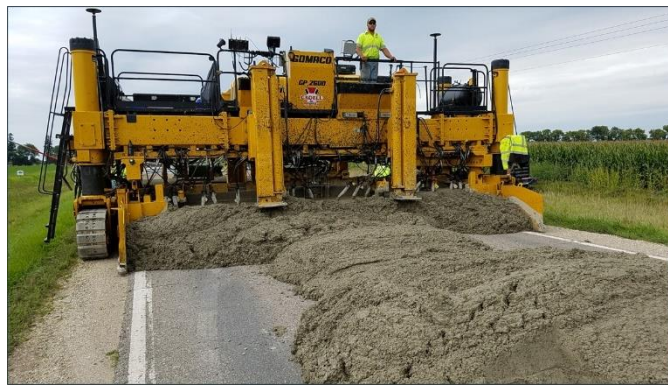
Figure 4. Mitchell County test section paving

Phase 2B included the construction of new overlay projects, with test sections of various joint spacing and thicknesses, with and without fibers (see Figure 4).

Test sections were constructed in Mitchell County of a bonded concrete overlay on asphalt (BCOA) and in Buchanan County of an unbonded concrete overlay on concrete (UBCOC).

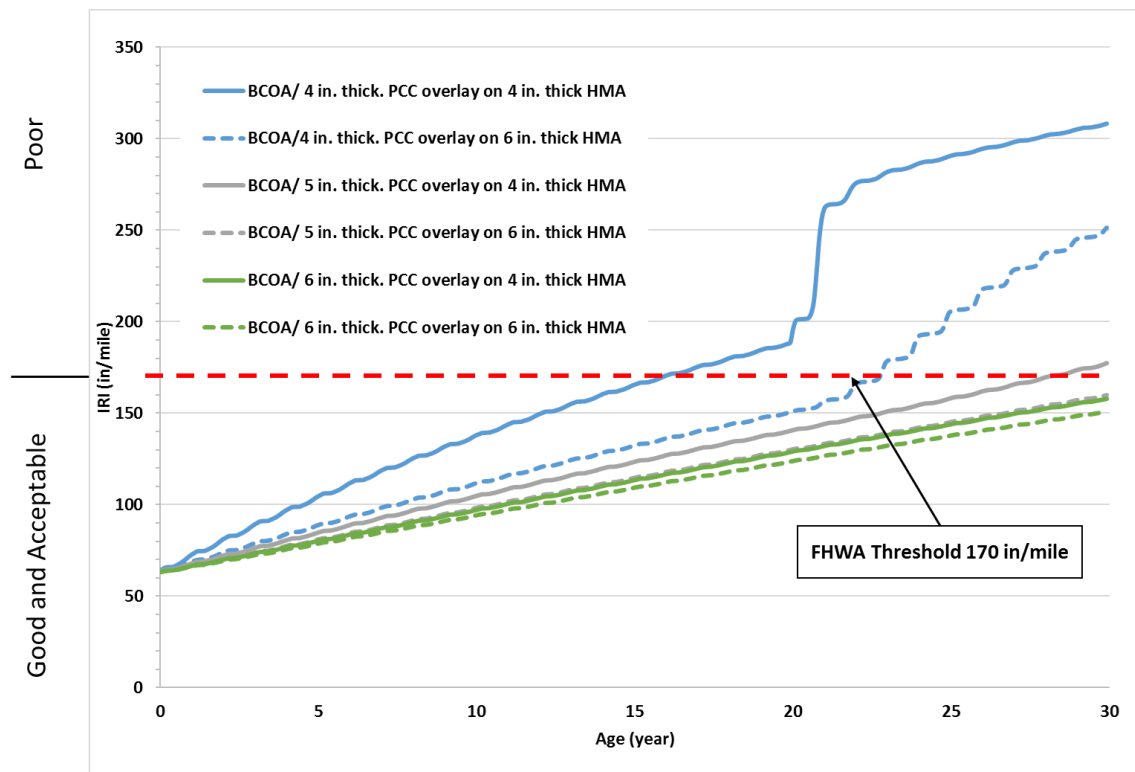
For the 12-foot joint spacing of 4- to 6-inch thick BCOA (Figure 5):

- Concrete overlays perform better when placed on thicker asphalt concrete (AC) pavements.
- The thicker the concrete overlay, the better the performance.
- The large increase in IRI in approximately year 20 and year 22 for the 4-inch thick BCOA on 4-inch thick asphalt coincides with the fact that the Pavement ME software does not recommend a thin concrete overlay (4-inch thick) for joint spacing 12-foot or larger.

Figure 5. 12-foot joint spacing concrete overlays Pavement ME Design predicted IRI values versus age: BCOA

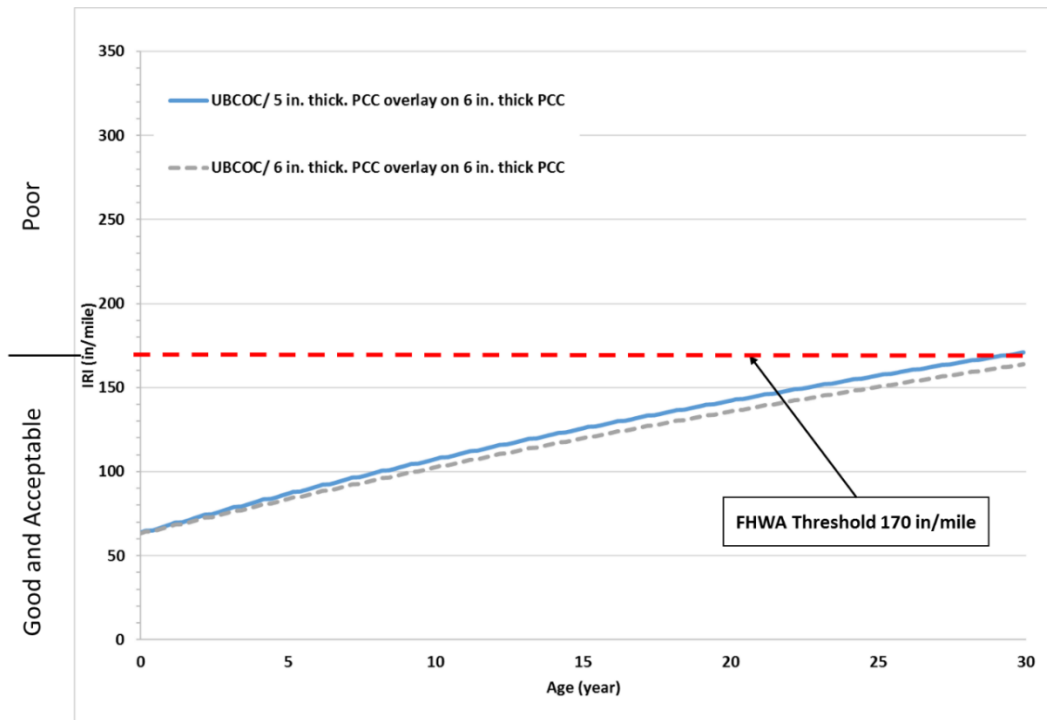
The key finding in Figure 6 for the 12-foot joint spacing of 5-inch to 6-inch thick UBCOCs on existing 6-inch thick concrete is that they perform well with a service life of approximately 30 years before an IRI threshold of 170 in./mi is reached.

Figure 6. 12-foot joint spacing concrete overlays Pavement ME Design predicted IRI values versus age: UBCOC

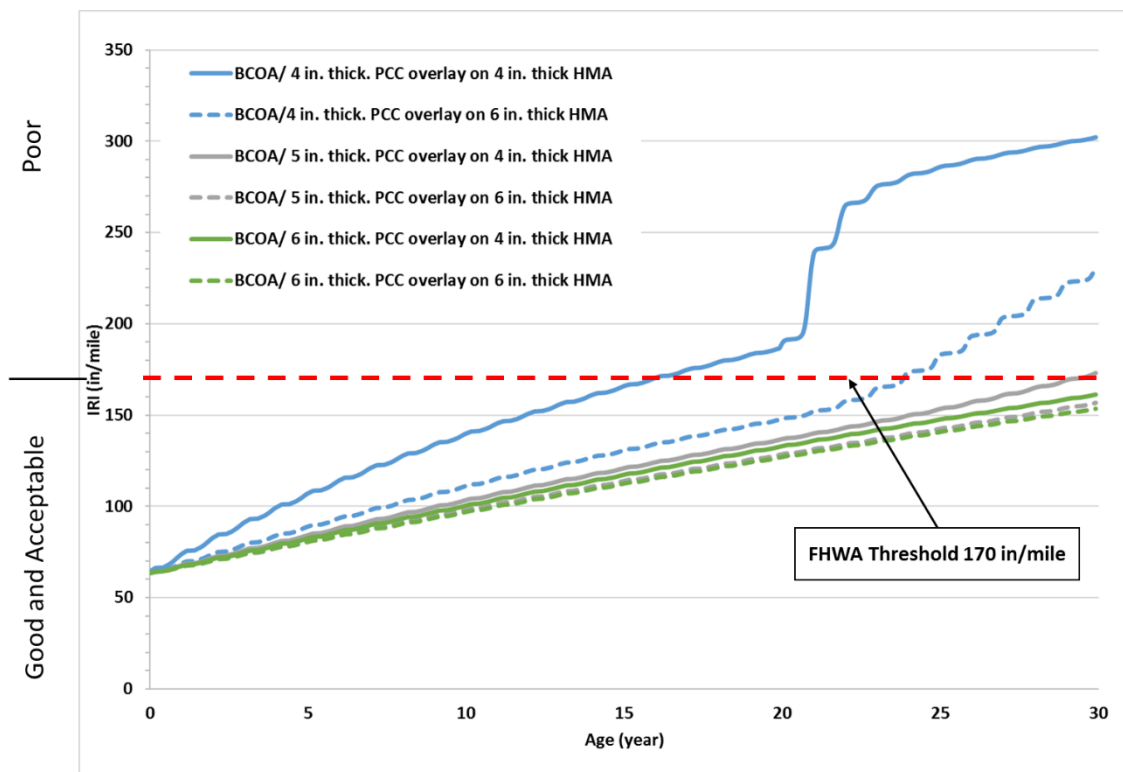
For the 15-foot joint spacing of 4-inch to 6-inch thick BCOAs (Figure 7):

- Concrete overlays perform better when placed on thicker AC pavements.
- The thicker the concrete overlays, the better the performance.
- The large increase in IRI in approximately year 21 for the 4-inch thick BCOA on 4-inch thick asphalt and year 22 on the 6-inch thick asphalt coincides with the fact that the Pavement ME software does not recommend a thin concrete overlay for joint spacing 12-foot or larger.

Figure 7. 15-foot joint spacing concrete overlays Pavement ME Design predicted IRI values versus age: BCOA

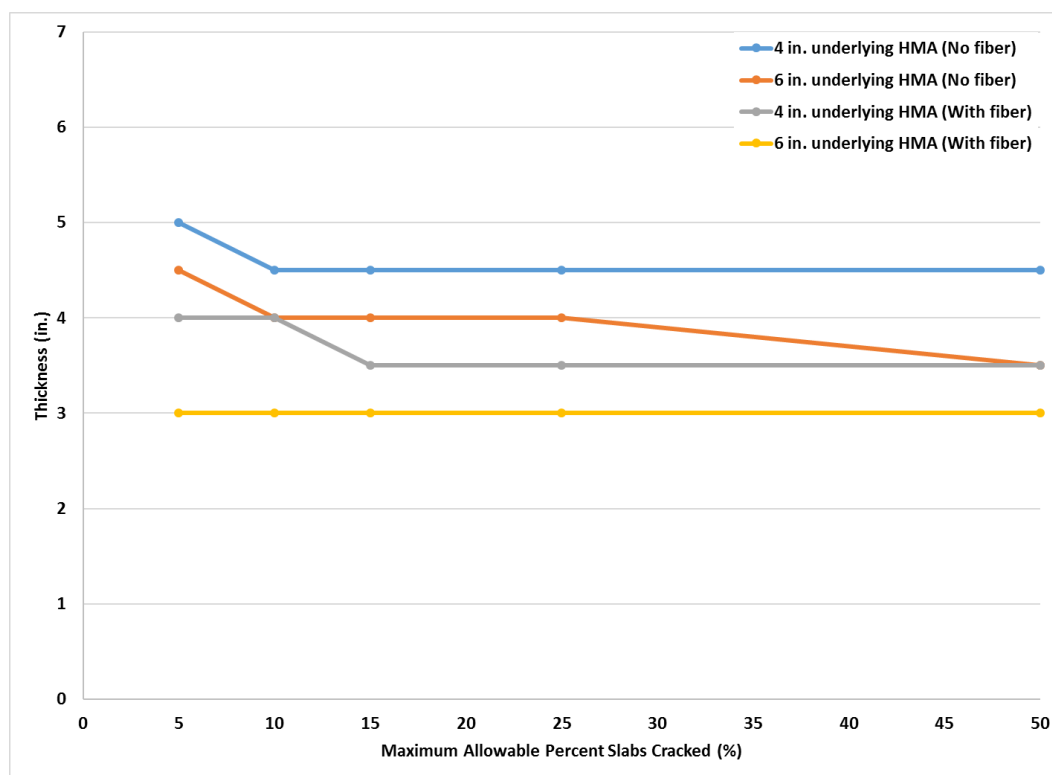
As shown in Figure 11, for concrete overlays with 6-foot joint spacing:

- Recommended concrete overlay thicknesses decreased with increasing thicknesses of underlying AC.
- Recommended concrete overlay thicknesses decreased with the use of fibers.

Figure 11. 6-foot joint spacing concrete overlays using BCOA-ME design predicted thickness versus maximum allowable percent of cracked slabs

Using BCOA-ME software, Figures 11 through Figure 13 were developed to show the relationship between the software recommended concrete overlay thickness and maximum allowable percentage of cracked slabs for different joint spacing. In each of the figures, existing AC thicknesses of 4-inch and 6-inch were analyzed.

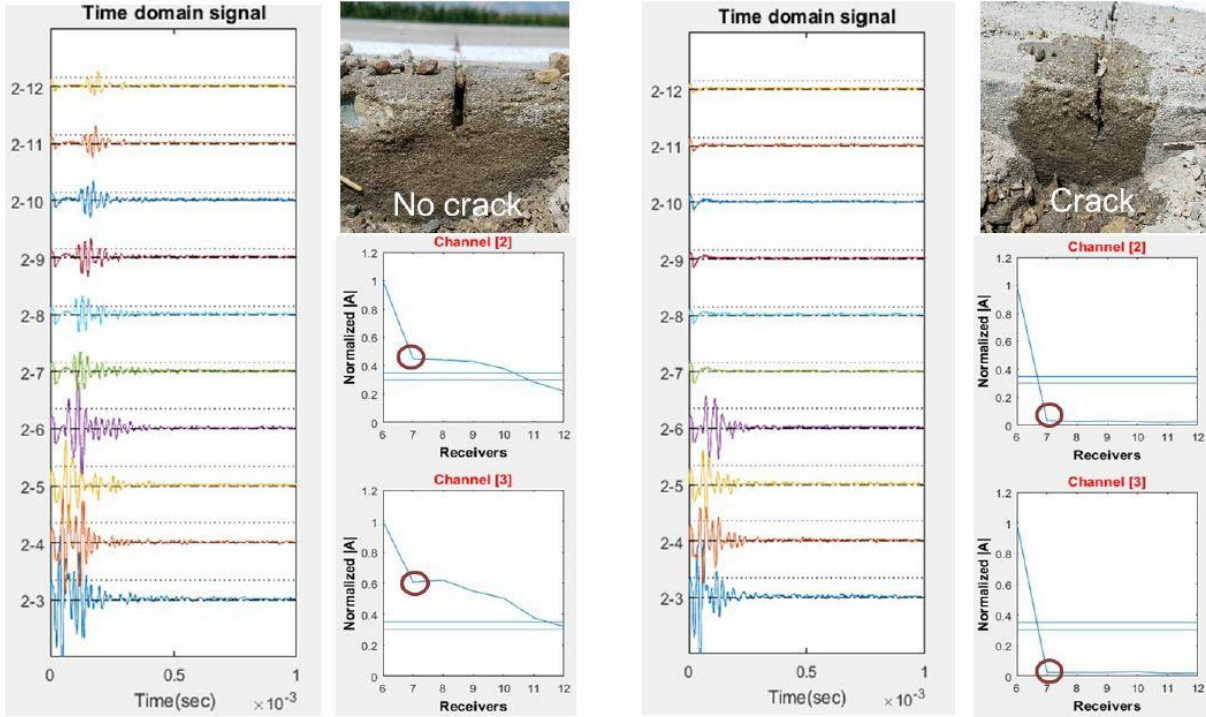
As shown in Figure 14, if the energy at receiver 7 is higher than 0.35, it indicates there was no crack deployment at the joint because energy was transferred to the sensor on the other side of the sawcut.

Figure 14. MIRA analysis results for joint activation

Conversely, normalized energy lower than 0.3 at receiver 7 suggests there was crack deployment at the joint. A normalized energy reading between 0.35 and 0.3 indicates either a very tight crack beneath the sawcut or no crack beneath the sawcut, and the data in such cases are reported as inconclusive. Tran and Roesler (2019) reported the method has an accuracy of 96% based on a visual check.

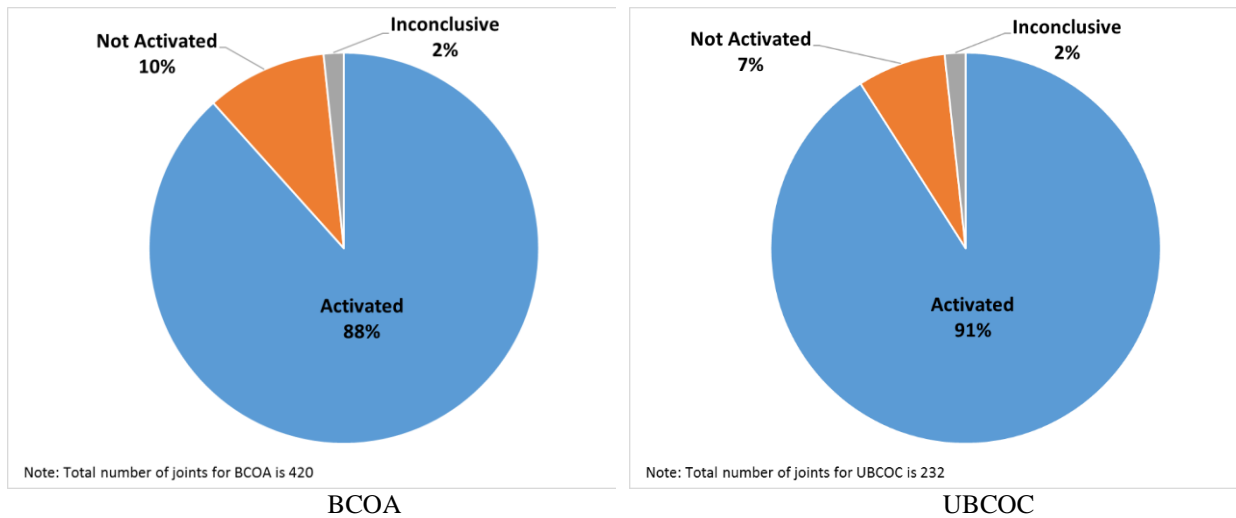
As shown in Figure 15, joint activation did not vary with overlay type (BCOA vs. UBCOC).

Figure 15. Percentage of joints activated for different concrete overlay types

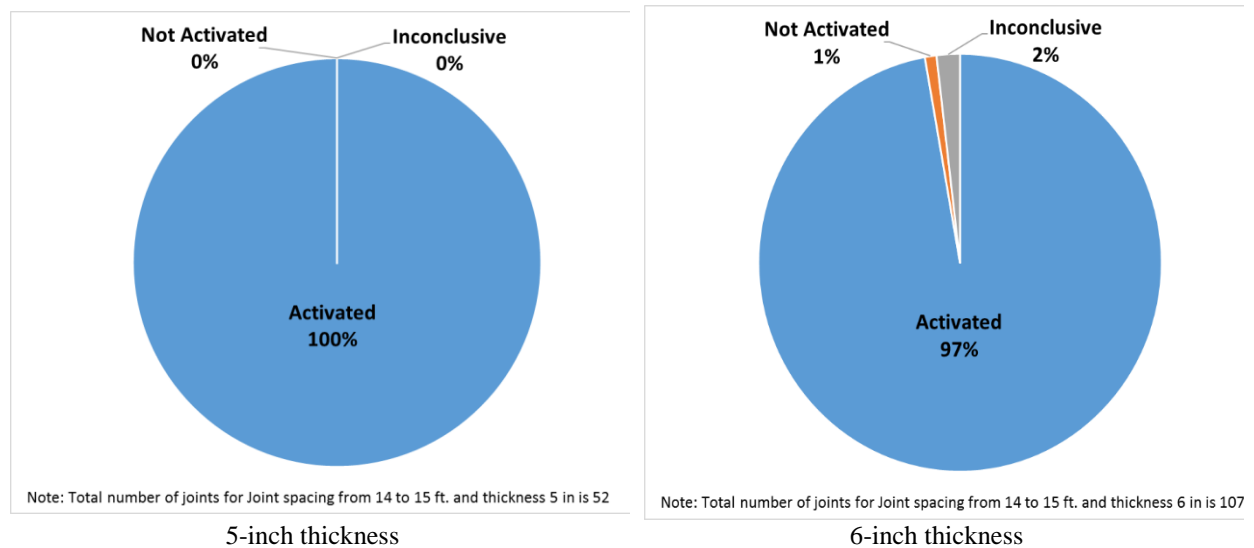
As shown in Figure 19, for 14- to 15-foot joint spacing, most of the joints were activated.

Figure 19. Percentage of joints activated for different thickness of 14- to 15-foot joint spacing overlays

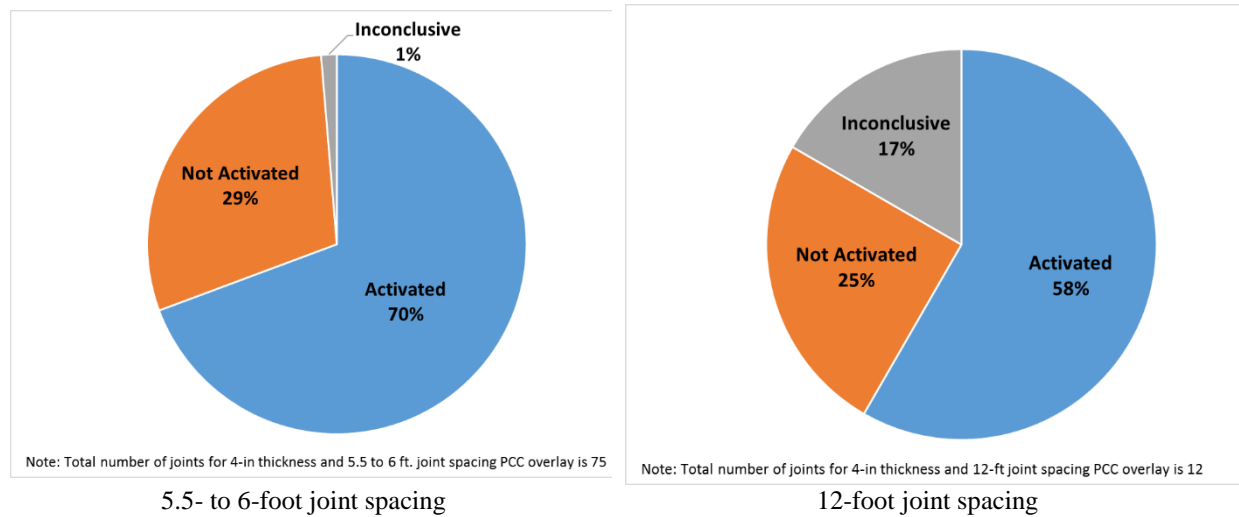
As shown in Figure 22, longer joint spacing did not lead to increased joint activation. This may have been due to a limited sample size.

Figure 22. Percentage of joints activated for different joint spacing of 4-inch thick concrete overlays

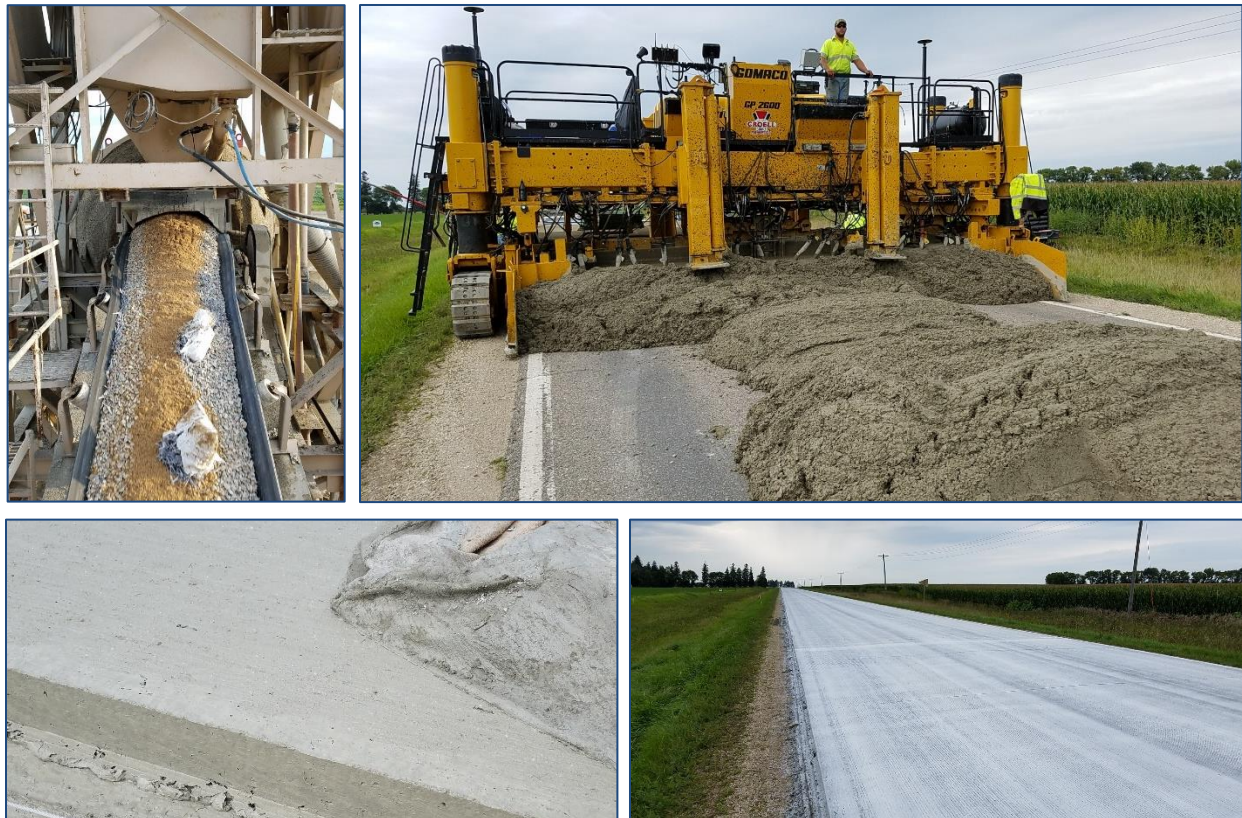
Figure 29. Mitchell County construction showing addition of fibers at the batch plant (top left), paving (top right), finishing with burlap drag (bottom left), and curing and tining (bottom right)

Figure 29 includes images from the August 2017 construction of the Mitchell County test sections.

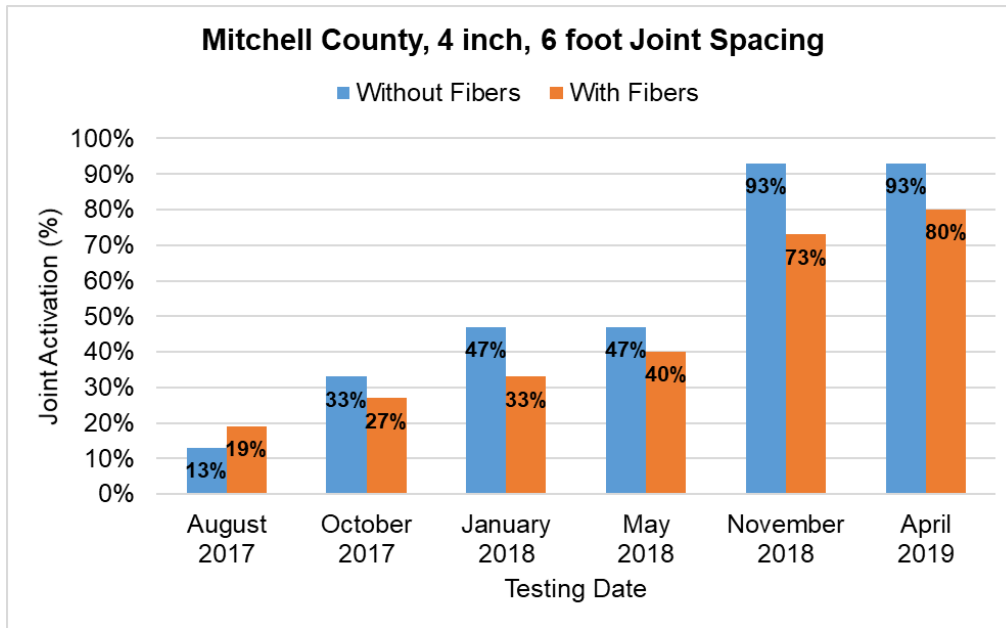
Figure 30. Joint activation results for Mitchell County, 4-inch, 6-foot joint spacing

Figures 30 through 43 present joint activation percentages measured for the various test sections over time, organized by thickness and joint spacing. Complete results for each transverse and longitudinal joint tested in every section are found in the Appendix.

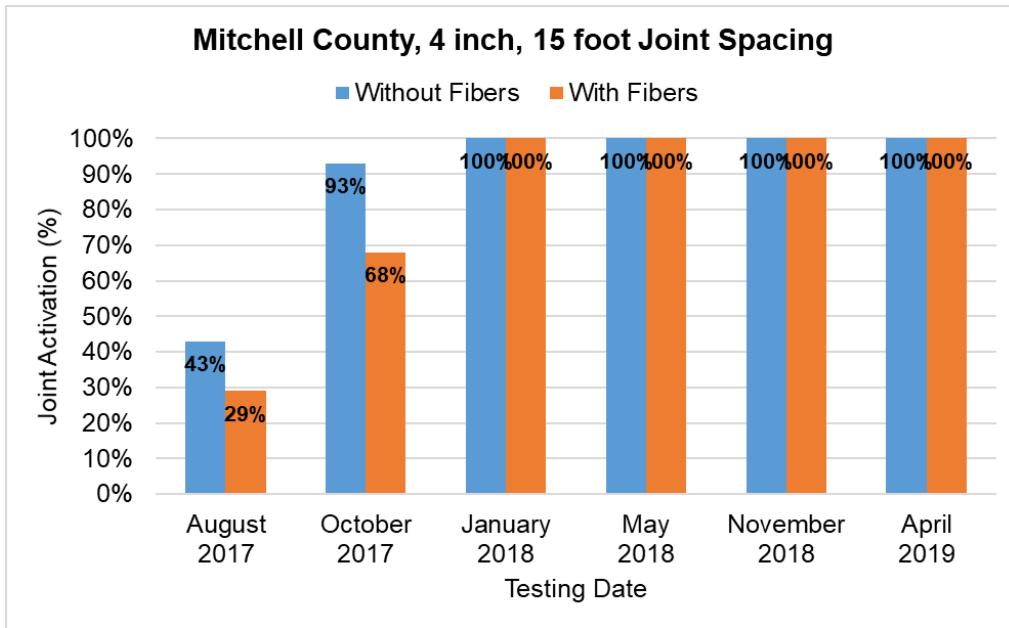
Figure 32. Joint activation results for Mitchell County, 4-inch, 15-foot joint spacing

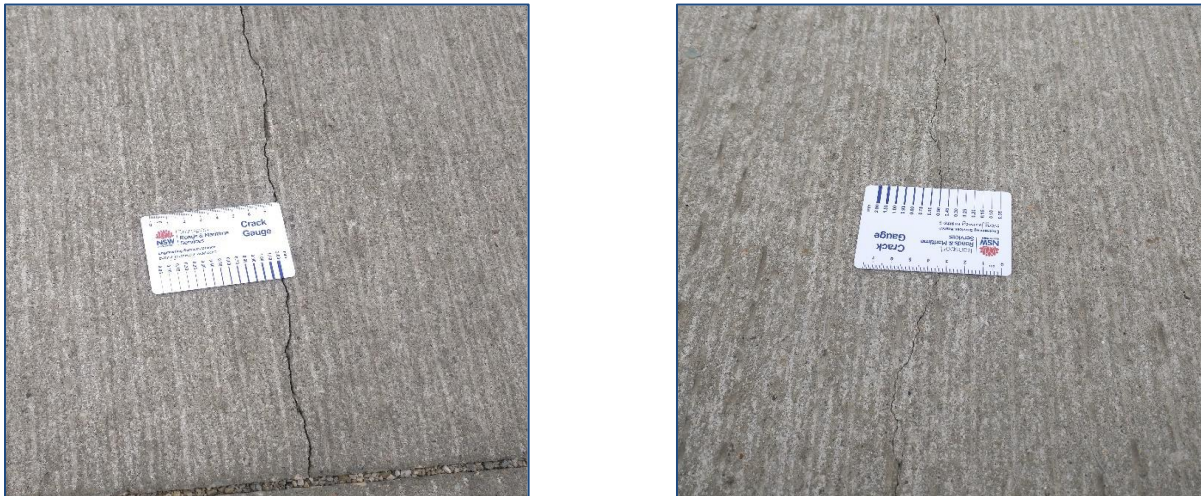
After the first winter of service, reflective cracking was observed in both the typical section and the test sections with fiber reinforcement. However, cracking was significantly reduced in the fiber-reinforced test sections, and when it did appear, the cracks were noticeably thinner than in the sections without fiber reinforcement. Side-by-side examples are shown in Figure 47.

Figure 47. Comparison of reflective cracks developed in test sections without fibers (left) to those with fiber reinforcement (right)
