Evaluation of Galvanized and Painted Galvanized Steel Piling

**Interim Report
September 2022**

Sponsored by
Iowa Highway Research Board
(IHRB Project TR-766)
Iowa Department of Transportation
(InTrans Project 18-678)

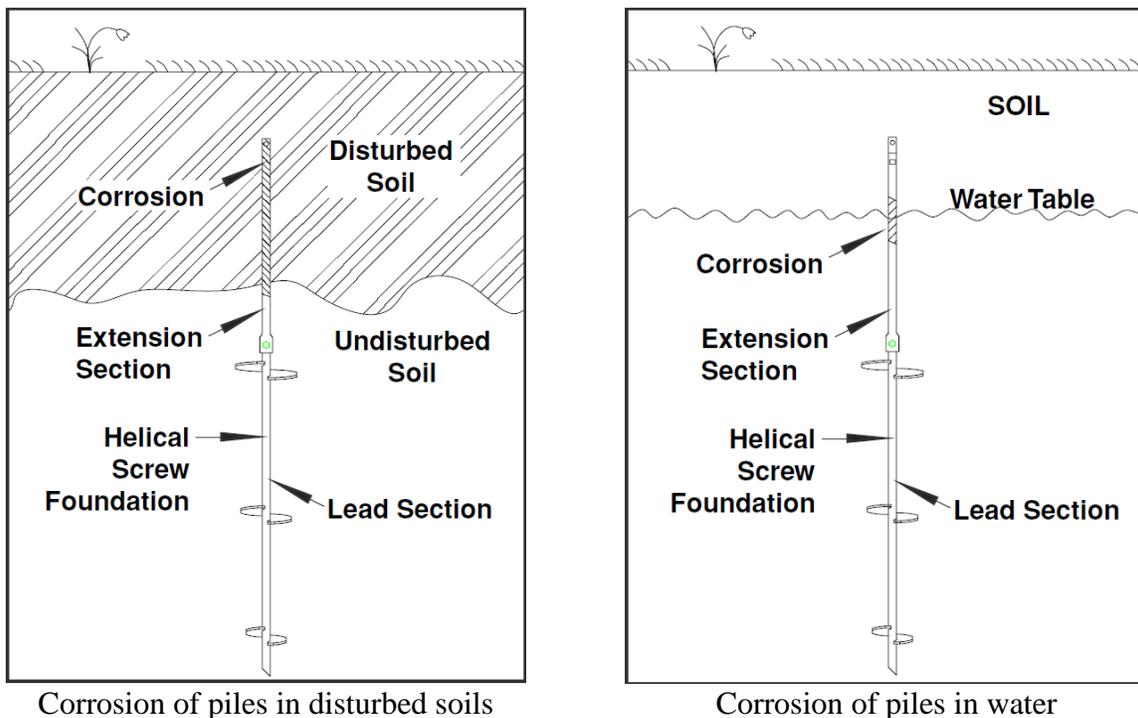
Figure 1 (left) illustrates the region prone to corrosion for piles immersed in disturbed soil.

Figure 1. Corrosion of piles in disturbed soils and water

Protective measures such as zinc coatings should be used on piles when corrosion may be a potential problem at a site. In the case of piles driven through disturbed soils, the protection should be applied to the critical region, which extends from the bottom of the pile cap down to about 3.28 ft (1 m) below the water table, as shown in the previous Figure 1 (right).

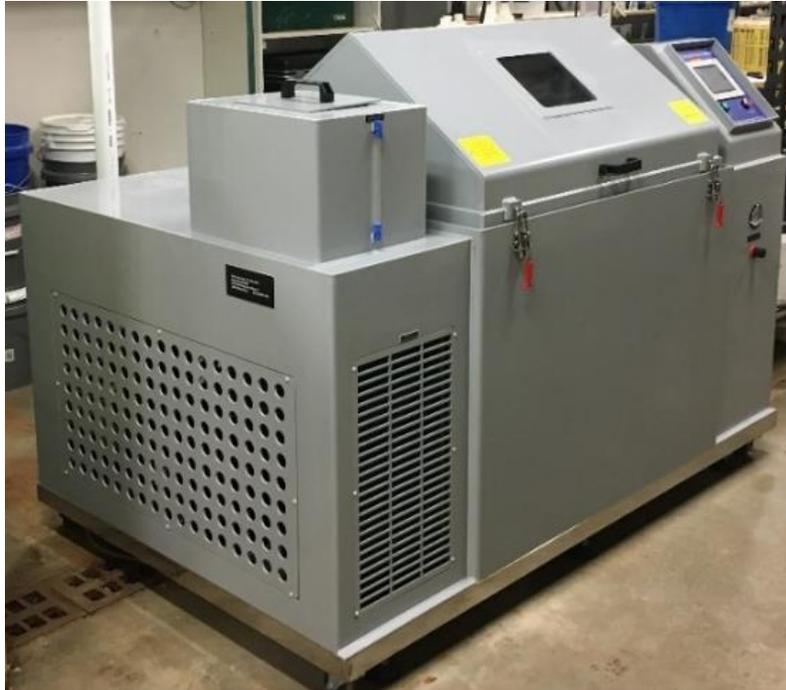
To perform the proposed laboratory testing, a chamber with sufficient internal space was utilized. Figure 2 shows the CCT chamber.

Figure 2. Cyclic corrosion test chamber

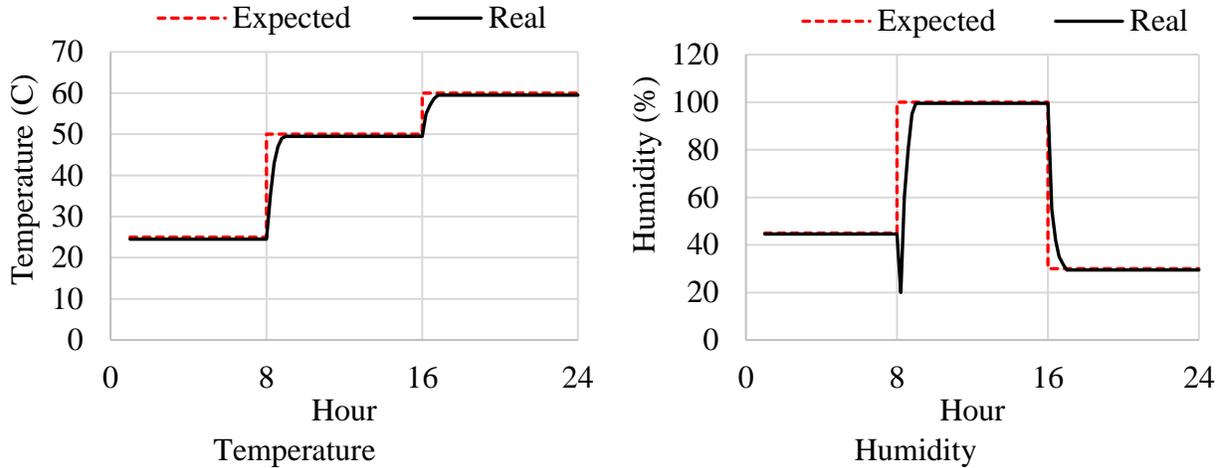
Figure 3. Temperature and humidity variation during each cycle

During the first 8-hr period, called the ambient stage, the temperature was 77°F (25°C), and the relative humidity was about 45%. In the second period, called the humid stage, the temperature rose to 122°F (50°C), and the relative humidity rose to nearly 100%. In this period, a salt solution fog was produced and uniformly enveloped the samples. The last 8-hr period is called the dry-off stage, and the temperature was increased to 140°F (60°C), while the relative humidity dropped to 30%.

As shown in Figure 3, changing the humidity and temperature inside the chamber between the stages took about 30 minutes, after which the measured temperature and relative humidity were maintained.

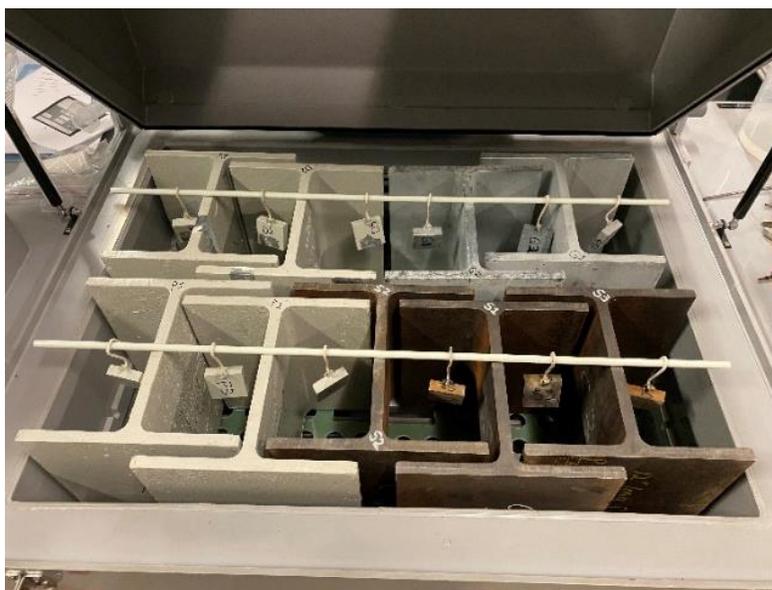
Five variations of coupon specimens were included: bare steel, galvanized, painted galvanized, painted galvanized with simulated paint layer damage, and galvanized with the galvanizing layer damaged. For the 1-ft pile specimens, four variations were included: bare steel, galvanized, painted galvanized, and painted galvanized with simulated paint layer damage. Figure 4 shows the samples inside the cyclic corrosion chamber.

Figure 4. Samples inside the cyclic corrosion chamber

To obtain a direct visualization of the corrosion process on the pile structures, nine 1-ft long HP 10×57 sections (three bare steel, two galvanized, two galvanized with painted coating, and two galvanized and painted with painting layer damaged) were prepared and placed into the chamber, as shown in the previous Figure 4. Appendix A.2.1 through A.2.4 show the condition of the S, G, P, and D pile samples, respectively, during the CCT process.

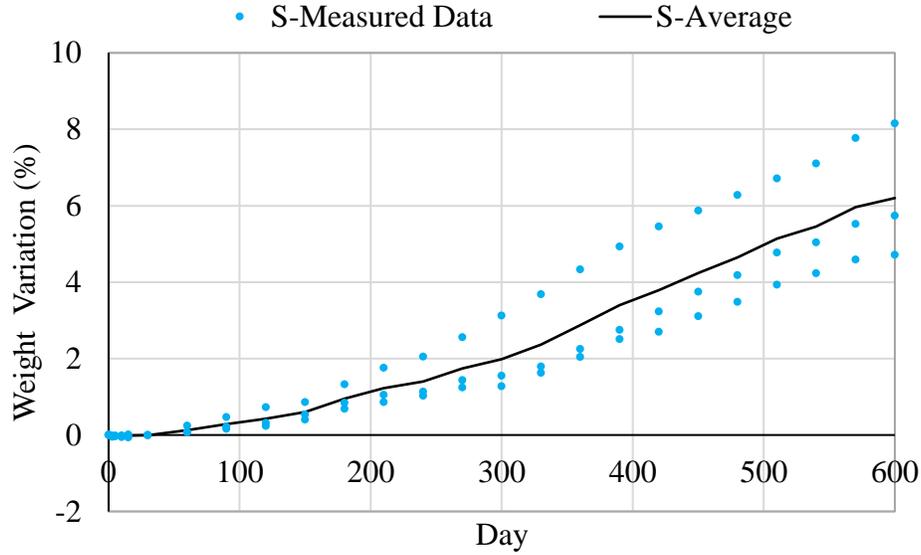
The S samples were bare steel samples without any coating. Figure 5 shows the weight variations for each of the S samples and their average during the 600 days.

Figure 5. Weight variation (%) of samples without coating

Figure 5 shows that the weight of the samples continually increased through the duration of the CCT process. This weight variation occurred as a result of a series of chemical reactions that take place during the oxidizing process of steel. These chemical reactions can be expressed as equation (2) (McCafferty 2010, Gräfen et al. 2000).

The plot shows that the weight of the samples decreased significantly during the first 100 days, which could be caused by the loss of the galvanized layer during brush cleaning. Although the metal brush was used through 600 days, the weight after nearly 120 days (20 years), started to increase until the end of the period. This is because a patina layer (zinc carbonate) formed on the surface of the coupons after 120 days, which is harder than the fresh galvanizing layer. Hence the hand brush induced less effect on the weight of the coupons. Nevertheless, comparing to the weight change (about 6%) of the S samples in the previous Figure 5 at 600 days, the weight variation of G samples was small (within $\pm 0.3\%$).

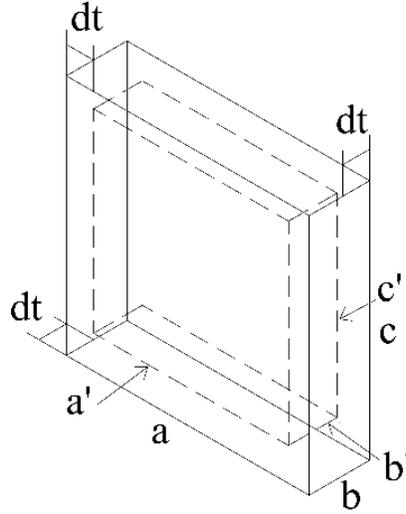
Figure 6 shows a view of the coupon with initial dimensions (a , b , and c) and final dimension (a' , b' , and c') after a thickness loss of dt of each face in all directions.

Figure 6. Coupon sample dimensions before and after corrosion

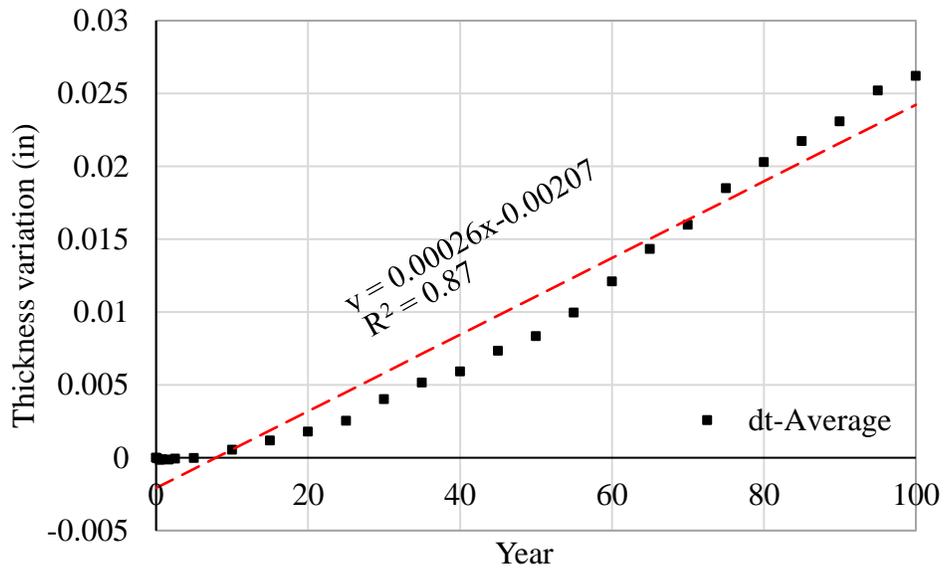
Figure 7 shows the resulting thickness variation (solid squares) fitted by the linear regression (dashed line).

Figure 7. Estimated thickness loss of the bare steel in each year

The slope of the dashed line (0.00026 in/yr) shows the thickness loss per year on one side of the coupon. This value is close to the suggested value of 0.000235 in/yr (0.00047 in/yr for two sides) in various references (EN 1993/Eurocode 3, Gaythwaite 1981, Ohsaki 1982).

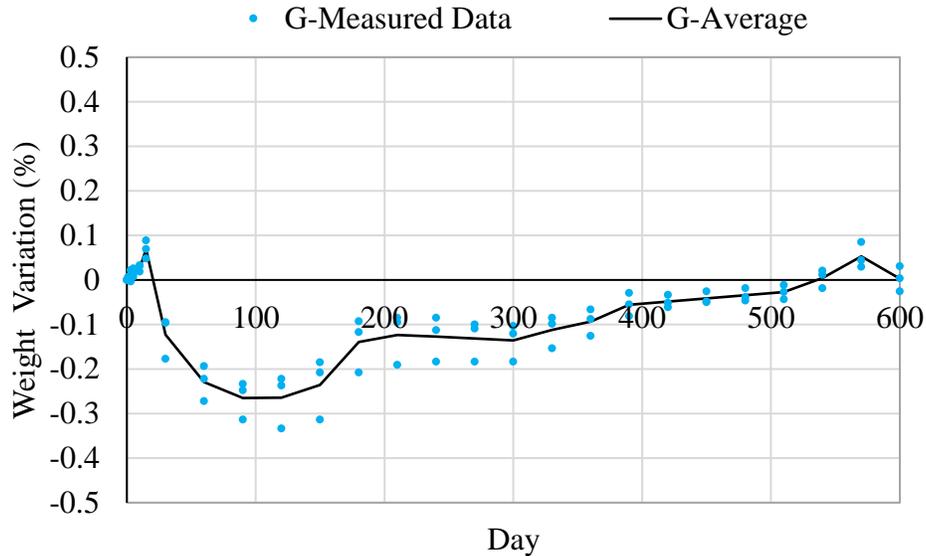
Figure 8 shows the weight variations for the G coupon samples and their average during the 600 days of CCT cycles.

Figure 8. Weight variation (%) of samples with galvanized coating

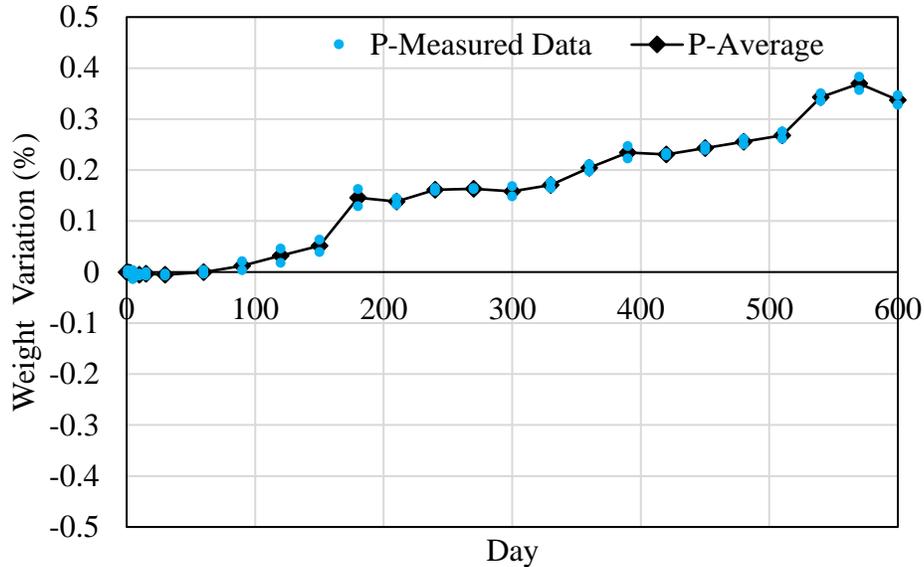
Figure 9 shows the weight variations for the P coupon samples and their average during the tests.

Figure 9, Weight variation (%) of samples with painted galvanized coating

Appendix A.1.3 includes images of the corrosion process for one of the P coupon samples. The data indicate that, in the first 60 days (10 years), the paint is completely intact and the variation in the weight of the samples is not significant. However, after 60 days, the weight of the samples started to increase, which coincides with the observed cracking of the paint layer.

The data for the P2 samples included two sudden weight drops, which occurred after 210 days and 270 days. These occurred because of the rapid deterioration of the paint layer (peeling and separation) from the sample. (Appendix A.1.3 includes images of a P2 sample.) Because of the significant change in the weight, the data from the P2 samples were not presented or used in the experimental result analysis. The previous Figure 9 includes the weight variations of the P1 and P3 samples and their average values in 600 days.

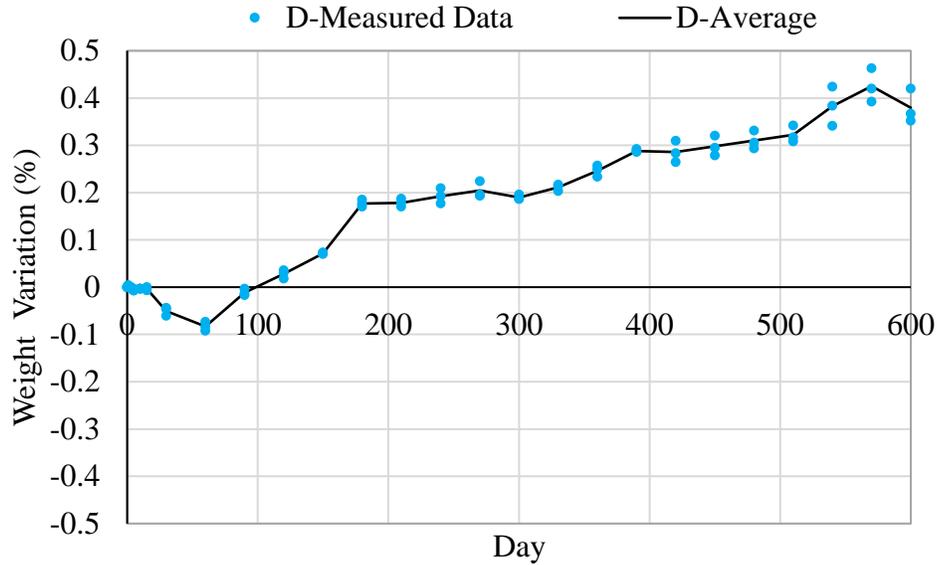
Figure 10 shows the weight variations for the D coupon samples and their average during the 600 days of testing.

Figure 10. Weight variation (%) of samples with damaged painted galvanized coating

In general, the weight changes of the D samples showed a similar trend and magnitude as that for the P samples. This result indicated that the damage on the paint layer does not impose significant weight change on the samples.

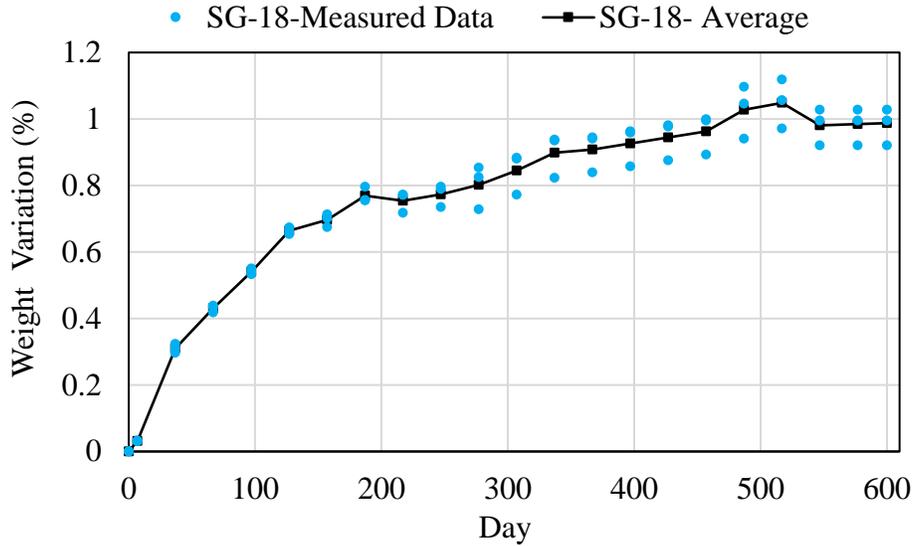
Figure 11, Figure 12, and Figure 13 show the weight variations for the SG-18, SG-28, and SG-38 samples, respectively, and their averages.

Figure 11. Weight variation (%) of SG-18 samples

The data indicated that, on all of these samples, the weight significantly increased during the first 120 days (20 years), regardless of the width of the scratches. These weight variations are induced by the steel oxidation process where the galvanizing layers are damaged, and the bare steel is exposed. After this period, the rates of the weight changes are reduced. In general, the samples with wider scratches resulted in higher weight variations.

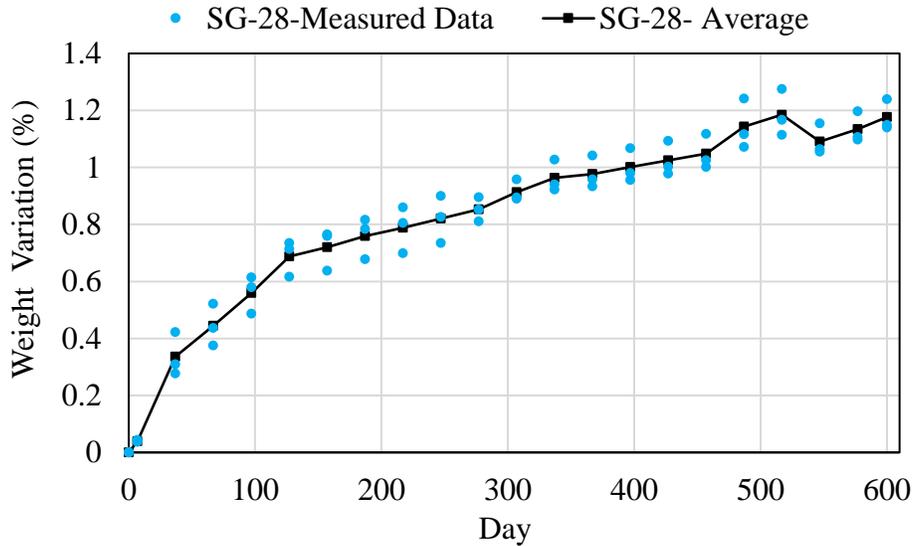
Figure 12. Weight variation (%) of SG-28 samples

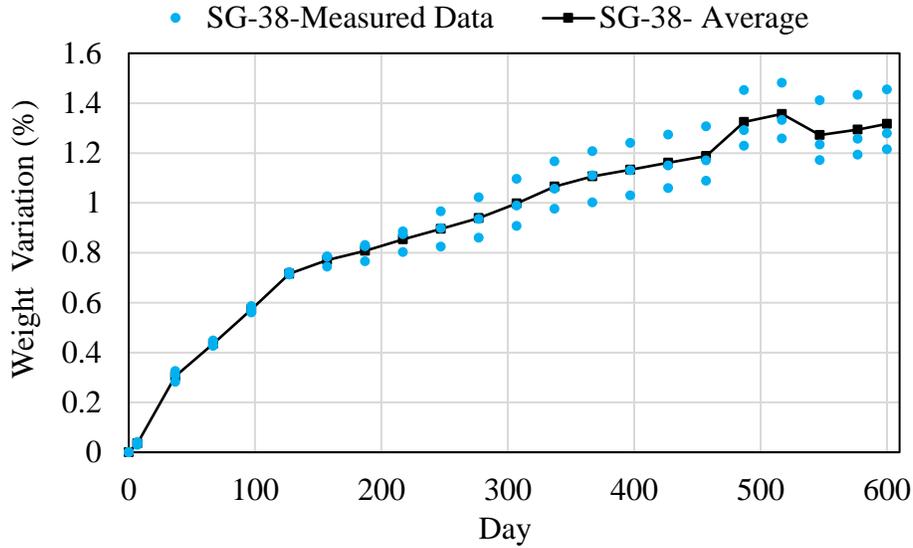
Figure 13. Weight variation (%) of SG-38 samples

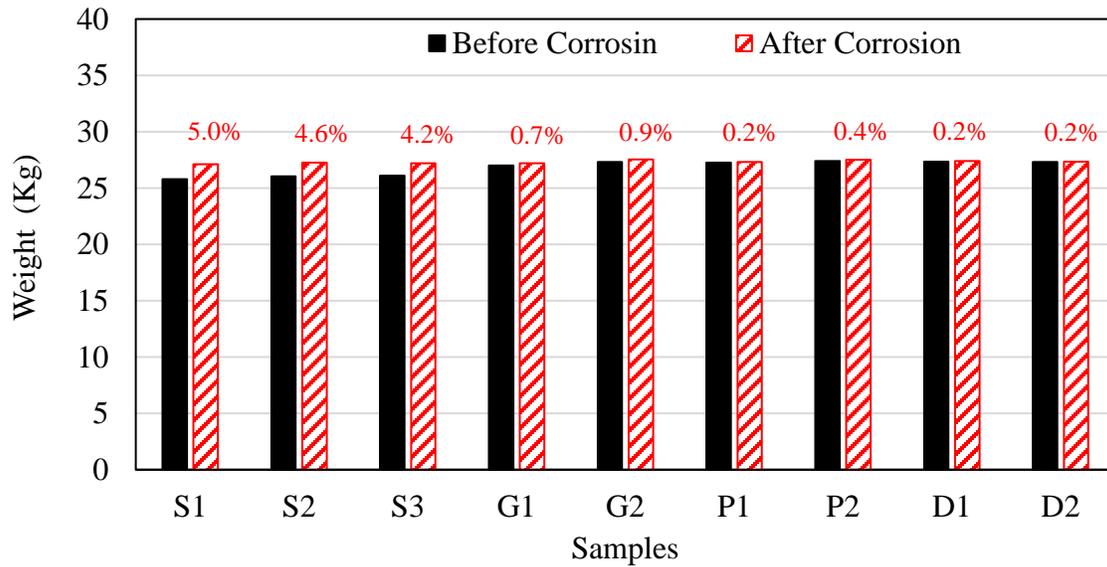
Figure 14 compares the weight measurements before and after the 600 days of testing for all the pile samples.

Figure 14. Weight variation in one-foot pile sections

The results indicated that, for the S samples, the weight of each pile increased by 4.2% to 5.0%. For the three types of coating samples, the weight of each increased by 0.2% to 0.9%.

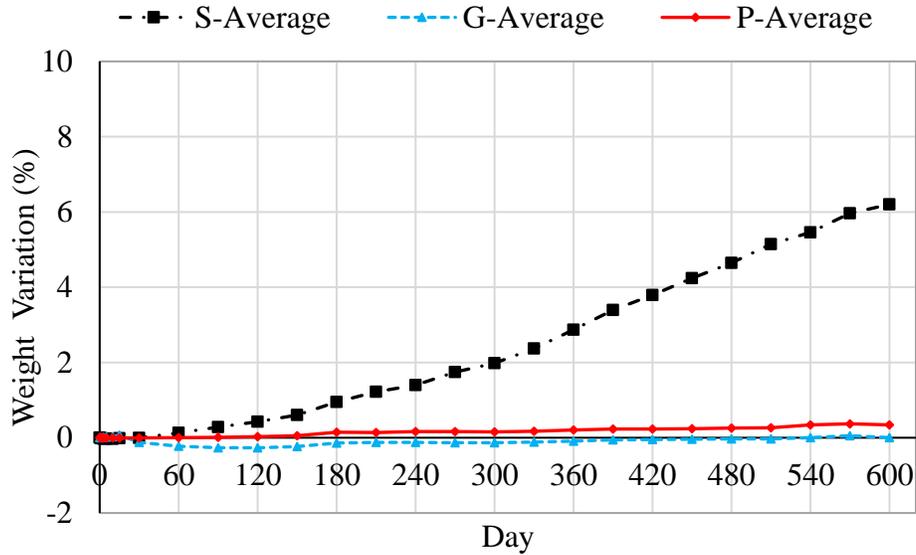
Figure 15 shows the average weight variations for the S, G, and P coupon samples.

Figure 15. Comparison of average weight variation (%) for S, G, and P samples

The results indicate that the S samples, without any protective measures, gain weight (and lose cross-sections) at a higher rate compared to the G and P samples with galvanized and/or paint layers. This figure also shows that the weight variation magnitude for the P and G samples are very similar.

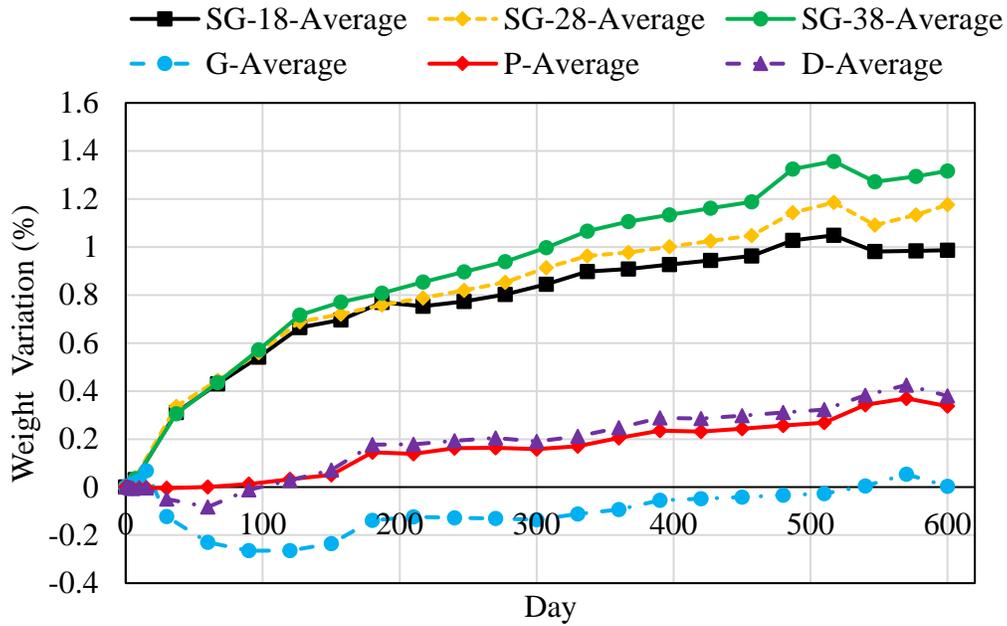
Figure 16 compares the average of the weight variations for the G, P, D, and SG samples.

Figure 16. Comparison of average weight variation (%) for G, P, D, and SG samples

The results indicate that, with a portion of steel exposed to the air, the SG samples experienced a much higher weight increase than the other three sample types. This is induced by the oxidation process of the bare steel. The results indicate that the oxidation process of the steel is the main source of the weight increase. This also demonstrates that damage of the galvanized surface can result in greater weight increases when compared to the damage of only the paint on painted galvanized samples.

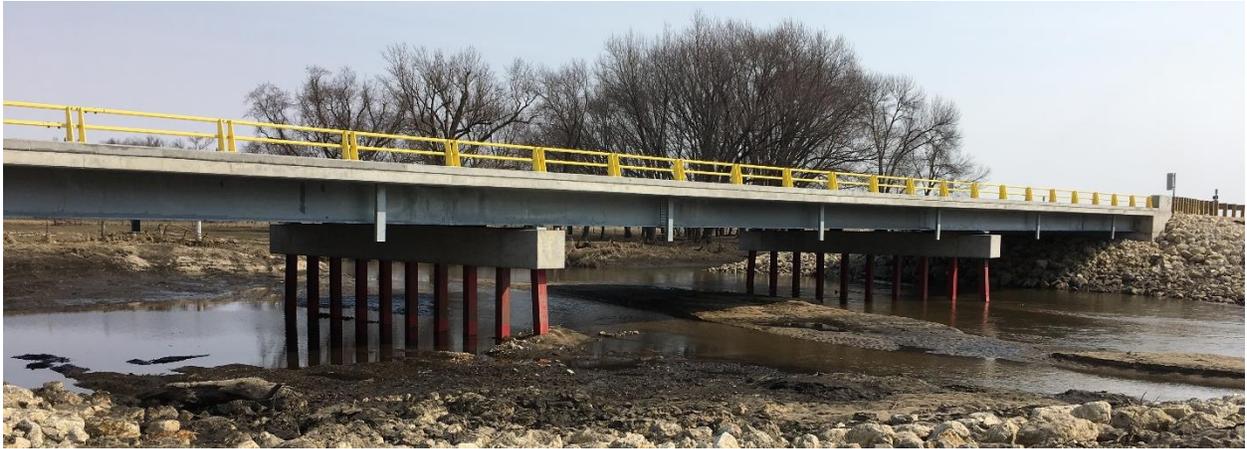
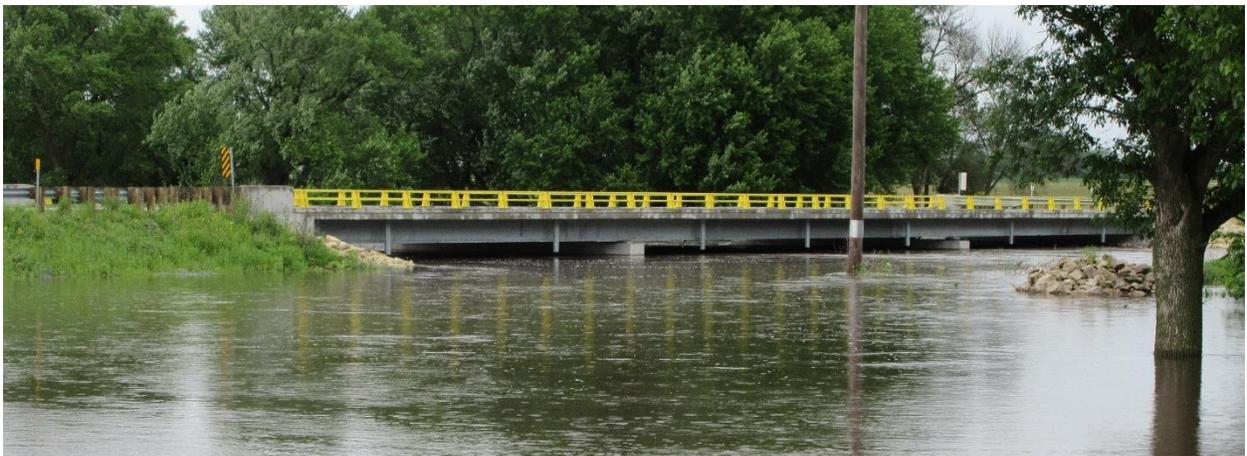
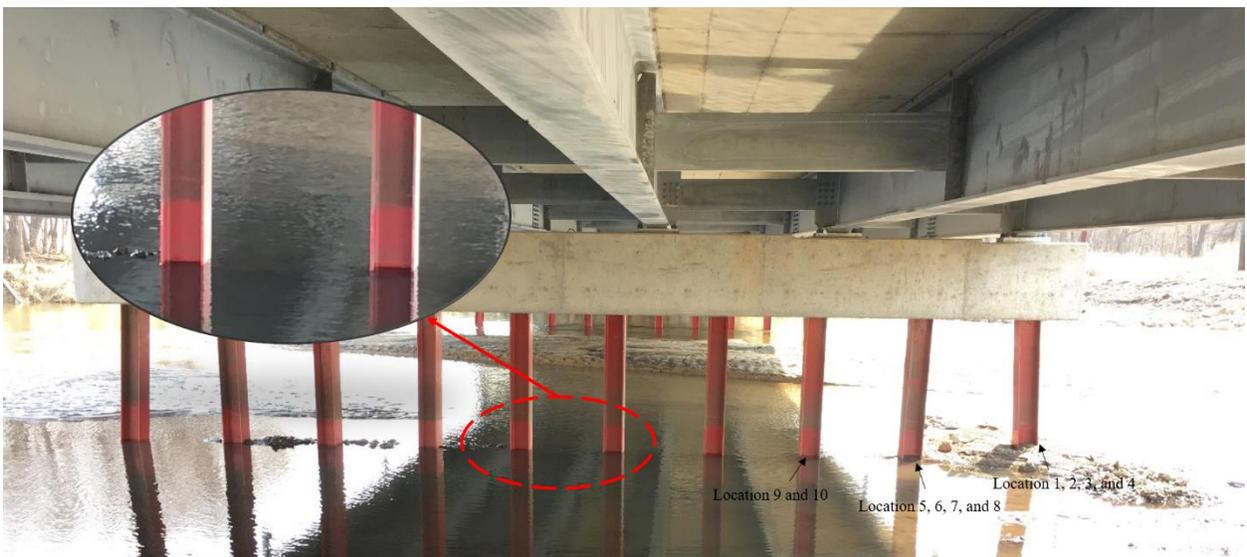
The bridge is located on Buchanan County Road (CR) D-22 over Buffalo Creek. The bridge has three spans totaling 200 ft in length, and the bridge is 40 ft wide. The bridge superstructure consists of steel girders and a concrete deck. The superstructure bears on concrete abutments supported by painted galvanized piles at each end and two piers comprised of painted galvanized piles and concrete pile caps. The pile size used in each location is HP 10×57. Figure 17 shows the bridge side view with specific focus on the pier structures.

a) Bridge side view (with water level low)

b) Bridge side view (with water level high)

c) Galvanized and painted piles

Figure 17. Field evaluated bridge

Buffalo Creek is especially sensitive to high-total rain events. A significant amount of rain can quickly raise the water levels; thus, the piles are differently exposed to air, water, and river debris throughout its service life. Generally, the water level remains low as shown in Figure 17-a. However, it is not unusual to see increased water levels like that shown in Figure 17-b. When precipitation ceases, the water levels drop relatively quickly.

The bridge is oriented in the east-west direction. Piles on the west pier were selected for the thickness measurements as shown in the previous Figure 17-b. Figure 18 compares the images of 10 measurement locations over three years from March 28, 2019 through May 3, 2021.

For the 2020 site visit, the water level was high (as shown in Figure 17), and no thickness data were collected.

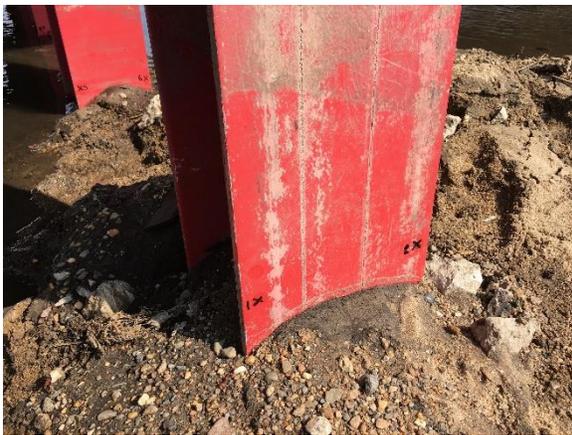
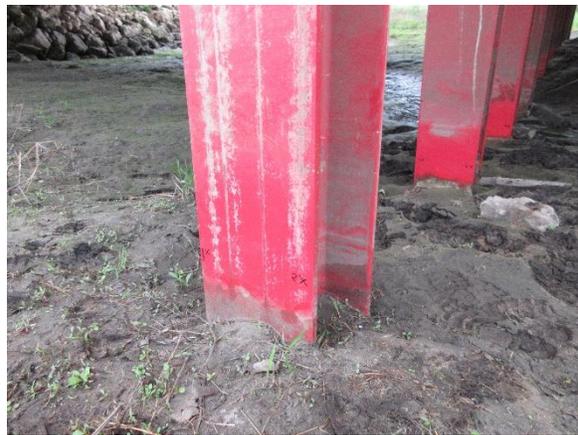
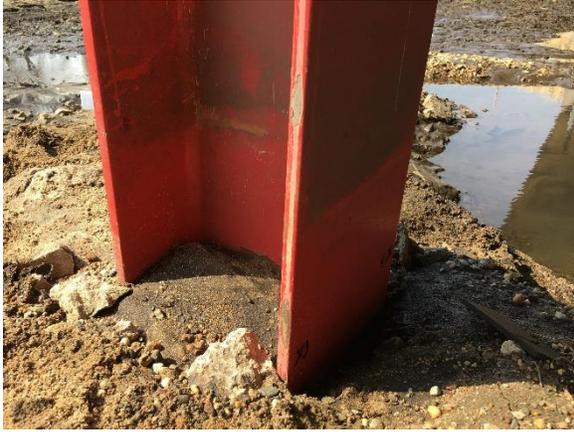
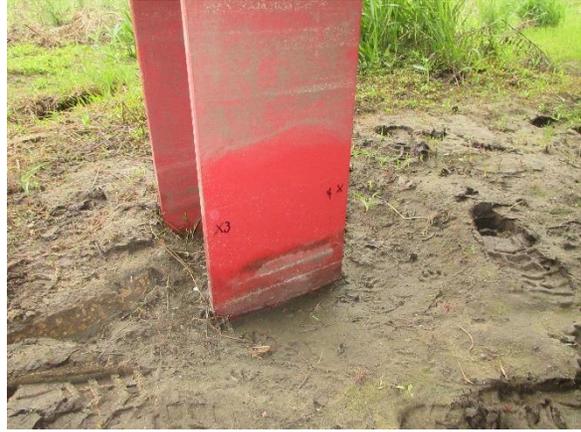
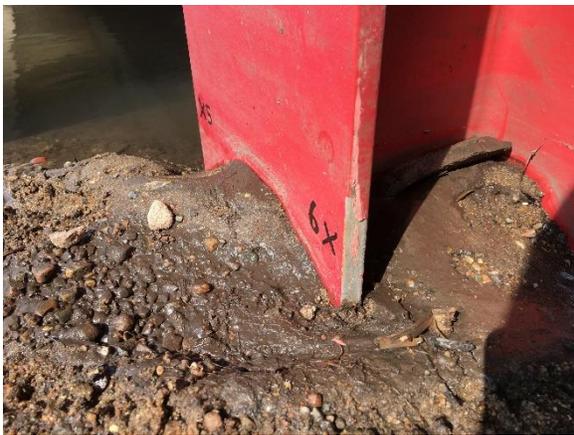
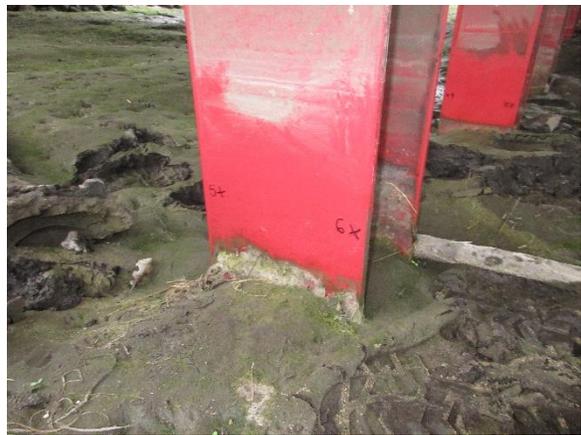
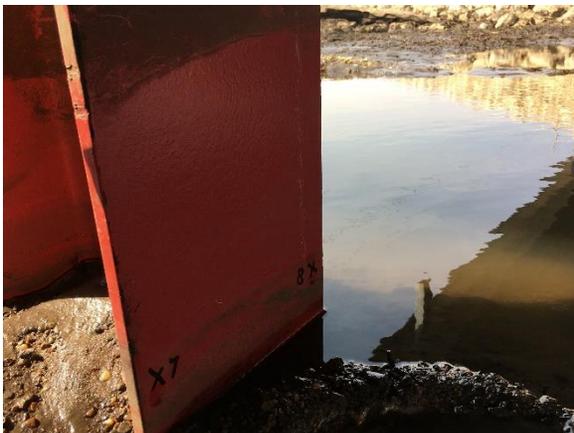
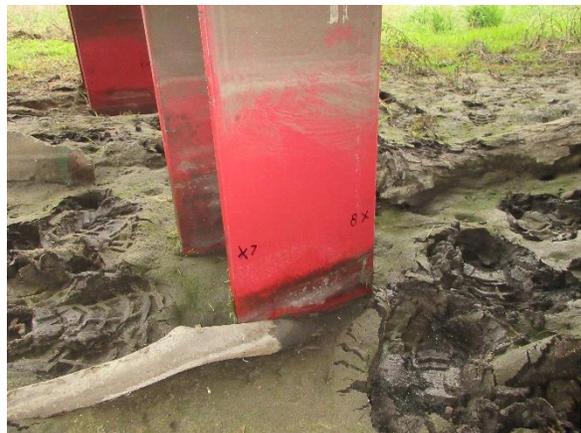
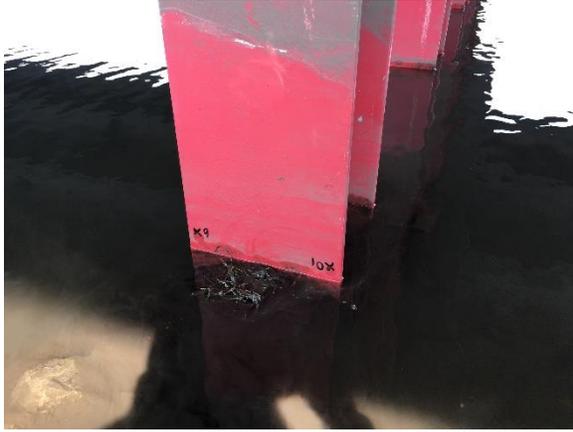
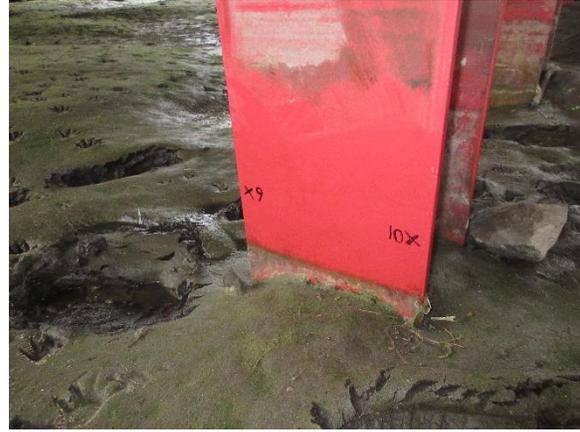
Figure 18. Measurement locations on March 28, 2019 and May 3, 2021

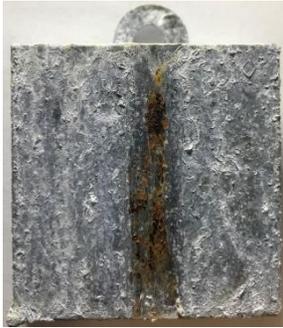
Day 7

A.1.7 SG-38 Coupon Sample Images

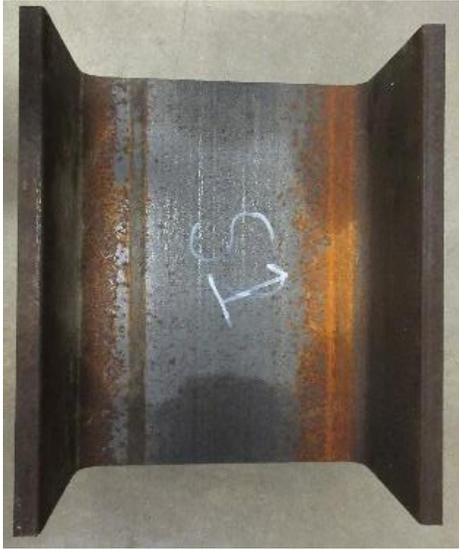
Day 0

A.2.1 S Pile Sample Images

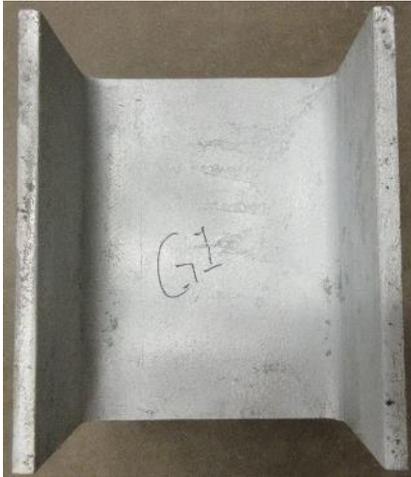
Day 0

A.2.2 G Pile Sample Images

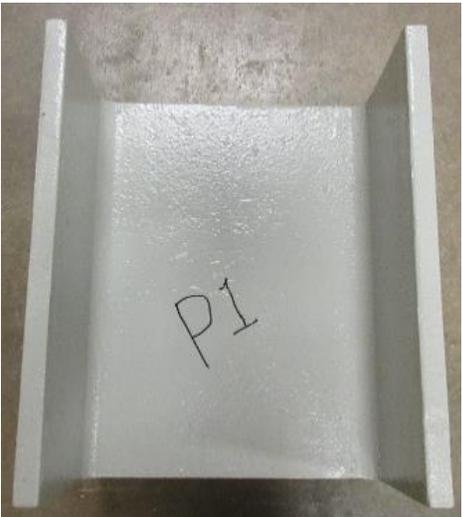
Day 0

A.2.3 P Pile Sample Images

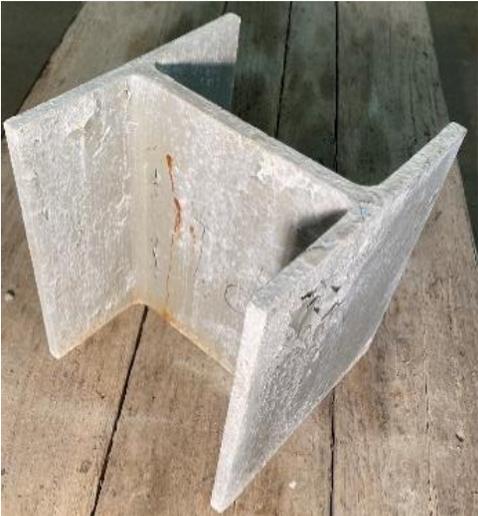
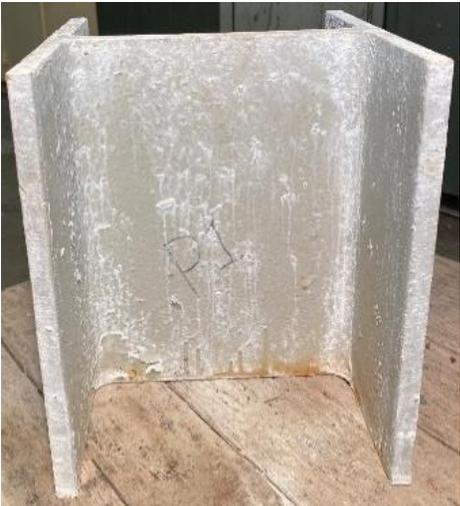
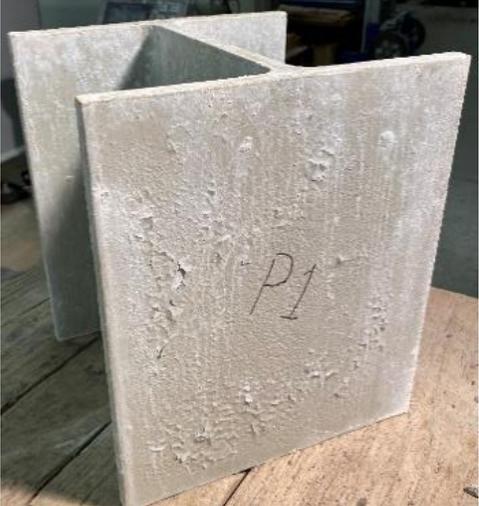
Day 600

- Paint coatings initially offer additional protection, but eventual degradation of paint leaves the galvanized layer to provide the protection alone. The paint layer delayed the oxidation of the galvanized layer for at least a simulated 10-yr period. The painted galvanized coupons showed no appreciable change on the surface condition except for where the paint had been penetrated.

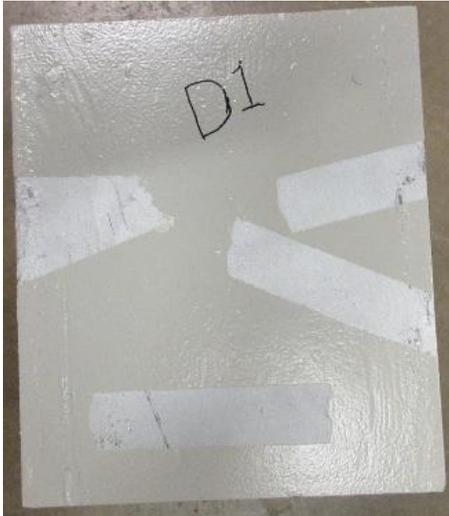
Day 0

A.2.4 D Pile Sample Images

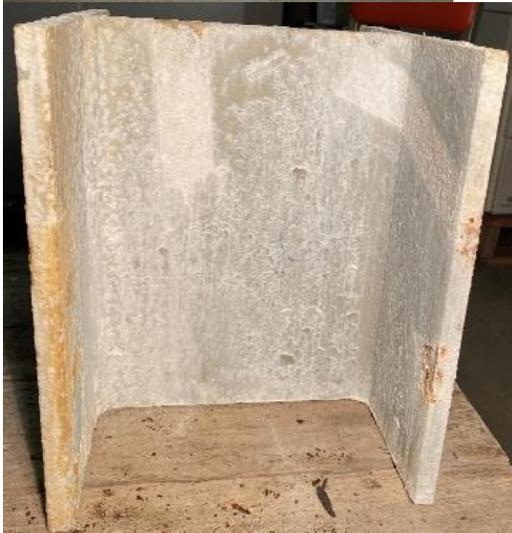
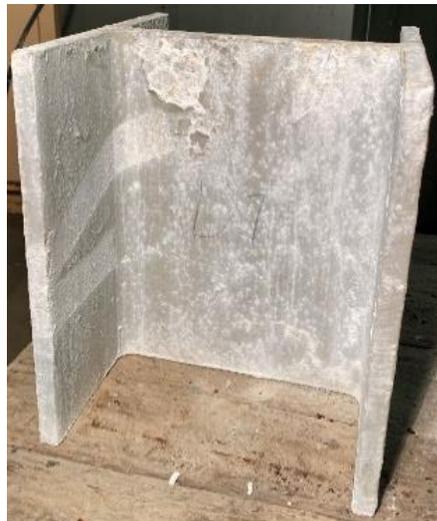
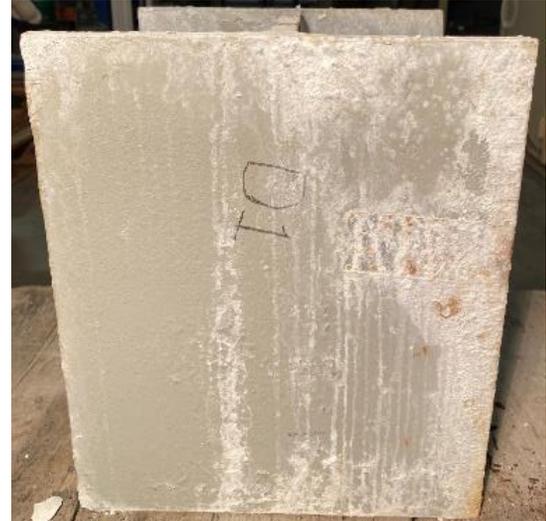
Day 600

- Damaged galvanized layers offer better protection to smaller scratches (self-healing).
- The initial three-year period of service life of the Buffalo Creek Bridge in Buchanan County shows the paint and galvanized coating of the piles to perform well with no damage or corrosion observed.
