Worldwide State-of-the-Art Bridge Management Systems (B.M.S.)

By
Terry Browne, P.E.
Collins Engineers, Inc.

January 16, 2004
Columbia, Missouri
Midwest Transportation Consortium

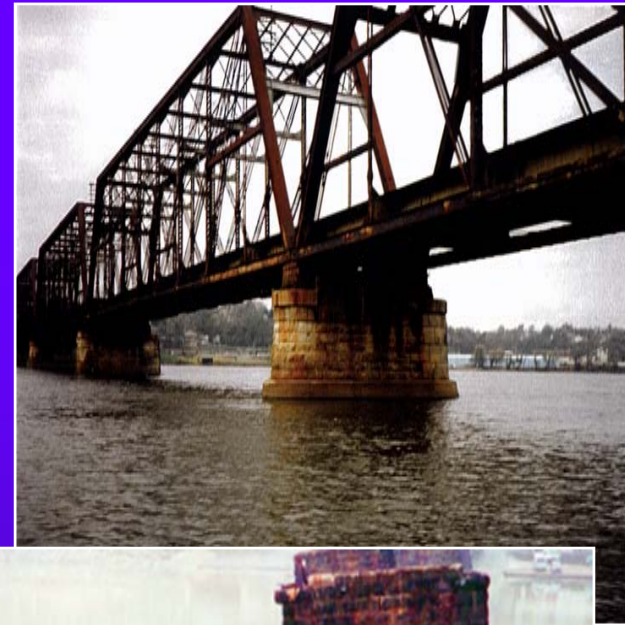
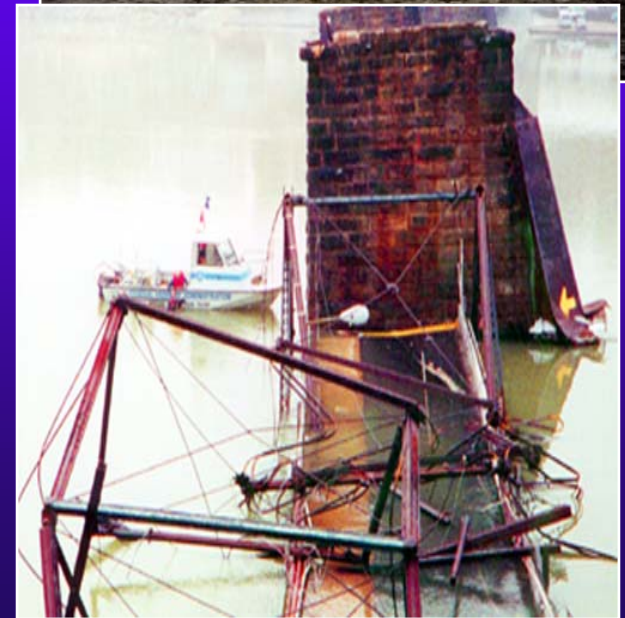
1996 Great Pennsylvania Flood

- Numerous Bridges Collapsed
- Several Bridges Were Closed and Weighed Down
- USGS had Just Begun a 1995 Scour Evaluation Program
- Engineer-Divers Assessed 600 Bridges w/in 3 Months

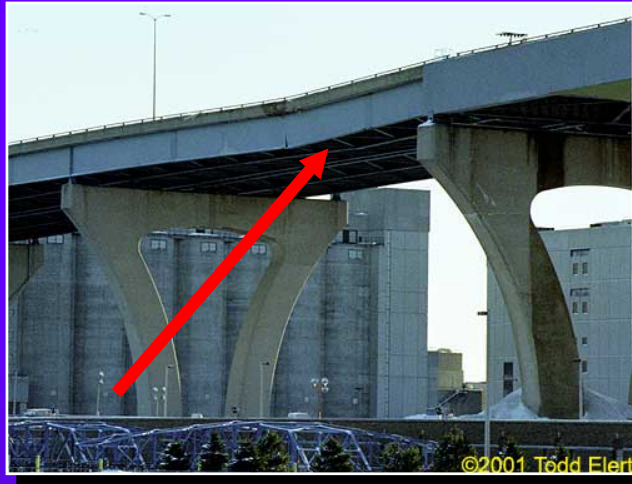
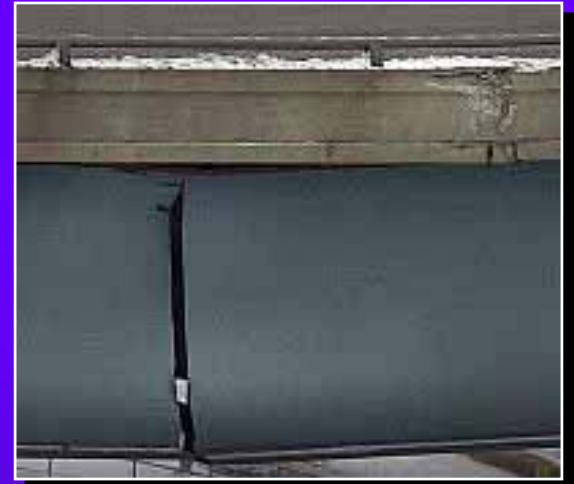
Hoan Bridge Failure

- From Minor to Major Cracks
- NBIS inspection could not determine cause
- Brittle failure from triaxial shear stresses
- Inherent design problem

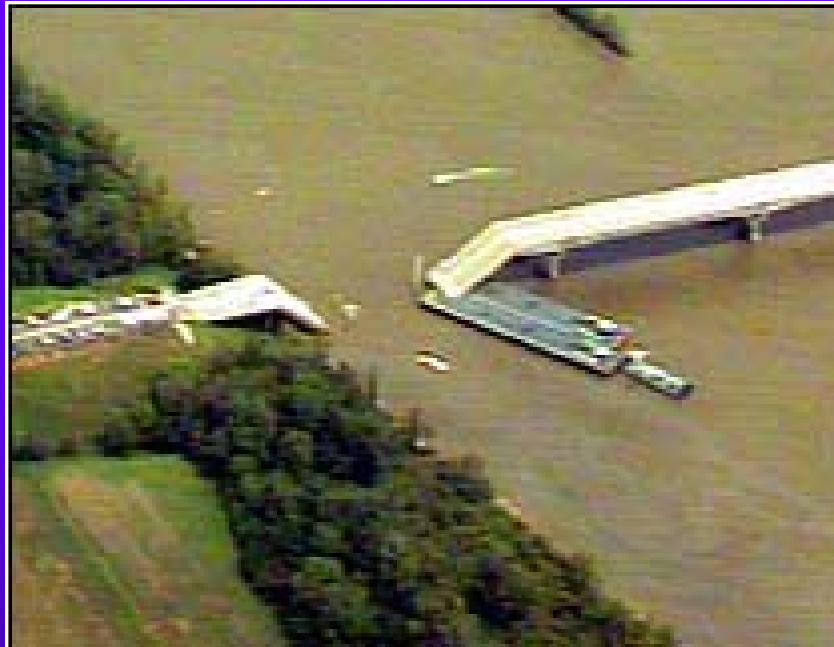
I-40 Barge Impact, May 26, 2002

“Majority of bridges do not have pier protection. The bridges that have protection usually only have cells on upstream side in front of the channel piers.”

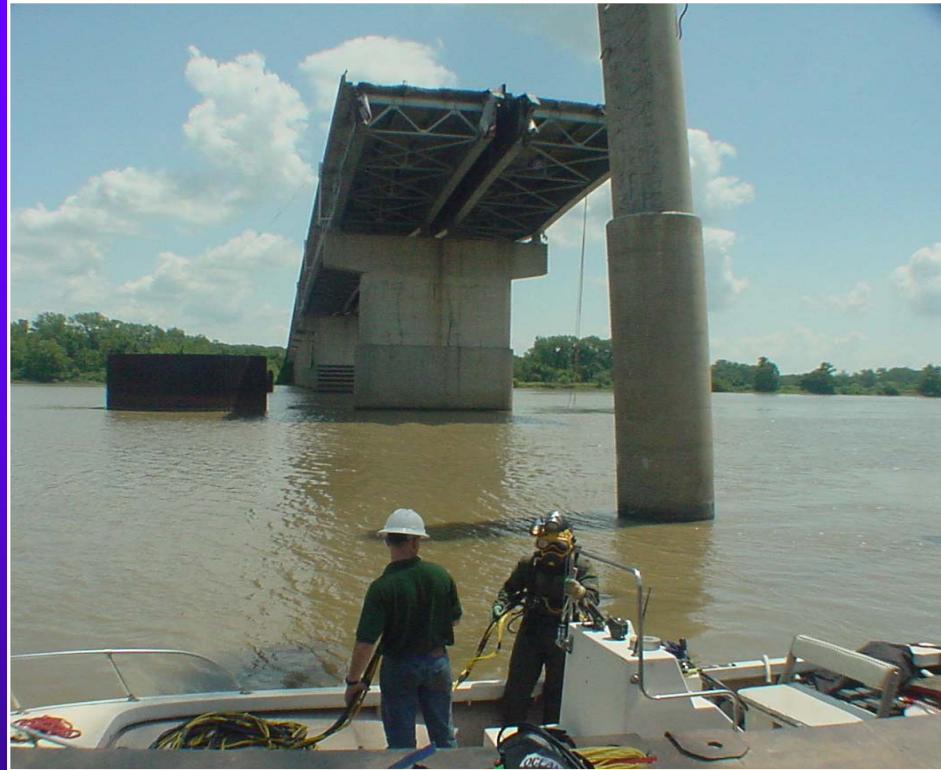
I-40 Barge Impact, May 26, 2002

“Bridge Built in 1967, Prior to vessel Impact Design Code”

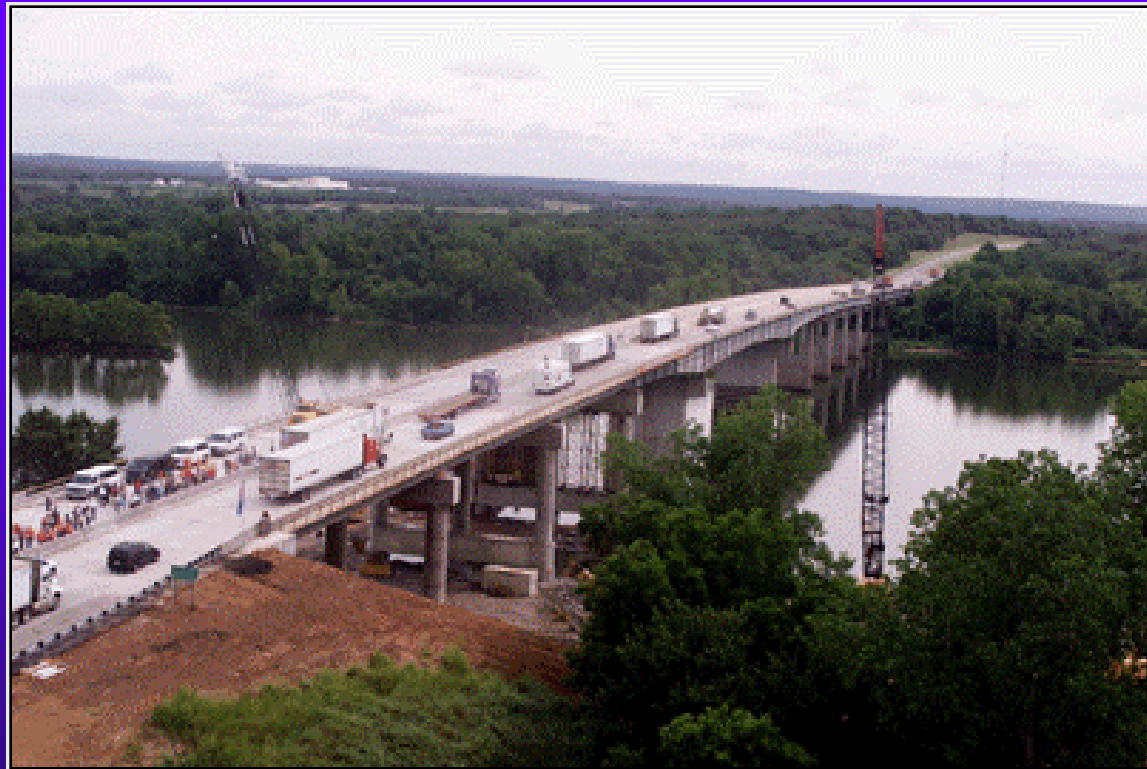
Reconstructed I-40 Bridge

**Vulnerability Assessments now Conducted.
Focus on Impact Critical Bridges.**

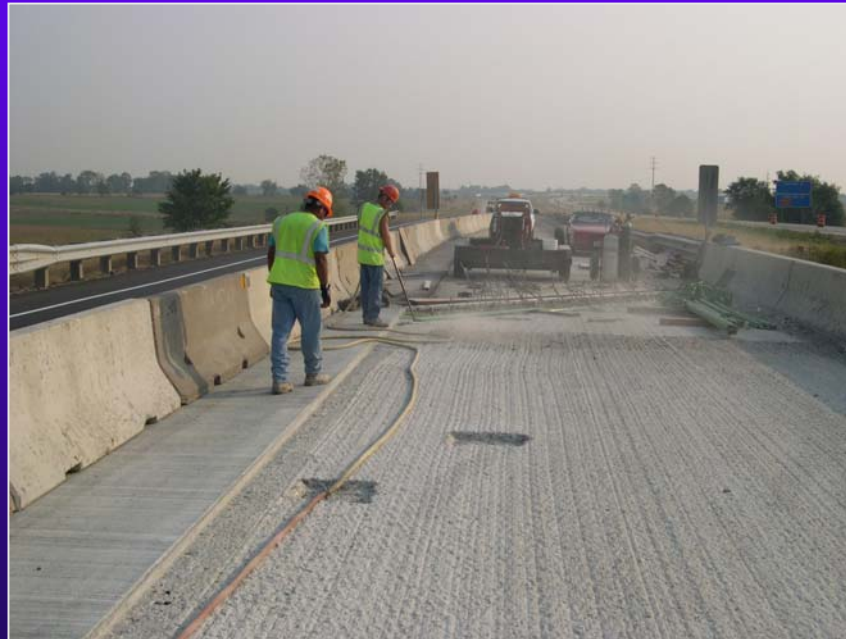
AASHTO Deck Elements

- ◆ “Major Change in the Percentages for Condition State Definitions since 2002”

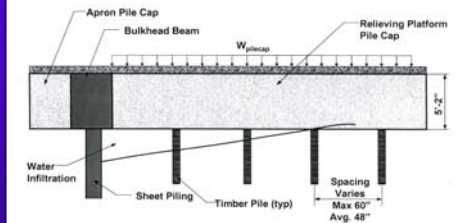
Section Looking East

Clear Span Between Pile
Span = 5 ft

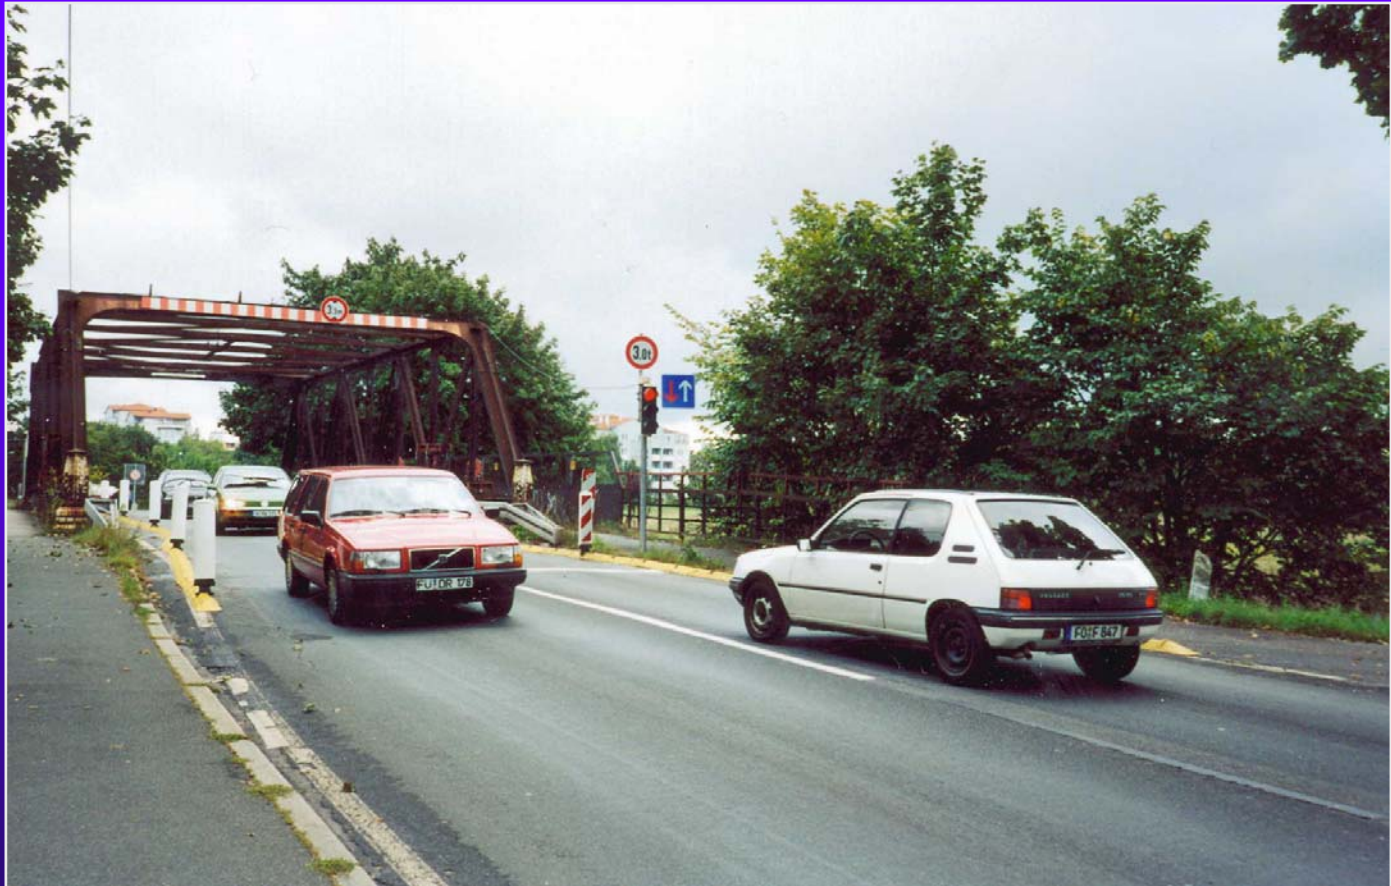
Load Posted due to Floor Beams

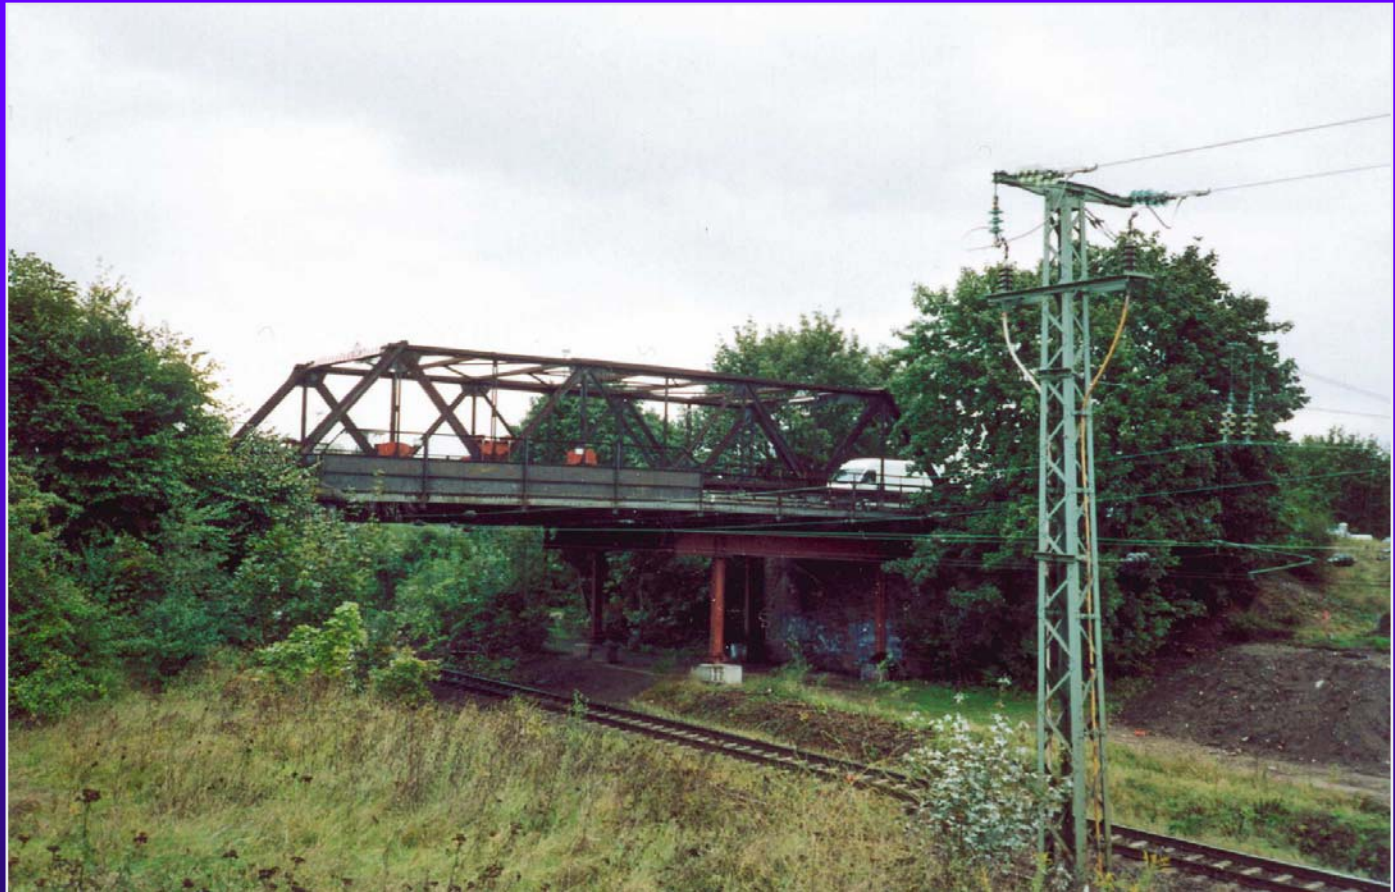
Temporary Shoring with New Columns

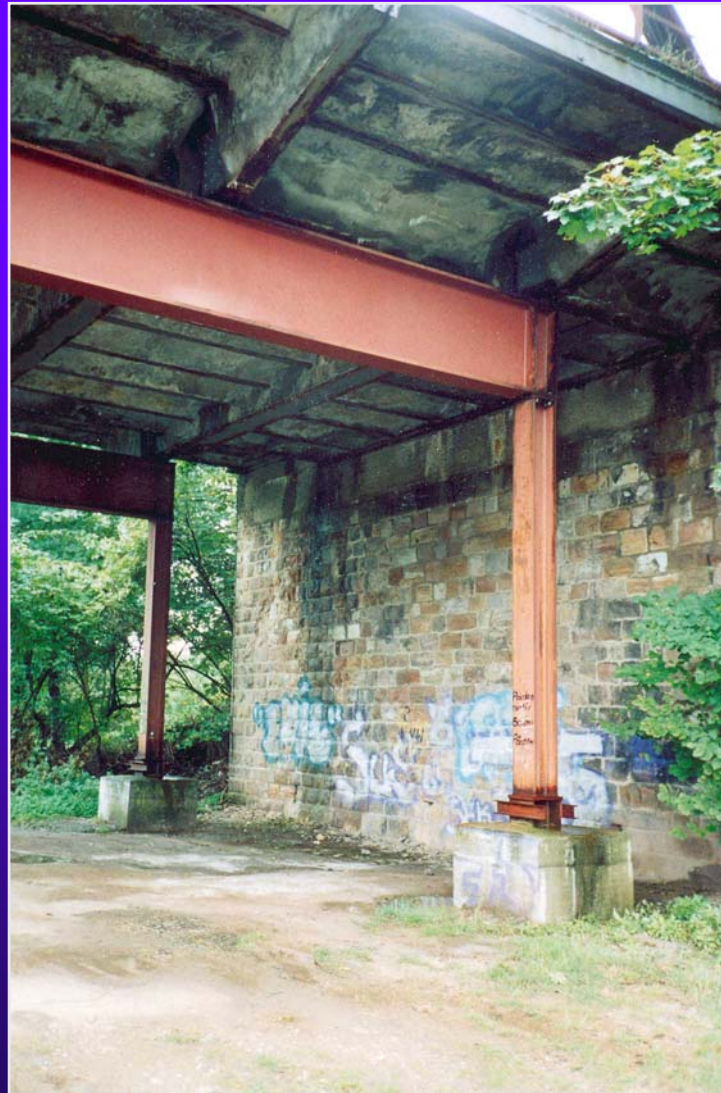
Temporary Supports with Hangers

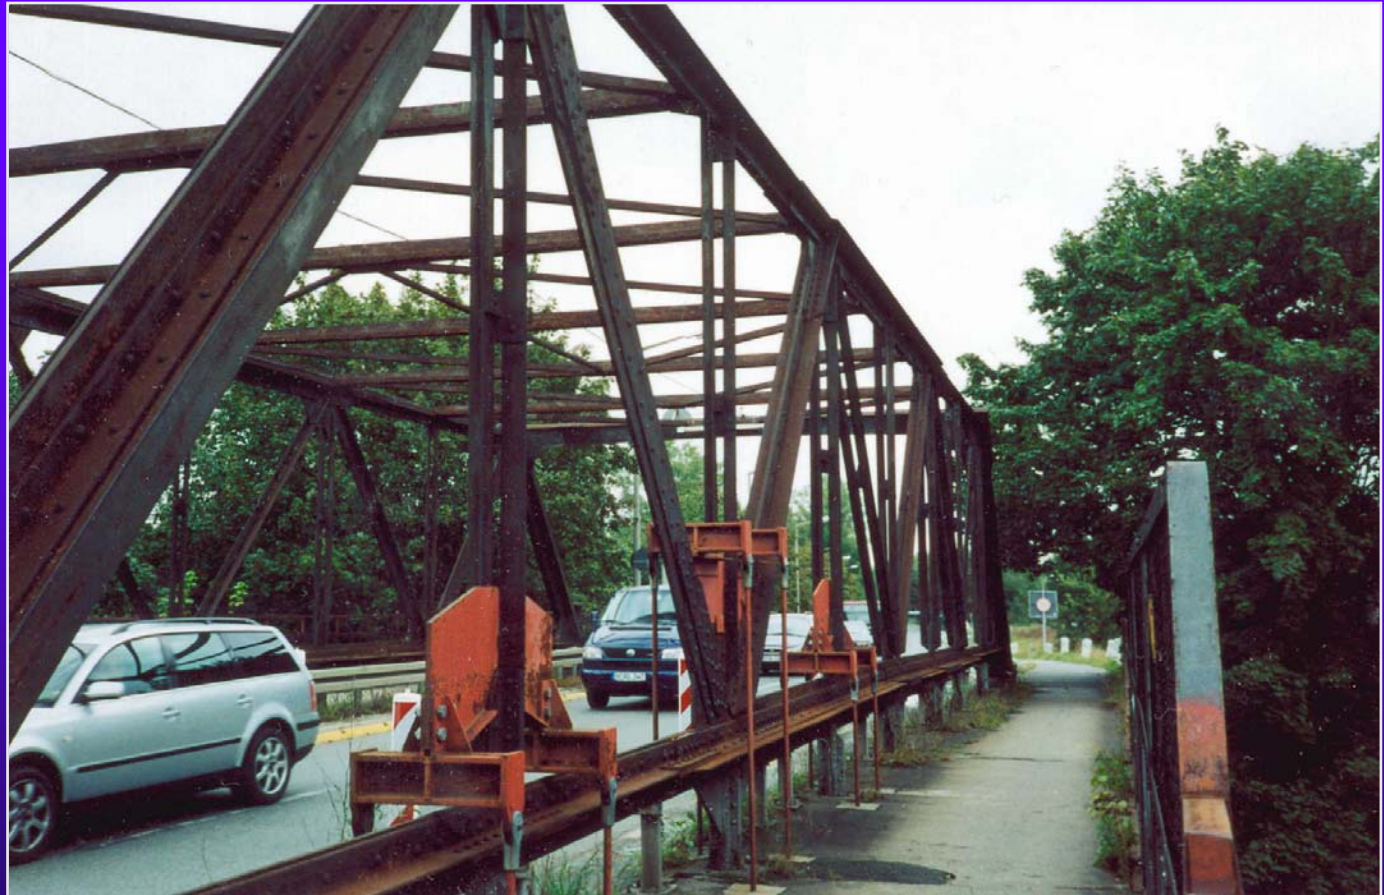
Retrofit Beams Supported by Hangers
