Lessons Learned & Success Stories For Long Life Pavements

**National Concrete Pavement
Technology Center**

Overview

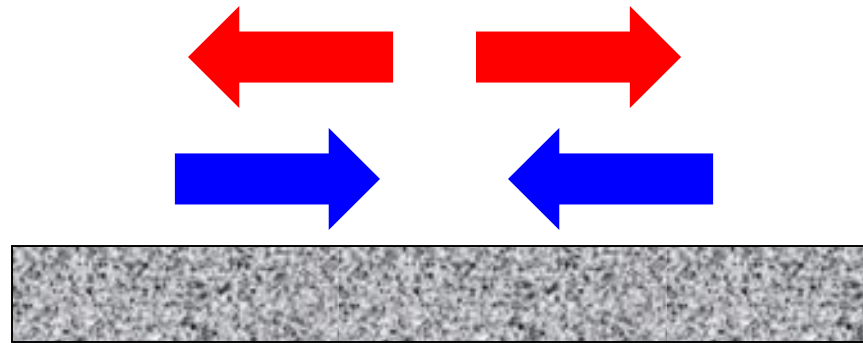
- Concrete expands as **temperature rises** and contracts as **temperature falls**

- Concrete expands as **moisture increases** and contracts as **moisture decreases**

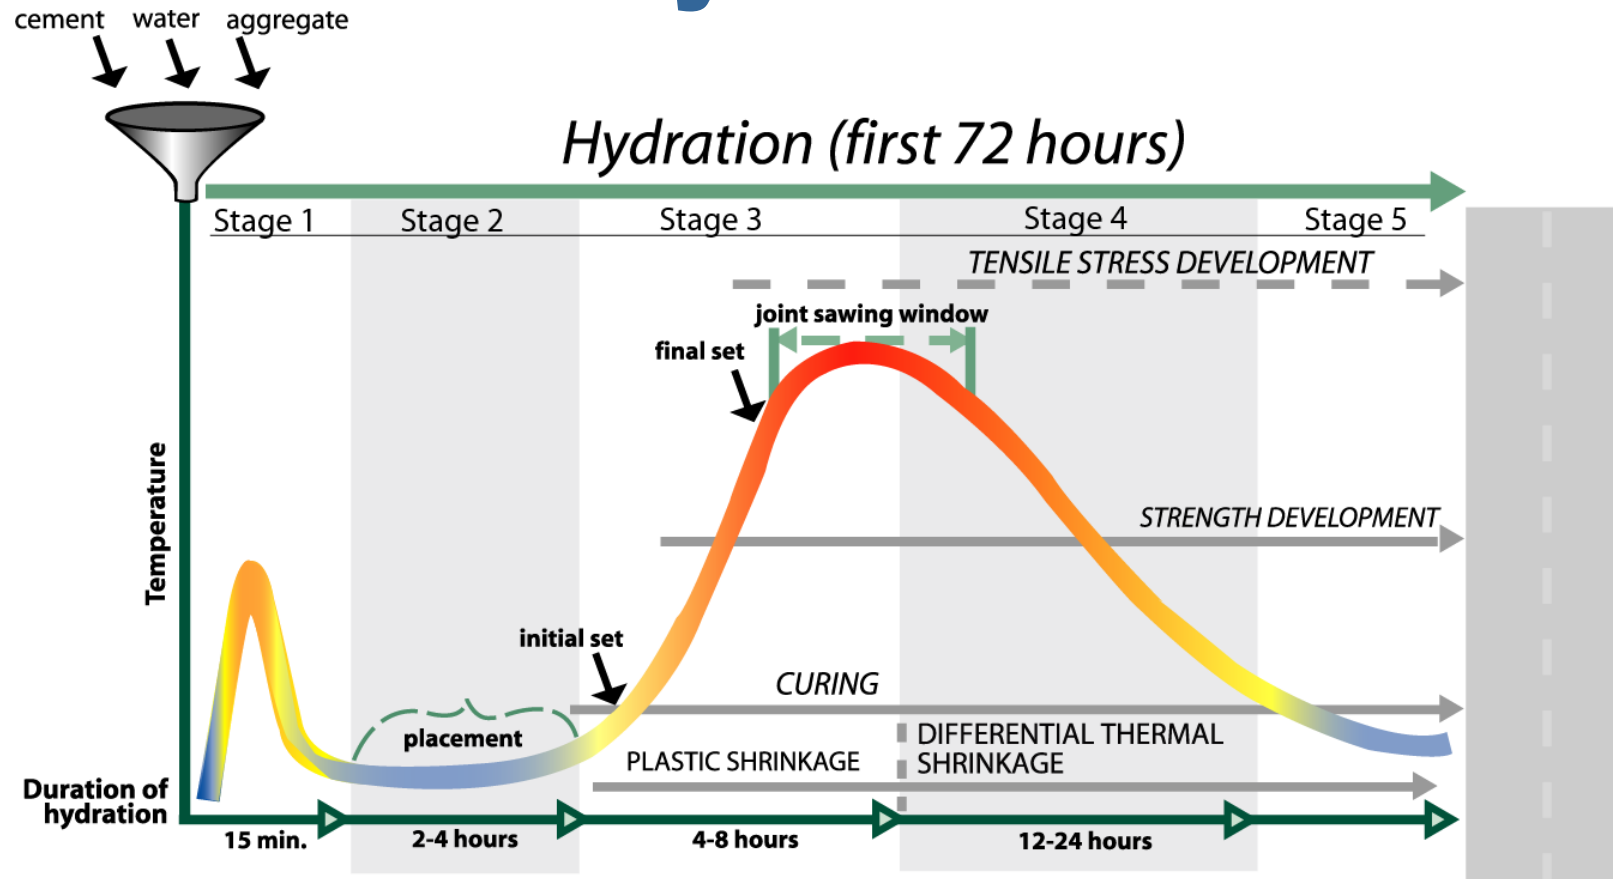
Initial Mix
(15 minutes)

High heat followed
by rapid cooling

Dormancy
(24 hours)

Cool, plastic,
workable

Acceleration
(4-8 hours)

Significant heat,
less workable,
begins to harden

Begin curing
Cut joints

Deceleration
-24 hours)

Becomes hard and
dense

Slow Hydration
(Indefinitely)

70 – 75%hydrated
after 28 days

Can continue
indefinitely, as long
as water can reach
un-hydrated particles

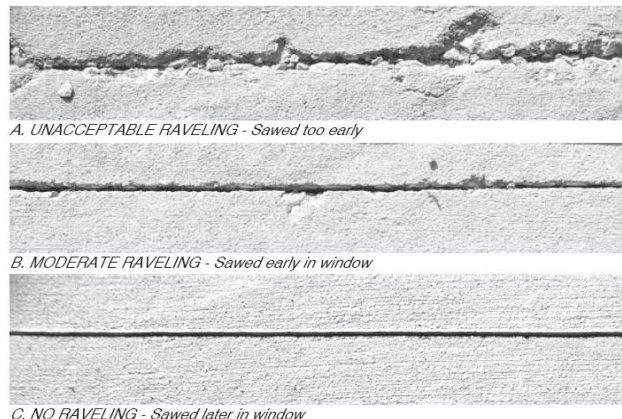
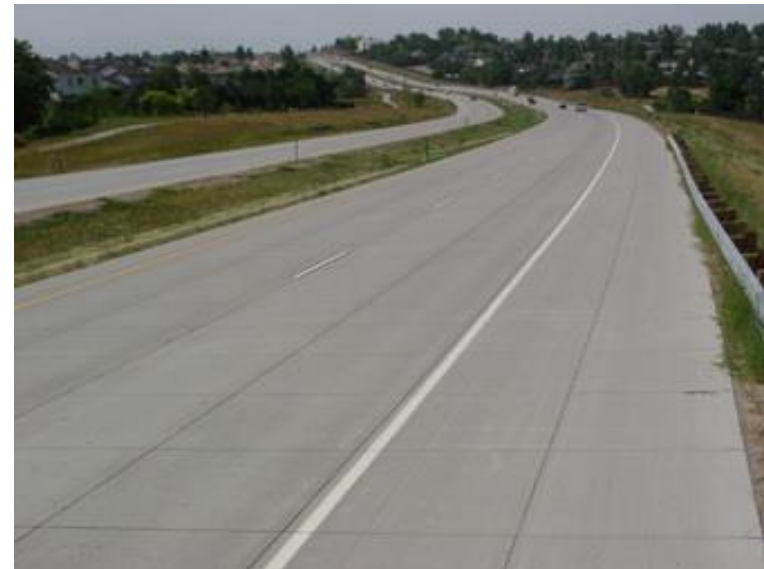
Sawing Window

- Weather:
 - Sudden temperature drop or rainshower
 - Sudden temperature rise
 - High winds & low humidity
 - Cool & cloudy
 - Hot & sunny
- Concrete Mixture:
 - Rapid early strength
 - Retarded set
 - Supplementary cementing materials

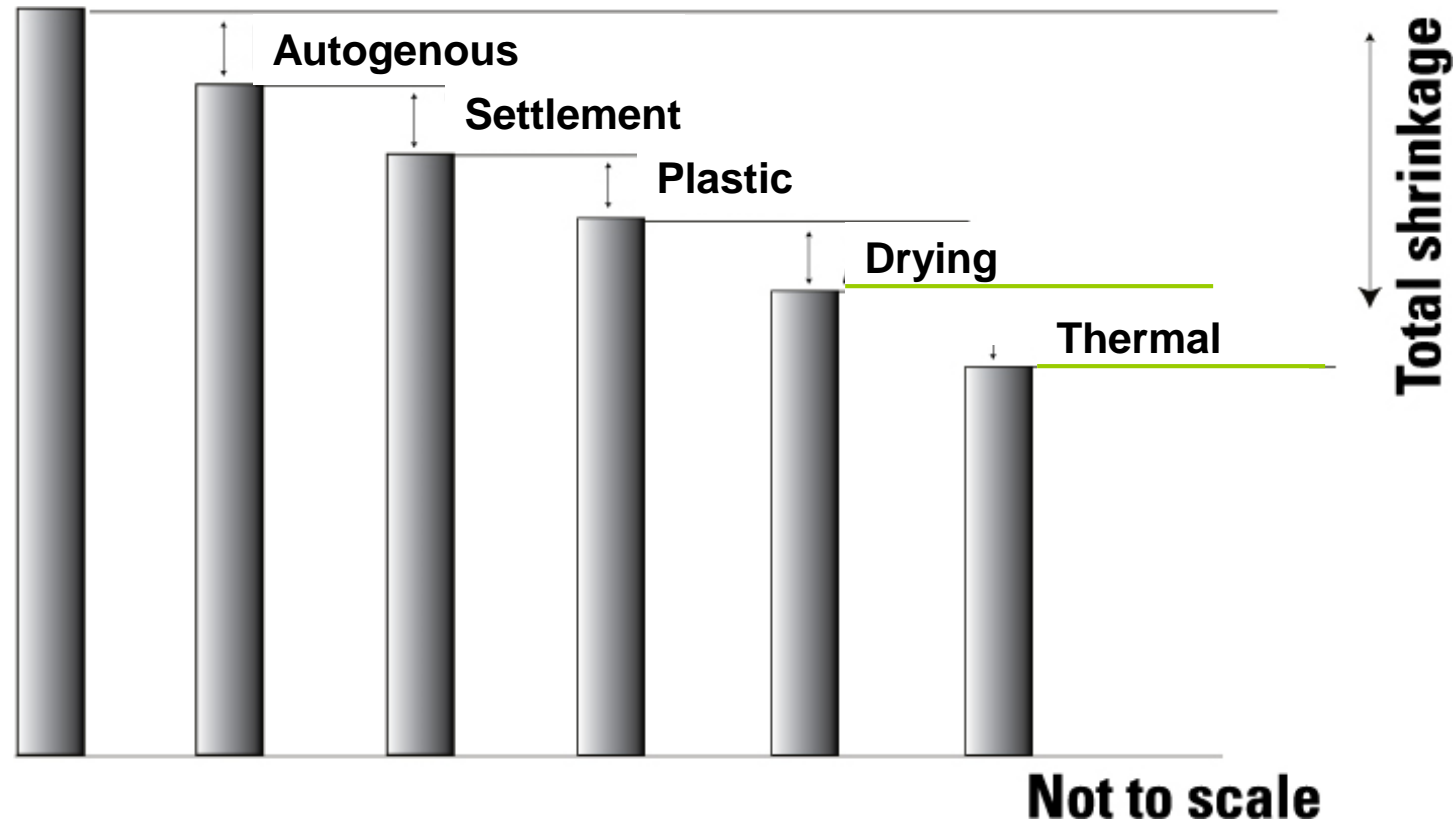
Volume Shrinkage

Total shrinkage is the sum of individual shrinkage mechanisms. Minimizing any or all mechanisms will reduce the risk of cracking.

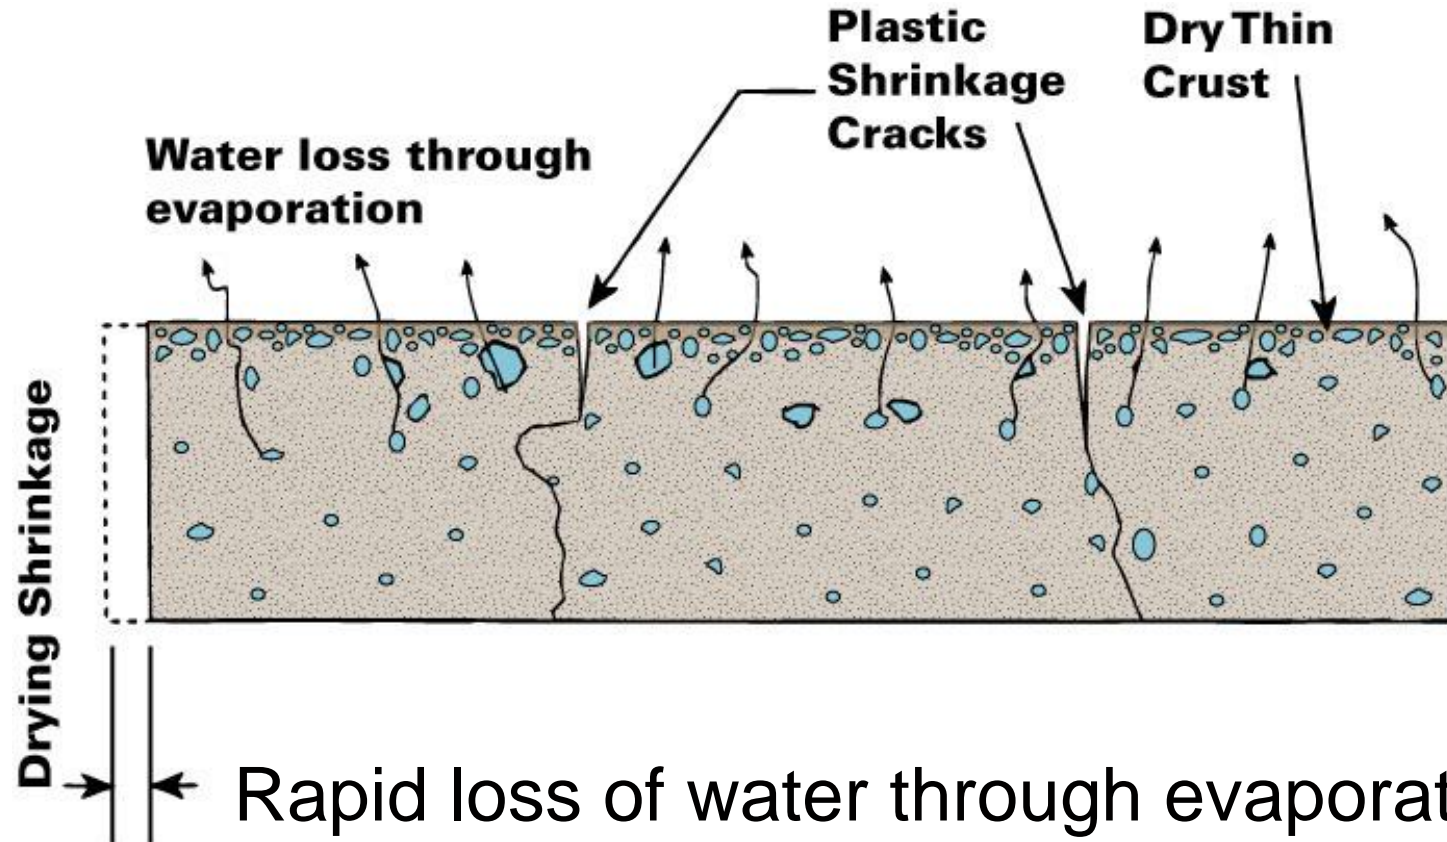
Plastic Shrinkage

Rapid loss of water through evaporation causes concrete **on the surface** to shrink. Tension develops, which may cause cracking if concrete strength is exceeded.

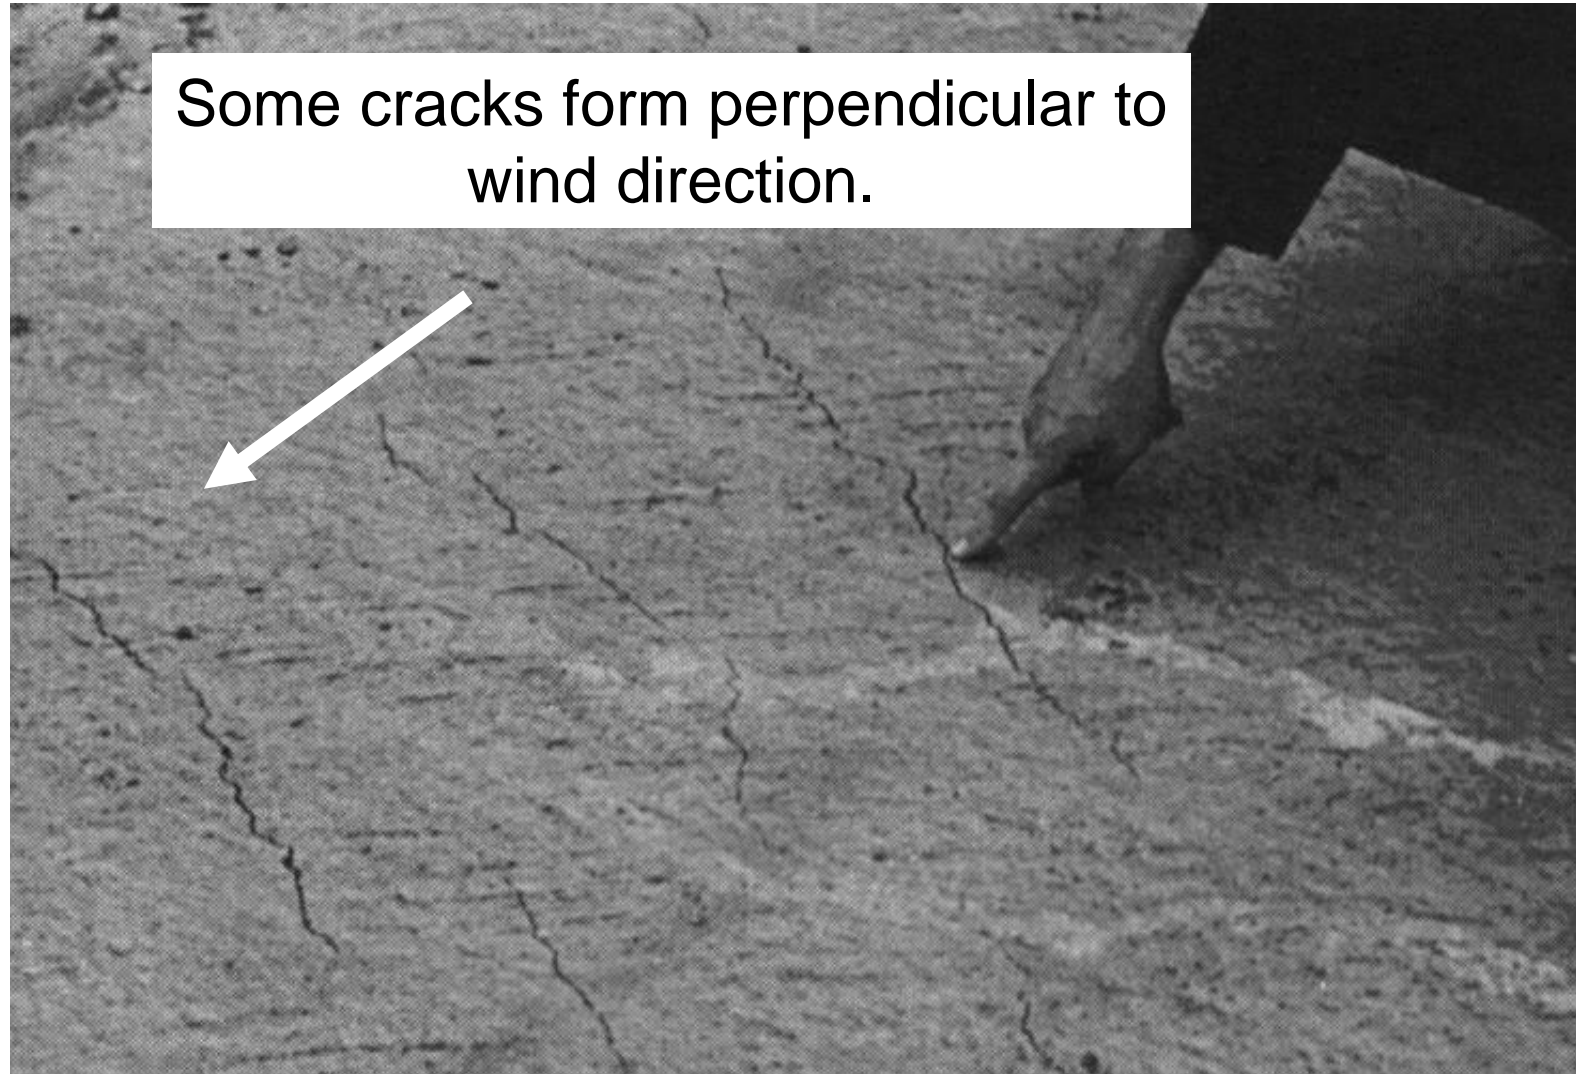
Plastic Shrinkage Cracks

Some cracks form perpendicular to wind direction.

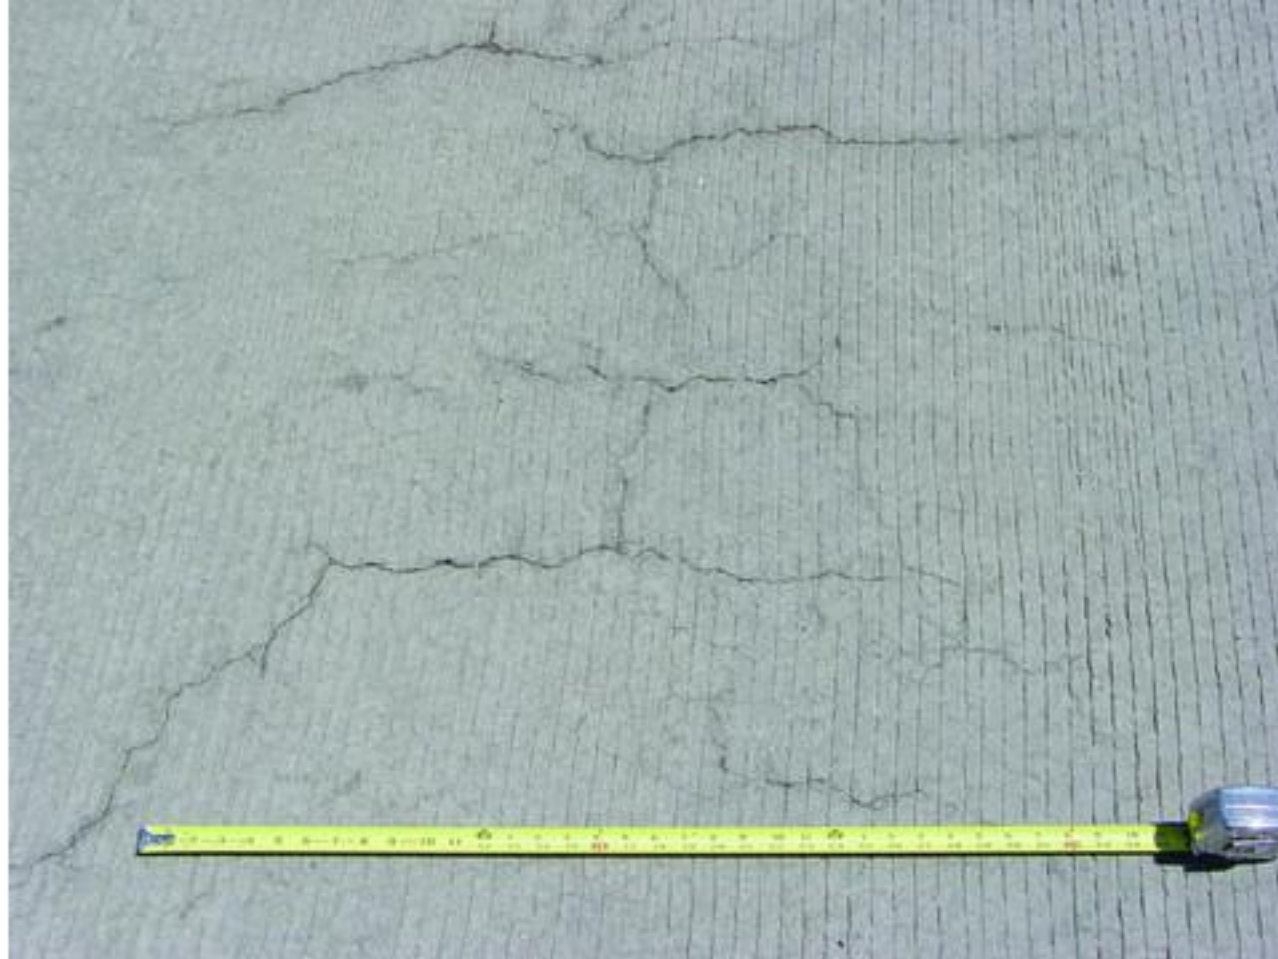
Drying Shrinkage

- Loss of mixing water through hydration and evaporation
 - Overall volume contracts
 - Greater paste content results in greater drying shrinkage and higher tensile stress
 - Low relative humidity of air can affect shrinkage diffusion

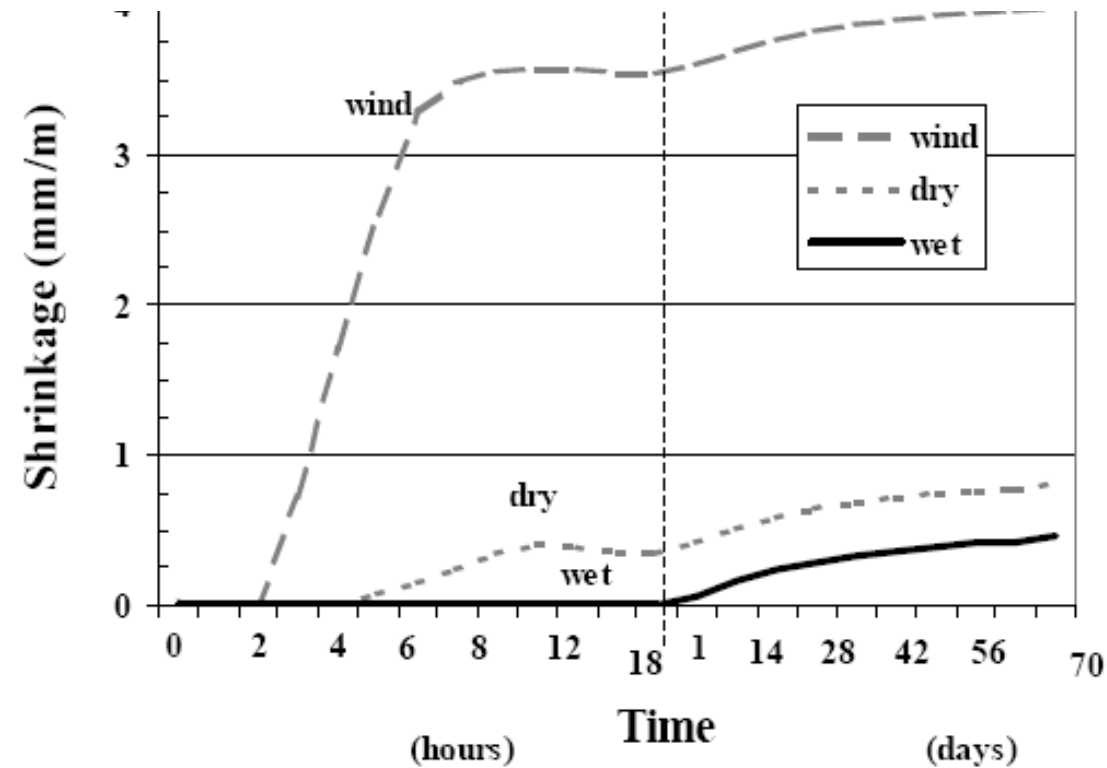
Wind on Shrinkage

FIGURE 6 Combined early age and long-term shrinkage for three different curing environments (Holt and Leivo, 2000). [1 mm/m = 1,000 μ m/m (0.001 in./in.).]

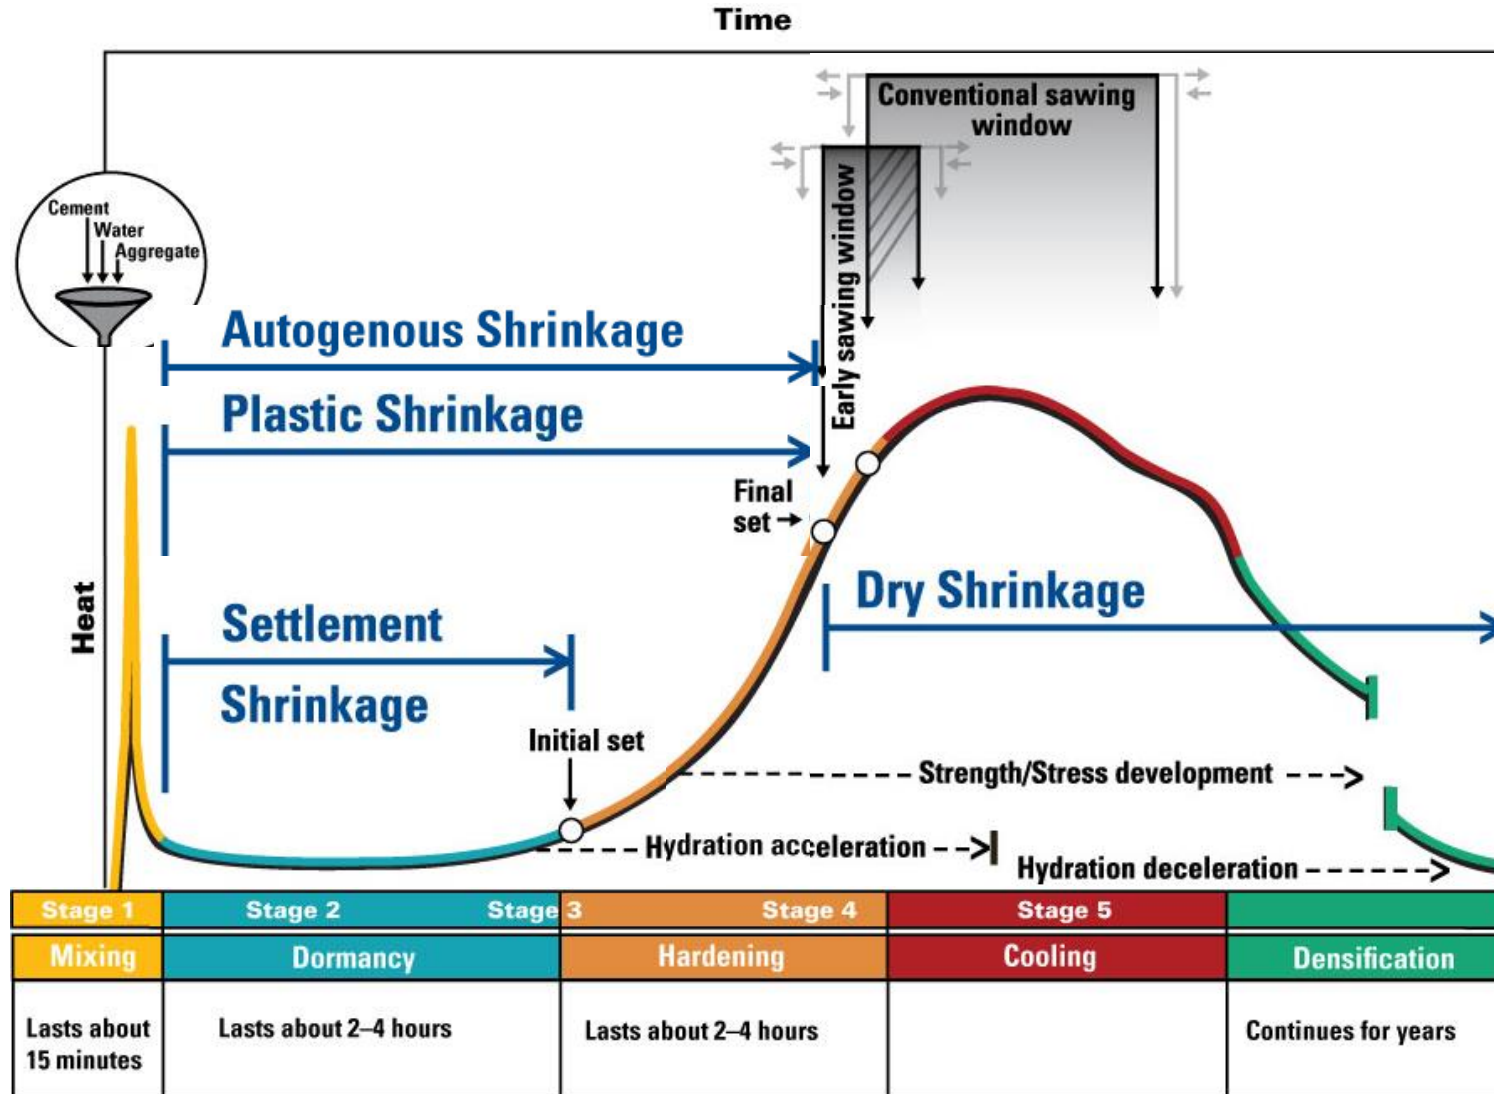
Concrete Shrinkage

Concrete shrinkage mechanisms receive positive benefit from a lower w/c ratio, and lower permeability!

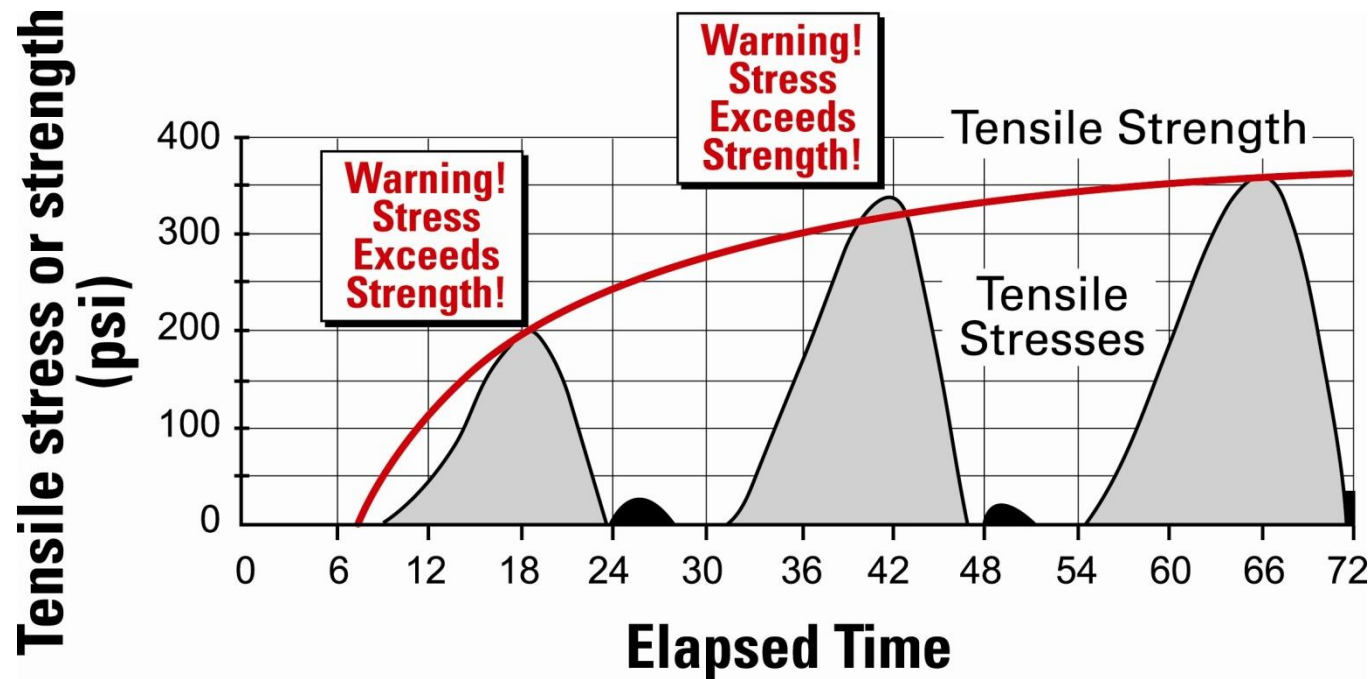
Combined Shrinkage and Curling Stresses

HIPERPAV
curve

If the sum of stresses exceeds established strength, cracks can develop.

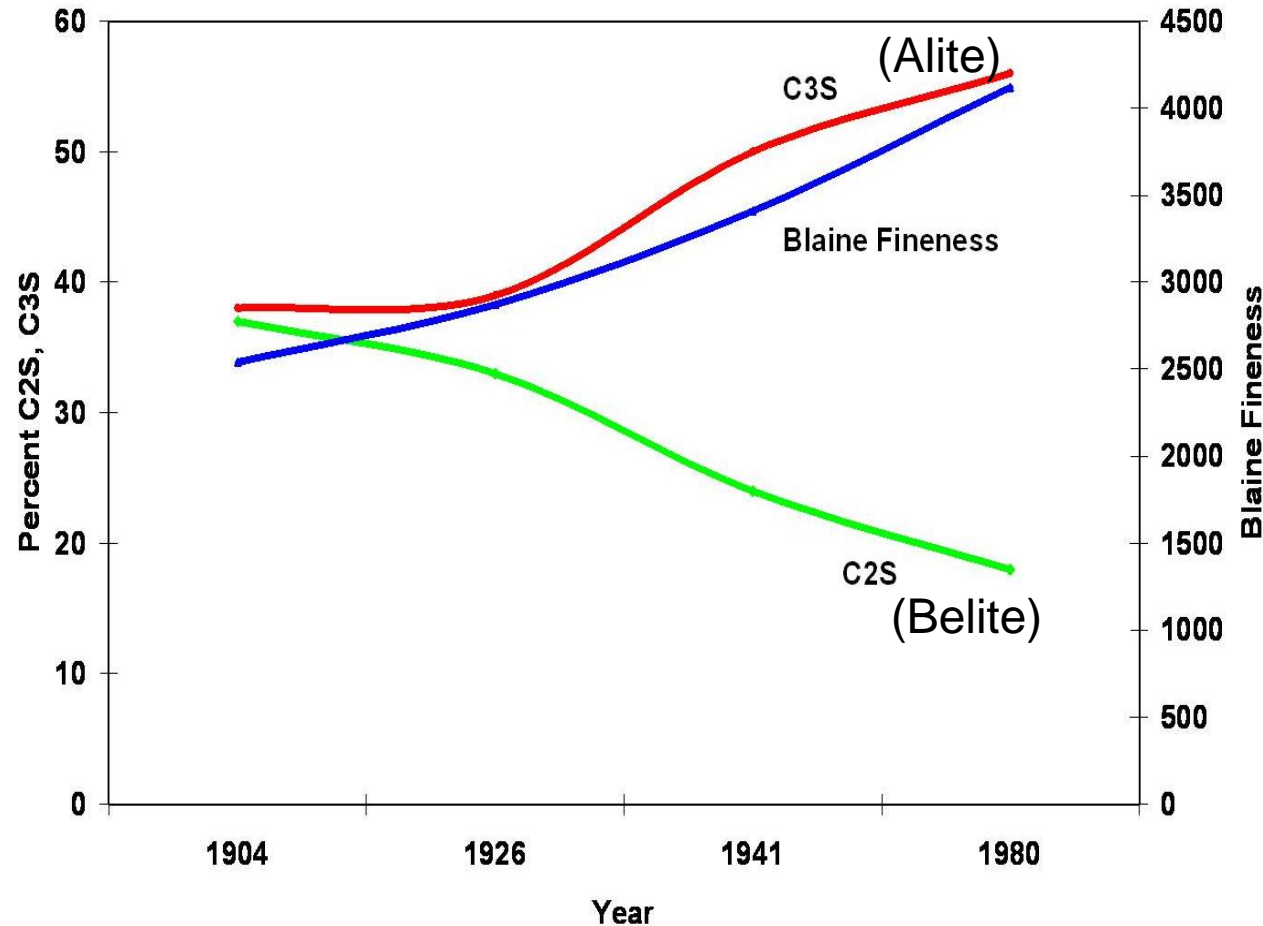
What has Changed? Cement Chemistry

Cement chemistry has changed over the years, but we have the same or better results

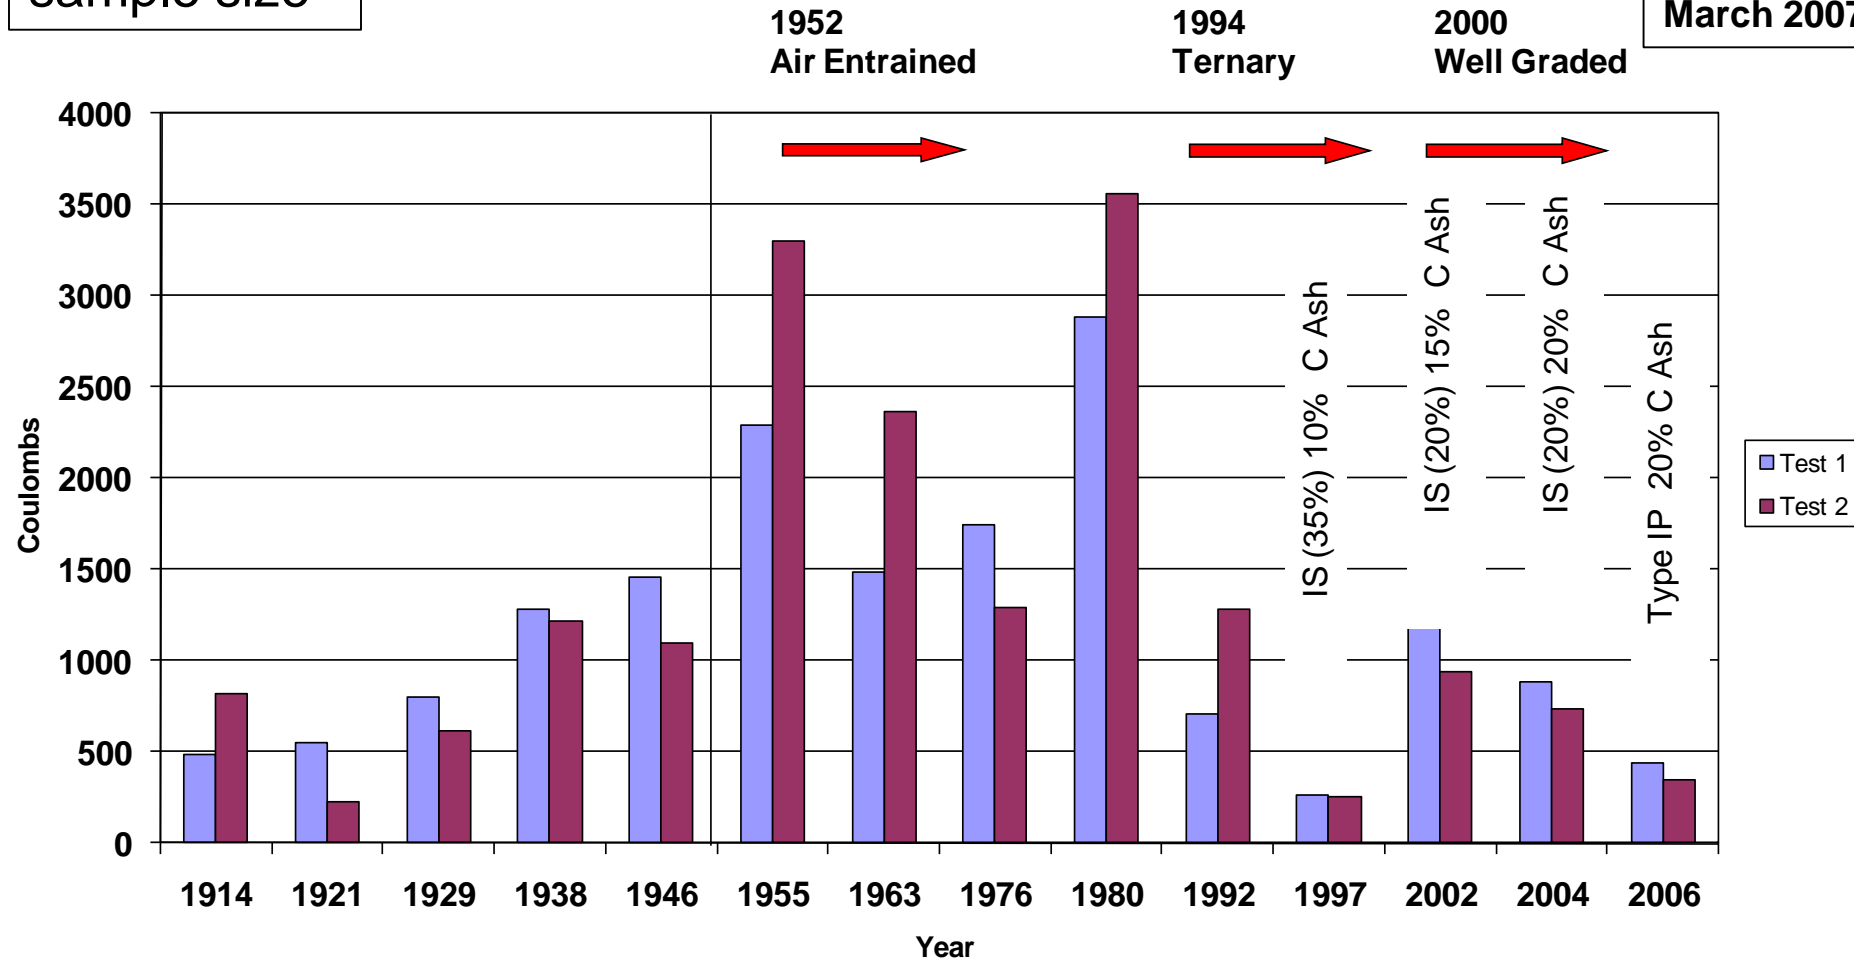
What has Changed? - Permeability

RCP - AASHTO T 277

Low permeability is more important than air (based on older pavements)

- The air content for projects placed prior to the requirement for air entrainment in 1952 is less than 3%
- Air contents increased as specification limits increased.
- The indicated permeability of older pavements is very low.
- **The permeability of pavements utilizing a Shilstone type gradation and supplementary cementitious materials, such as slag and fly ash, can reduce indicated permeability to the level of older pavements.**

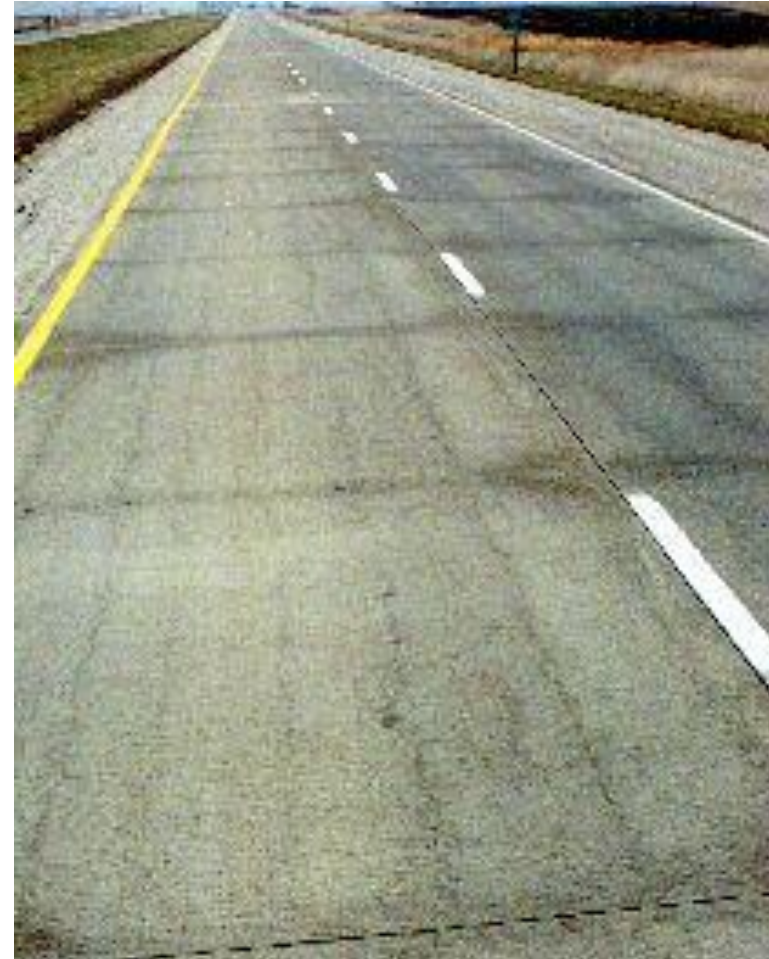
Pavement Placement Problems

- 1991- Distress
 - Vibrator trails
 - Joint spalling
- Visible in 3 – 5 yrs
- Strength vs other properties?

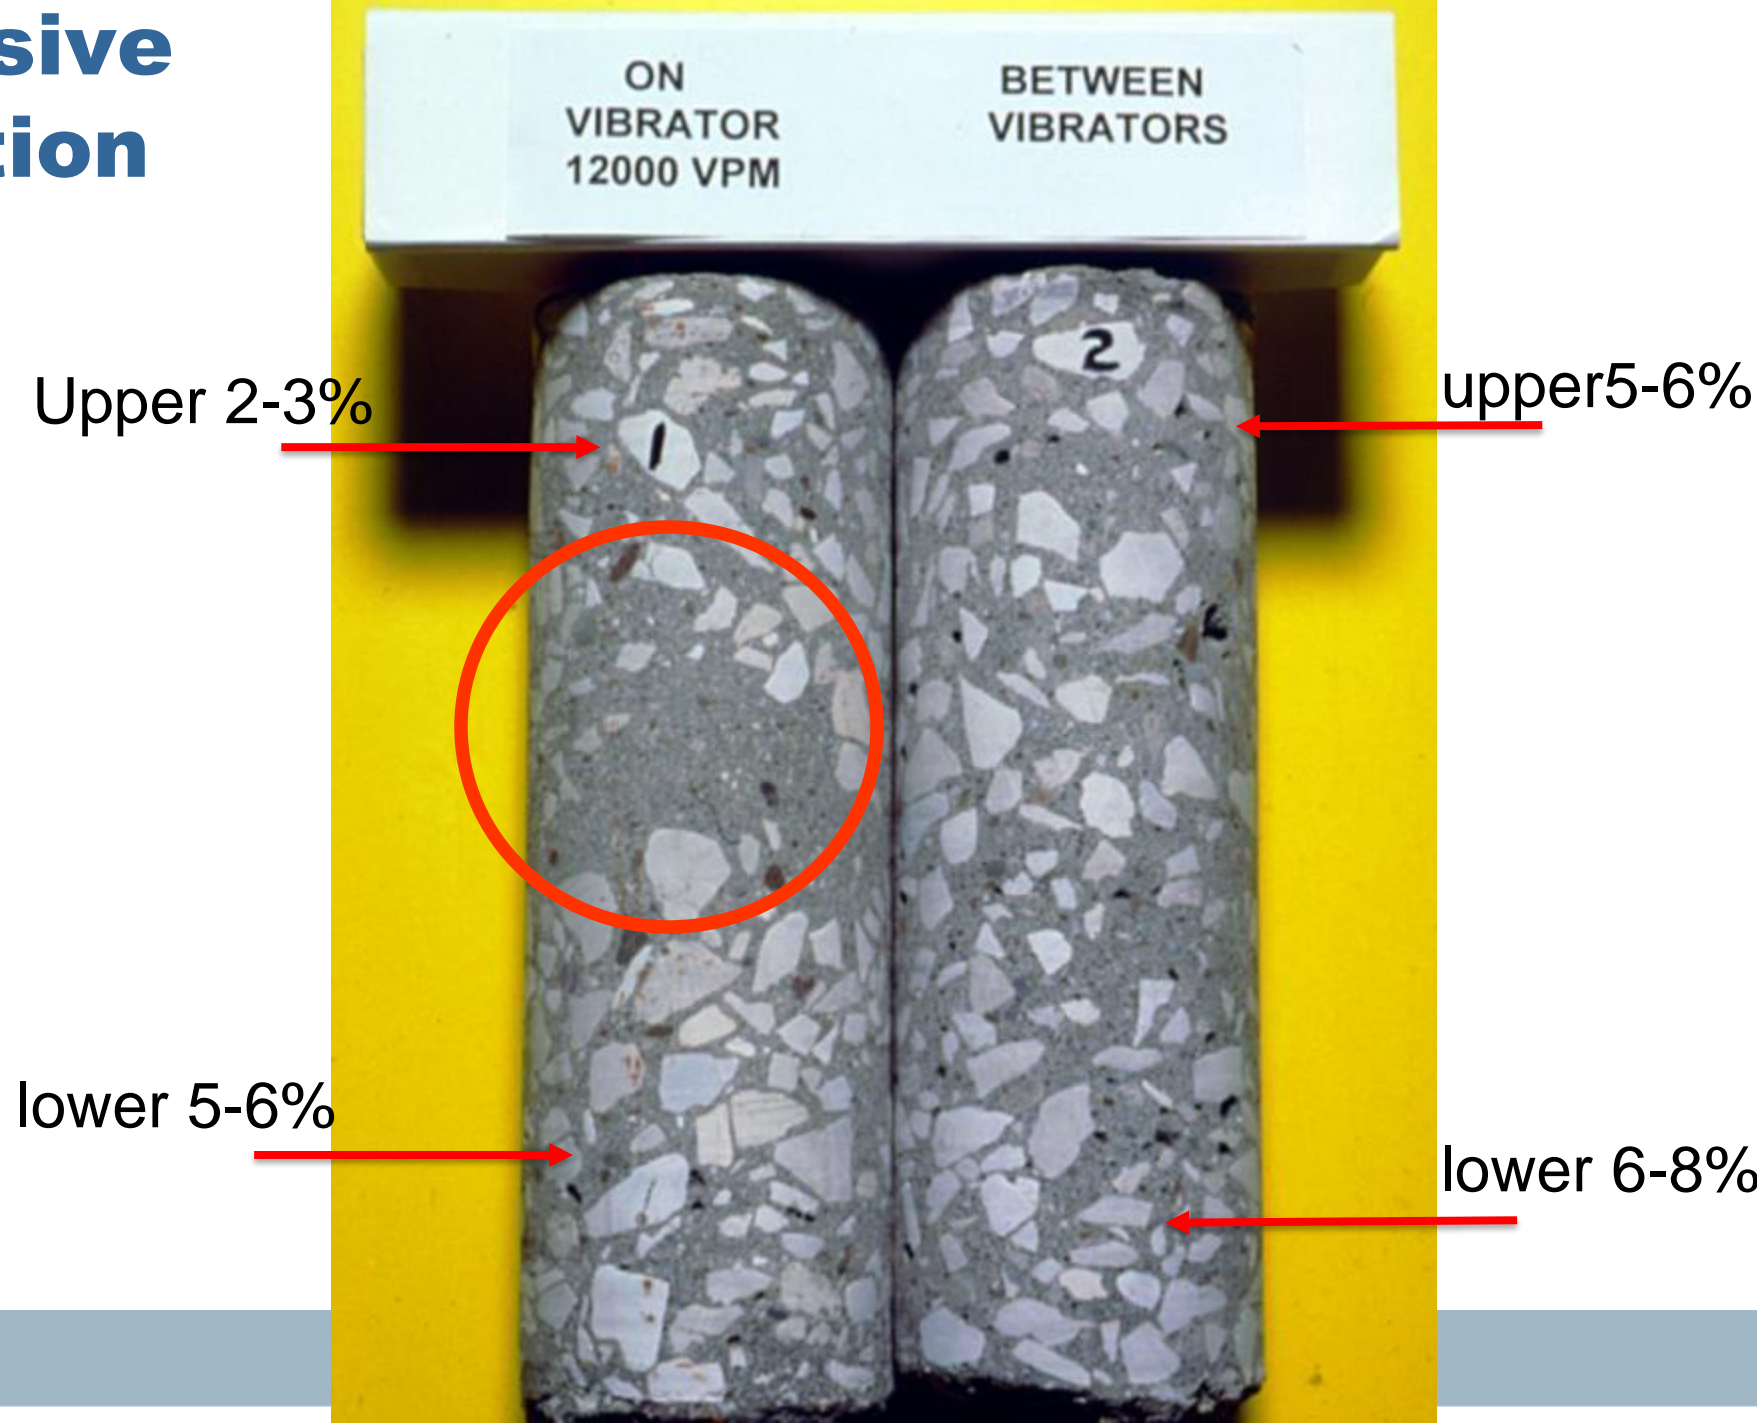
Excessive Vibration

- Aggregate segregation
- High mortar area
- Low Air <3%
- Poor Spacing Factors >0.35 mm

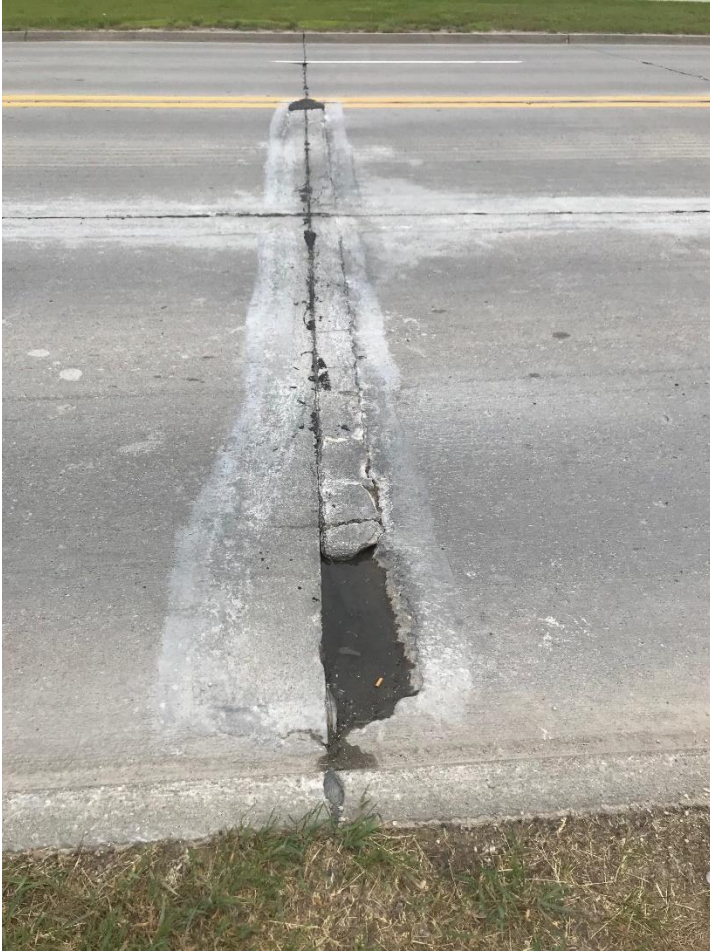
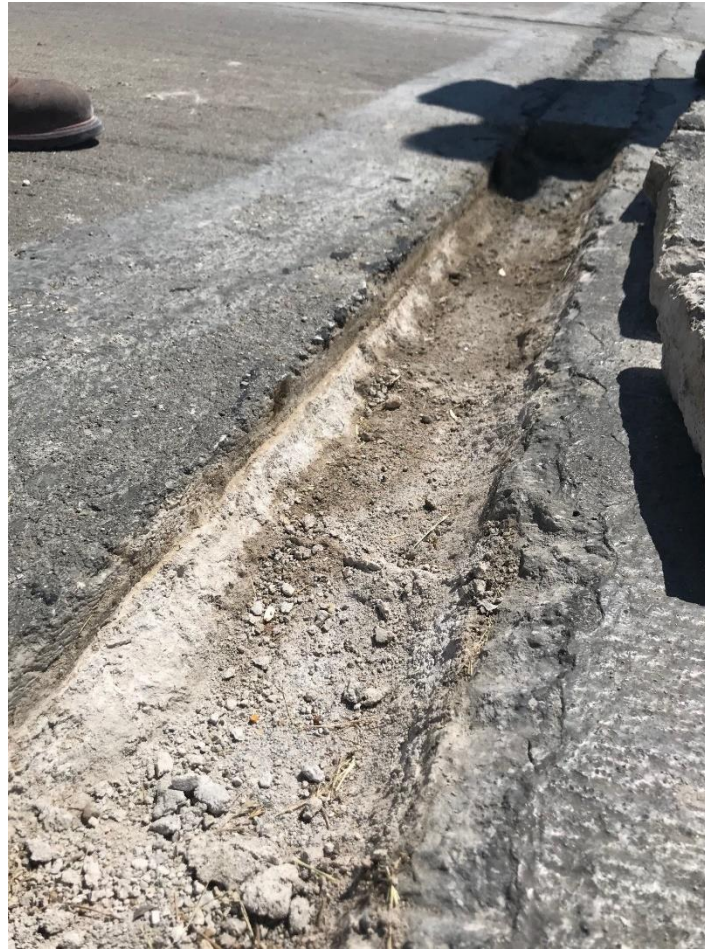
Construction – Partial Depth Repairs

Restore the Joint

- Better results with compressive relief material
- Saw to full depth of patch **only** if board cannot provide complete separation of patch material on both sides of joint (Iowa DOT)
- SUDAS requires board

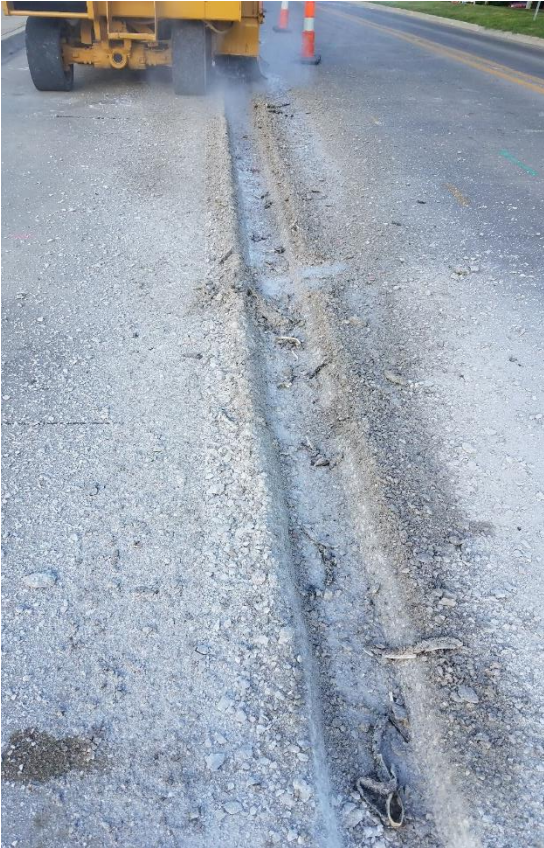
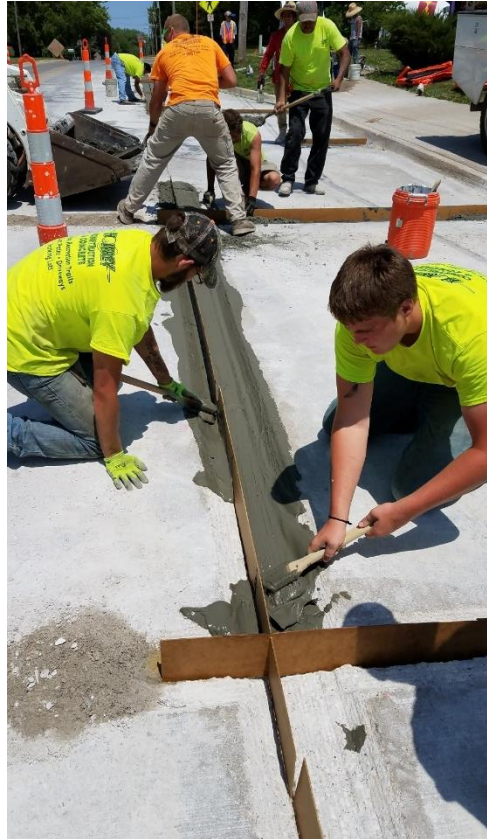
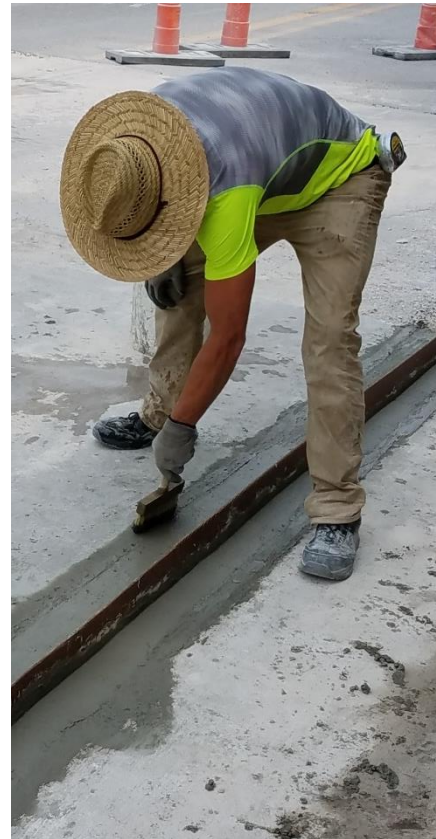
Construction – Partial Depth Repairs

Critical Items:

- Remove loose material
- Prepare surface
- Grout
- Restore the joint

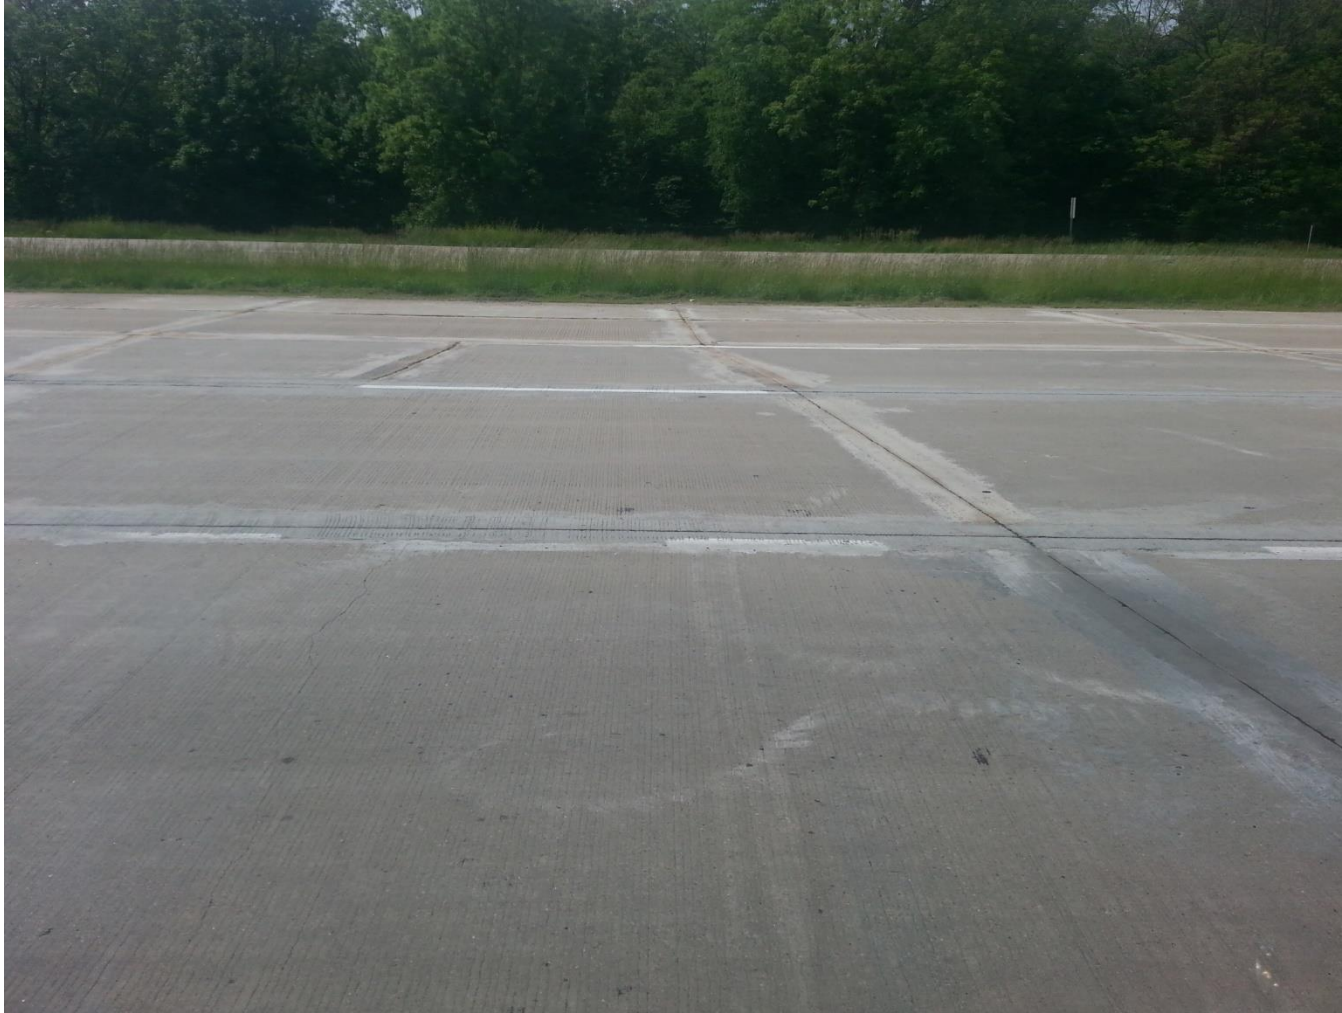
US 20 – Waterloo, Iowa

Partial-Depth Repairs

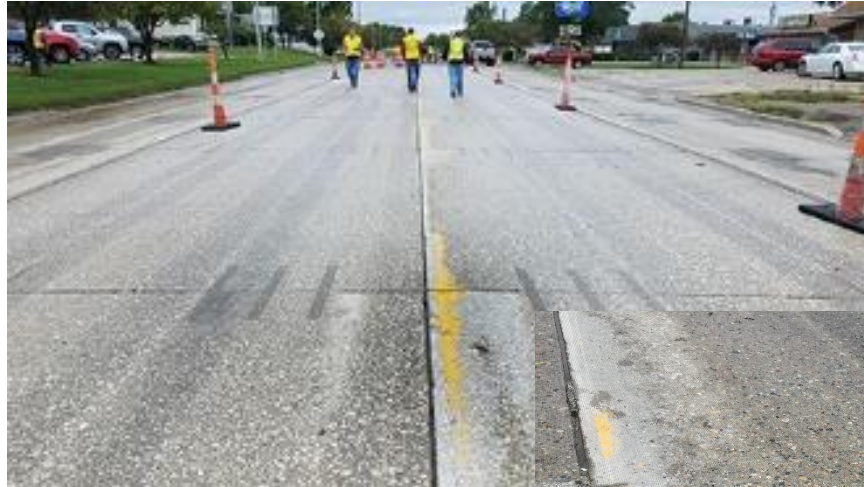
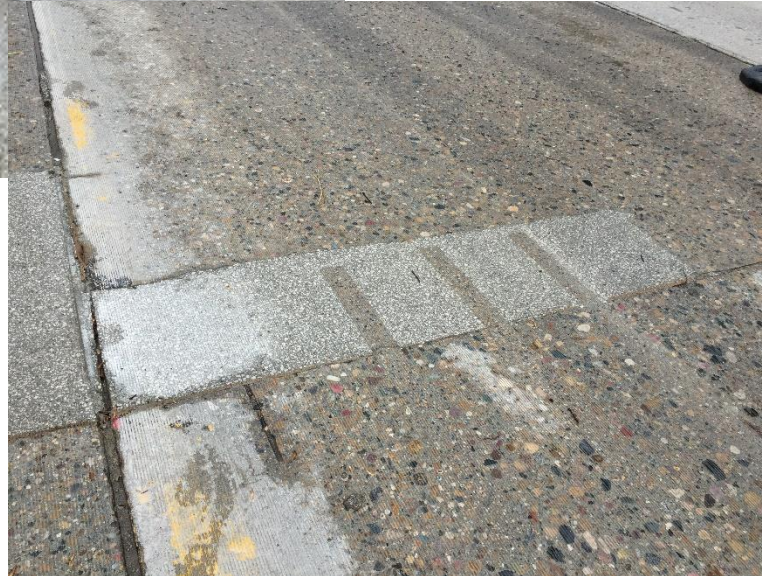
US 59 - Denison

- Partial-Depth Repairs
- Full-Depth Repairs
- Dowel Bar Retrofit
- Diamond Grinding
