Lessons Learned & Success Stories For Long Life Pavements

**National Concrete Pavement
Technology Center**

Overview

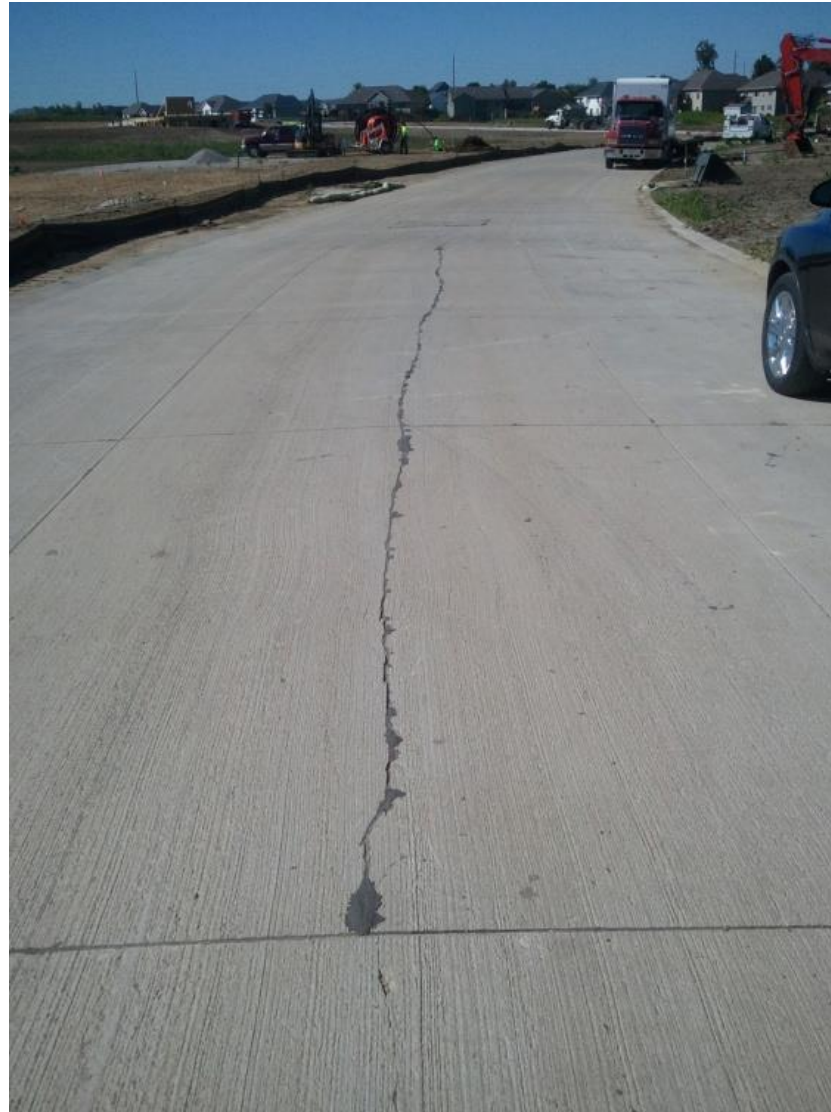
Longitudinal Cracking

Saw too late or not deep enough

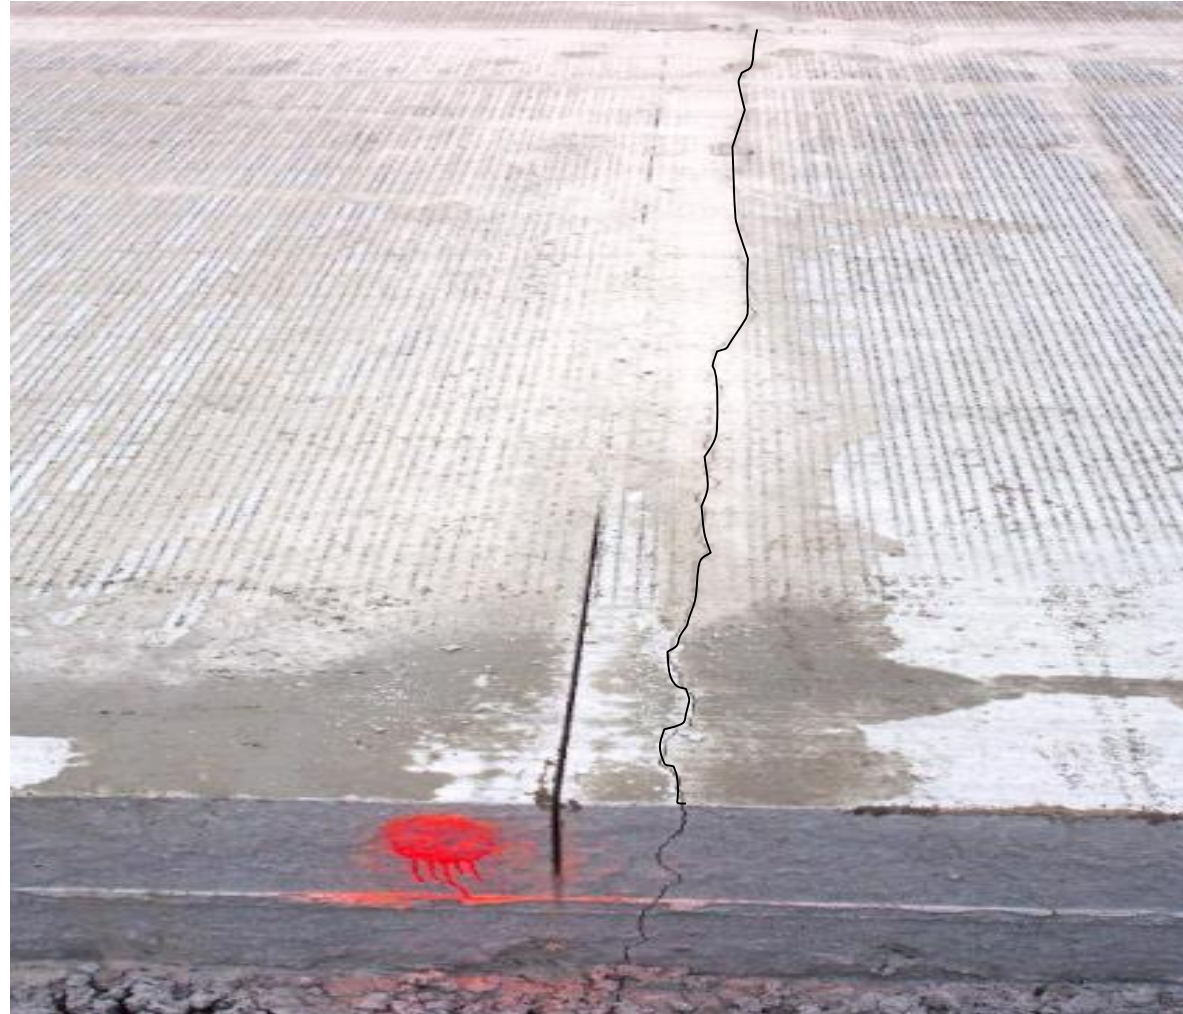
Transverse Cracking

Sawed too late

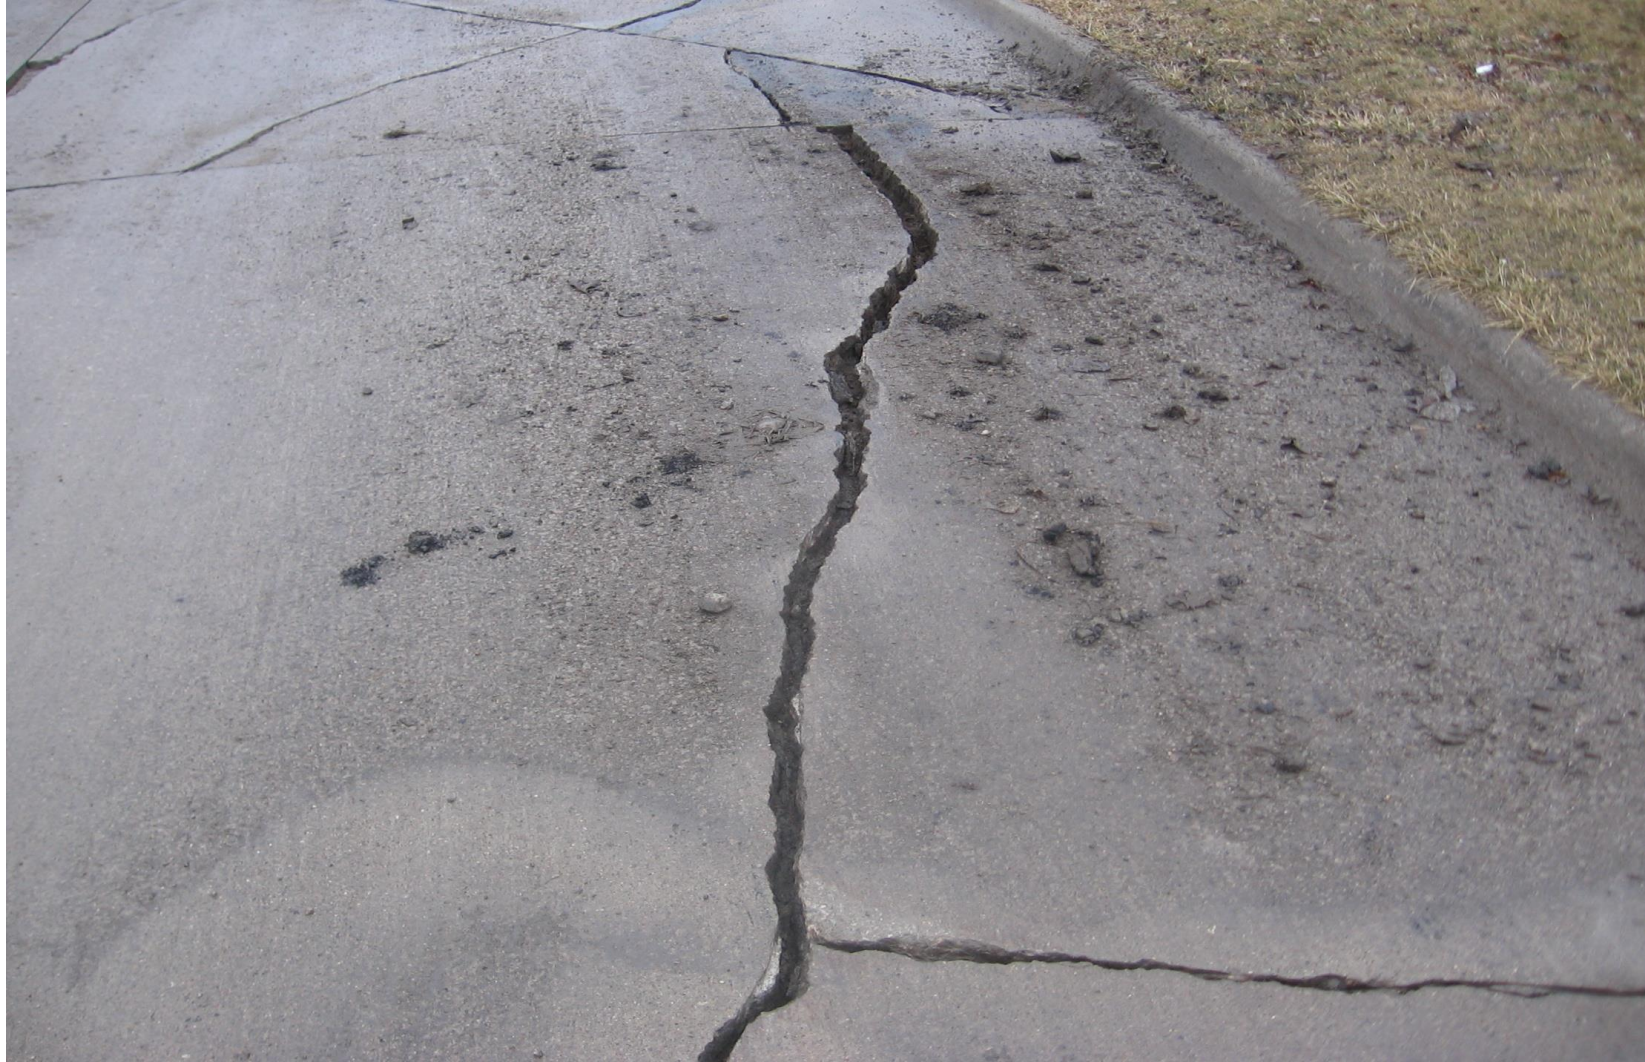
Diagonal (Random) Cracking

Very poor subgrade

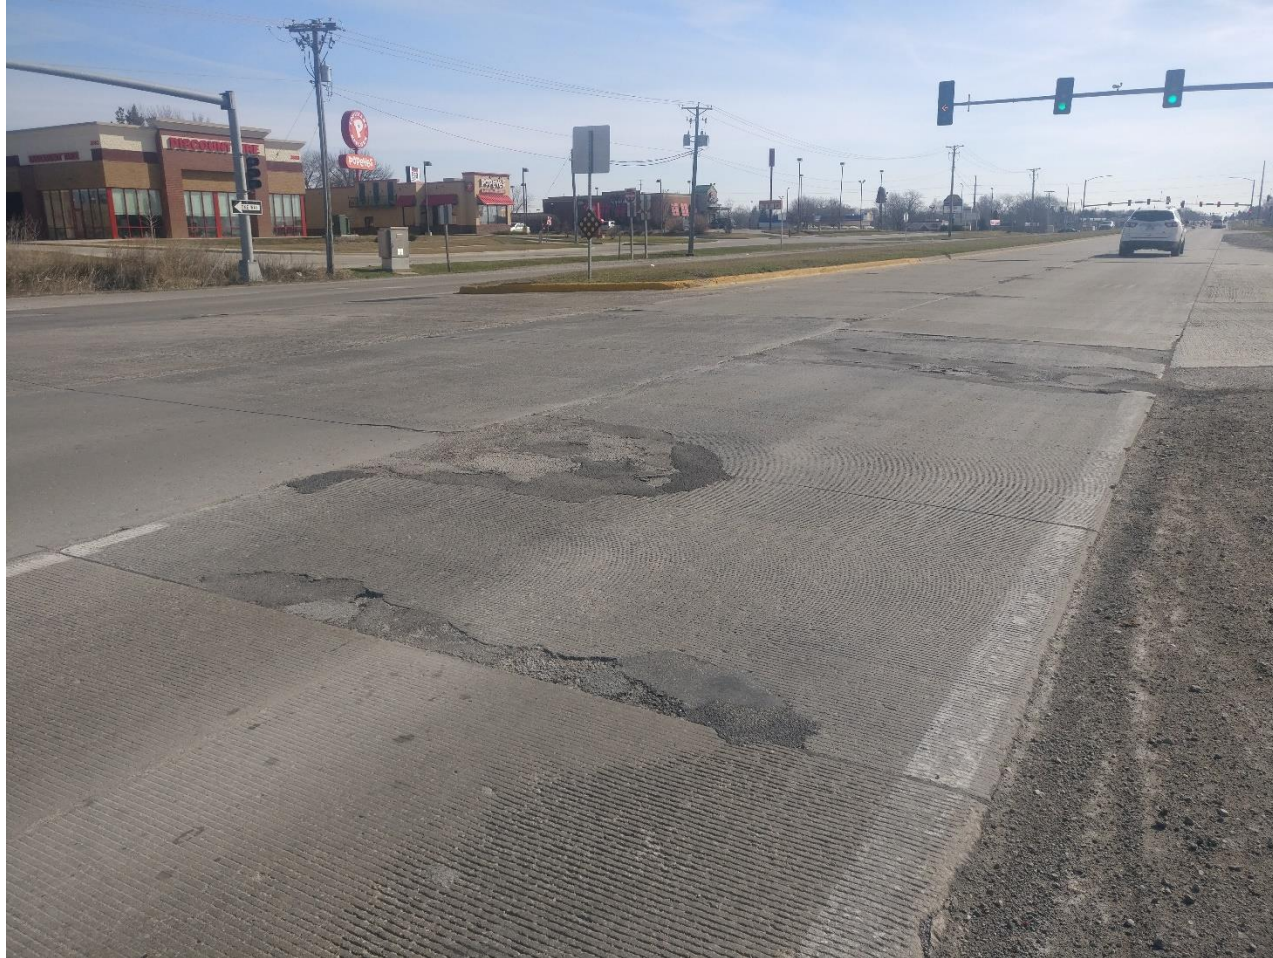
Case Study: Existing Condition

Joint deterioration

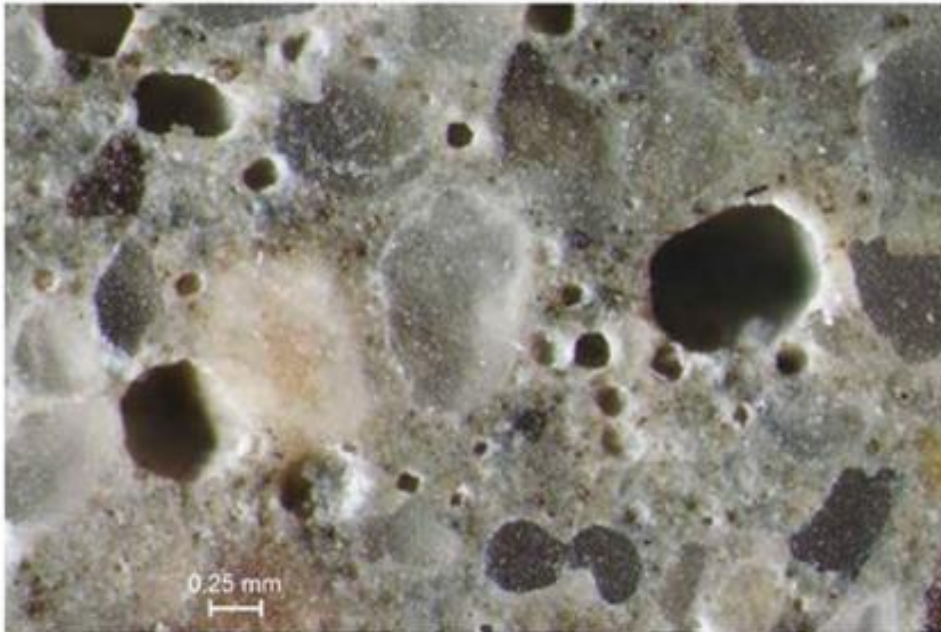
Figure 13a – Adequate Air Entrained System

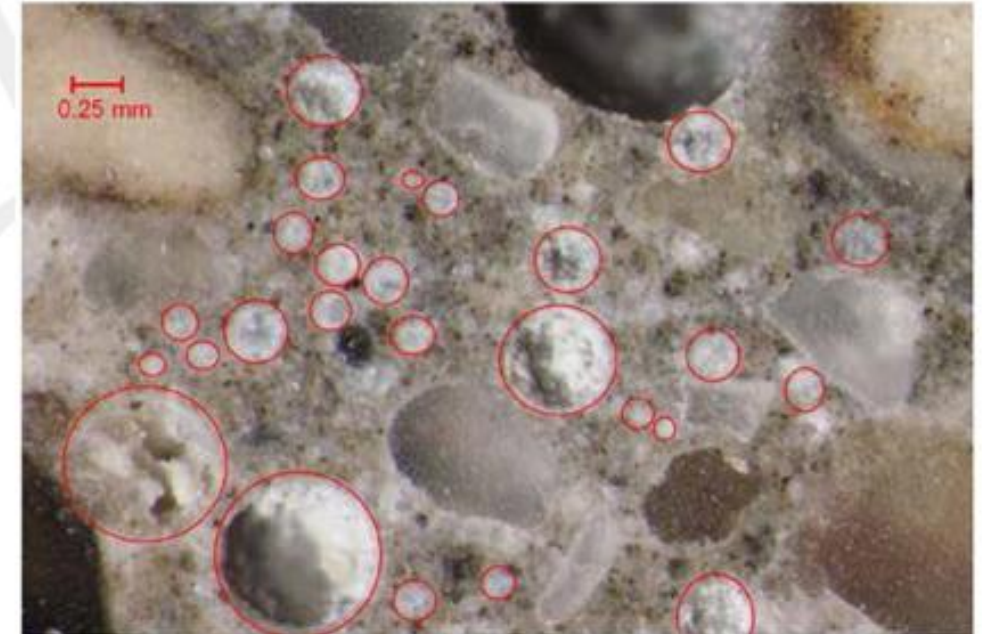
Figure 13b – Air voids Filled with Ettringite

- Subsurface moisture and saturation
- Development of ettringite in air voids.
- Deficient air void system because of ettringite
- Aggregate durability (25 years of freeze-thaw)

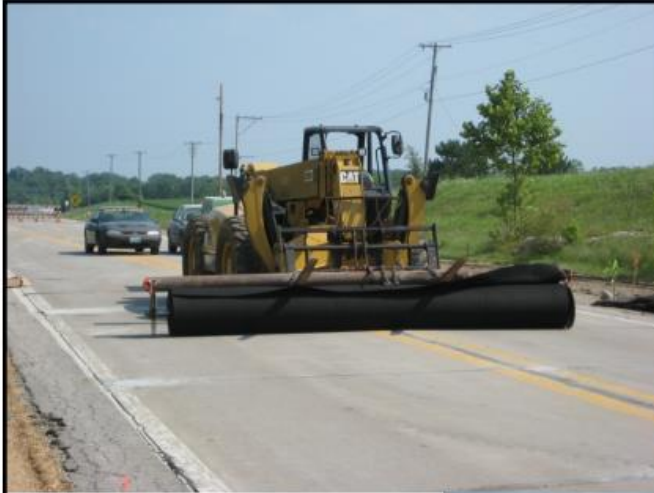
Placing Fabric

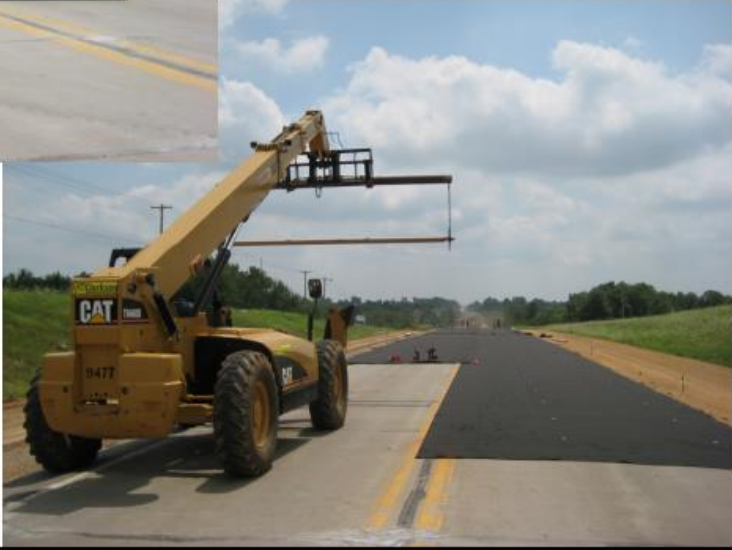
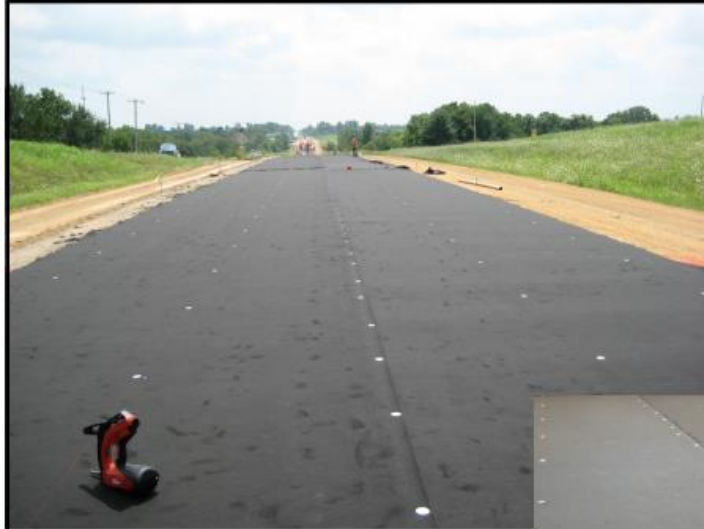
Securing Fabric

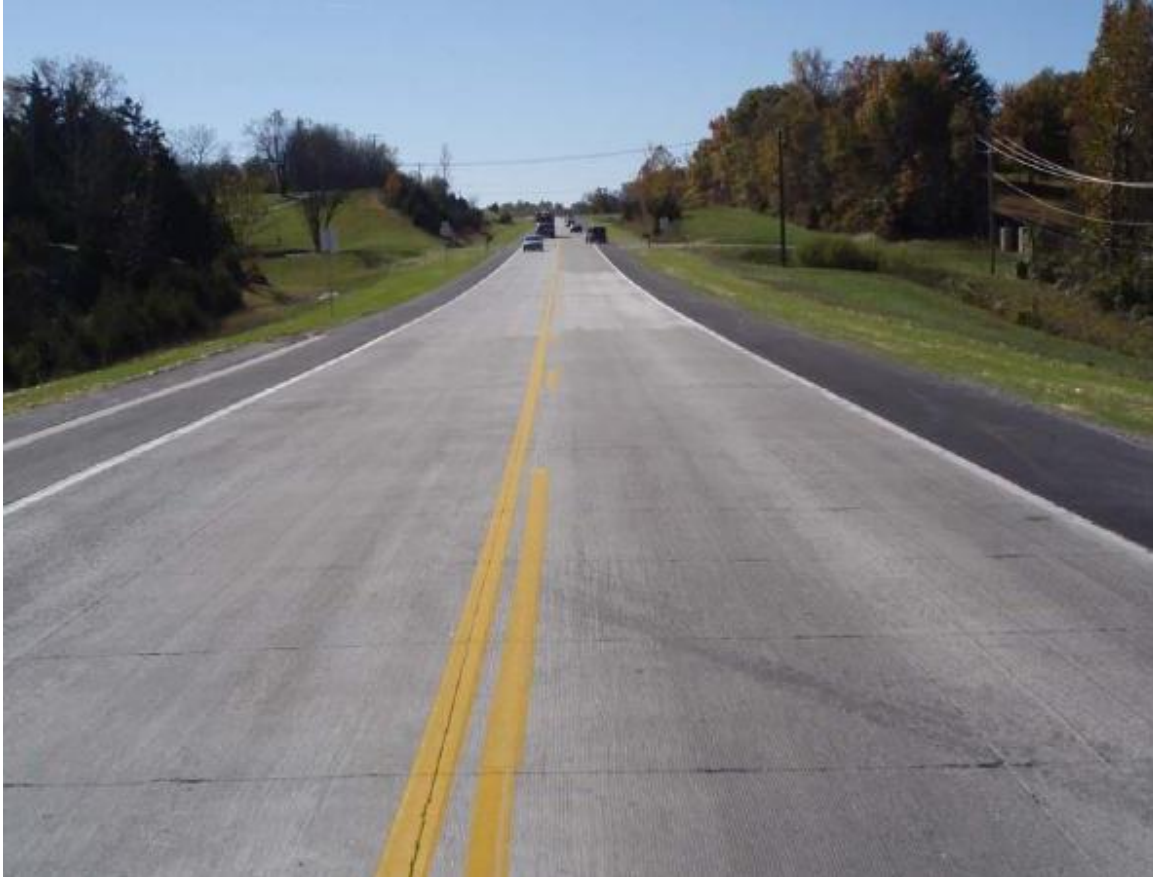
Route D-35 near Kansas City

2008 Unbonded Concrete Overlay

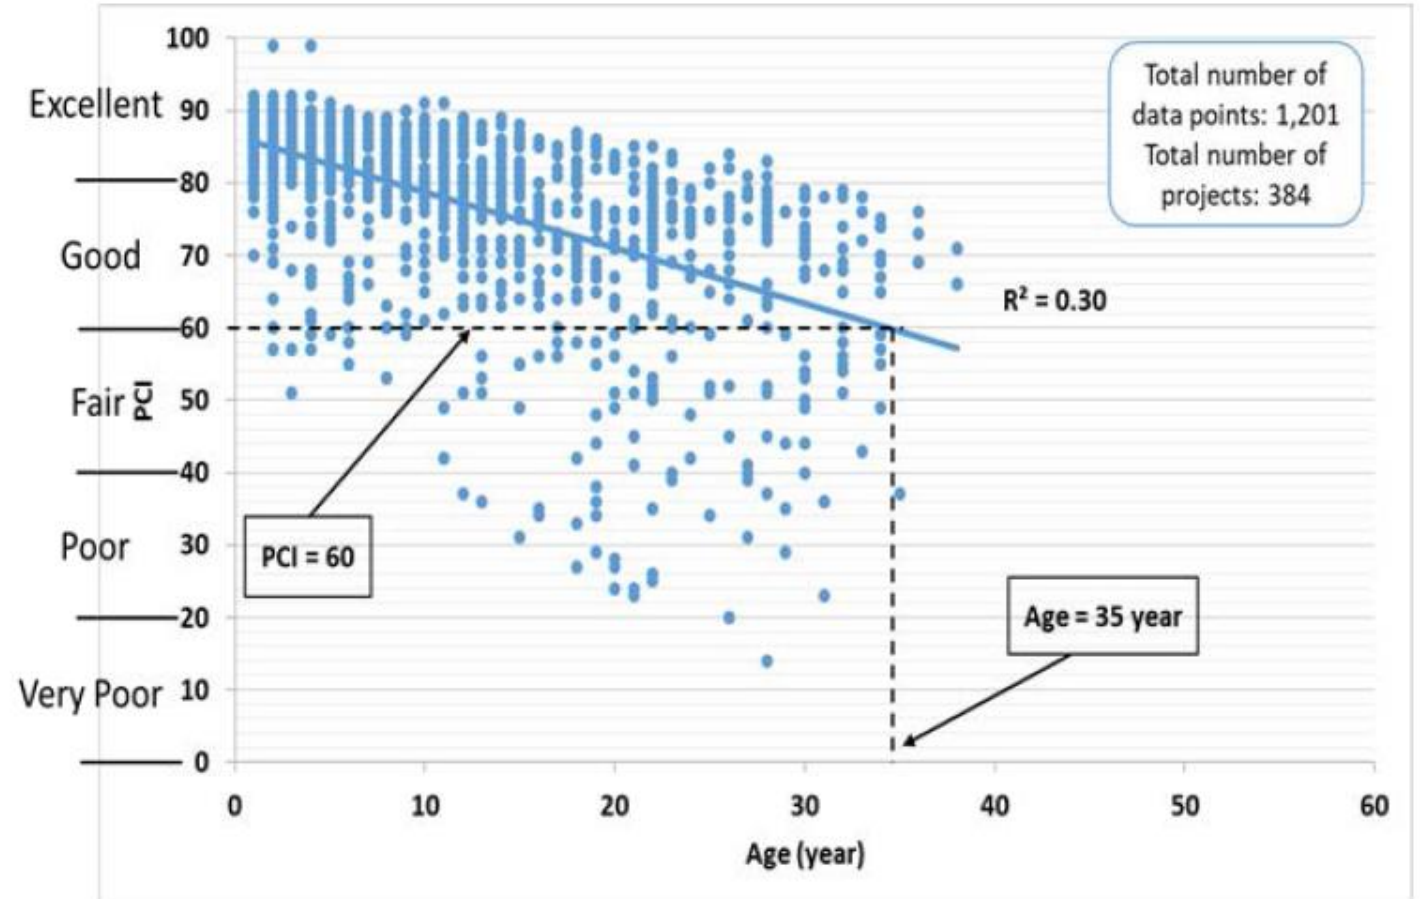
Concrete overlays performing very well

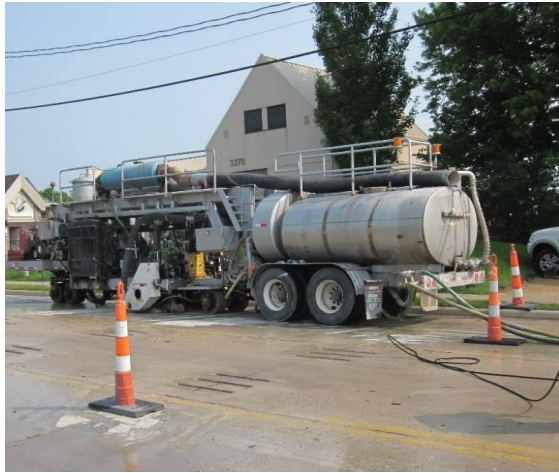
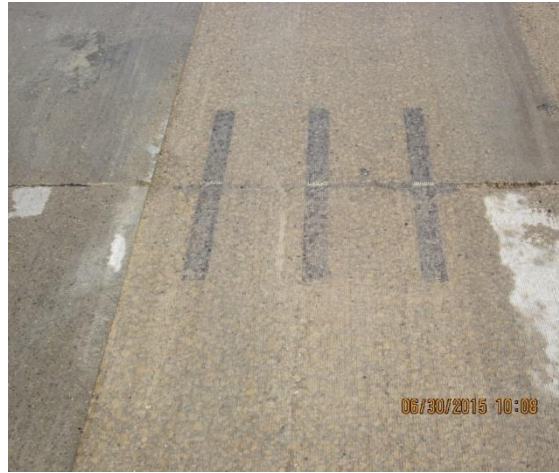
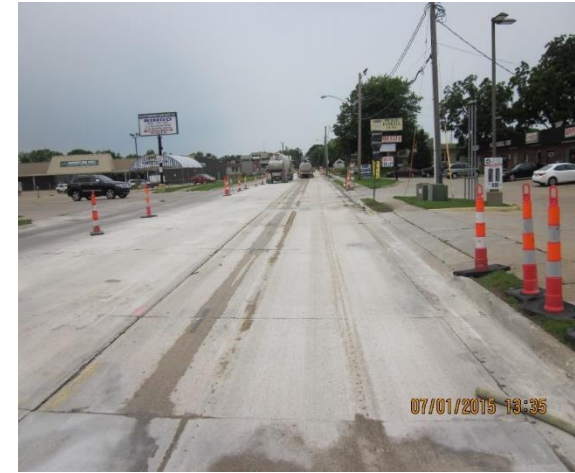
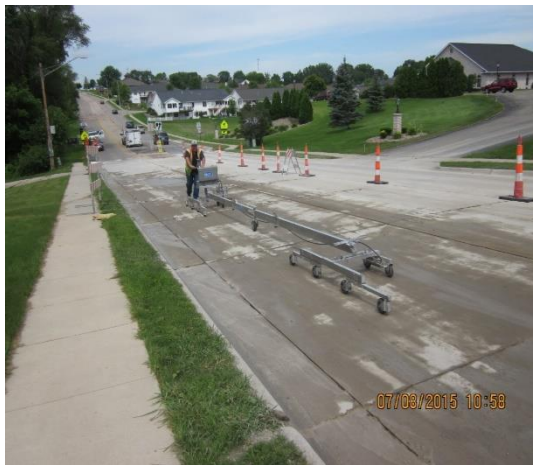
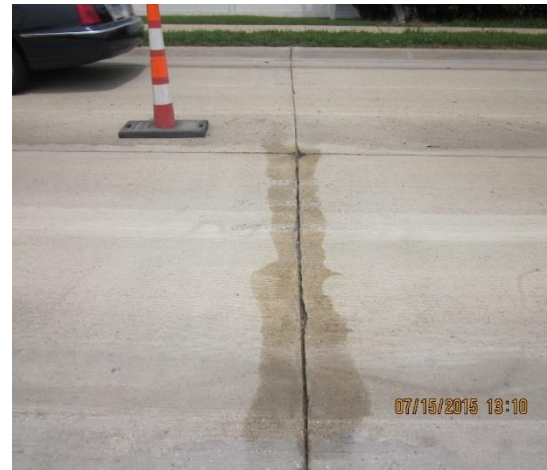
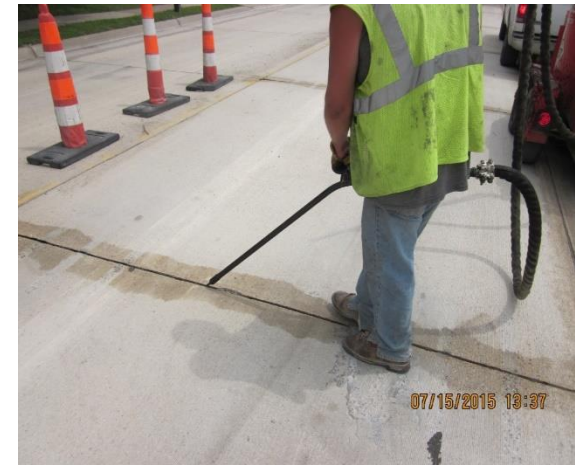
Rehabilitation - Asbury Rd, Dubuque

COMPLETED PROJECT - DETAILS
