DOWEL BAR ALIGNMENT USING PULSE INDUCTION TECHNOLOGY

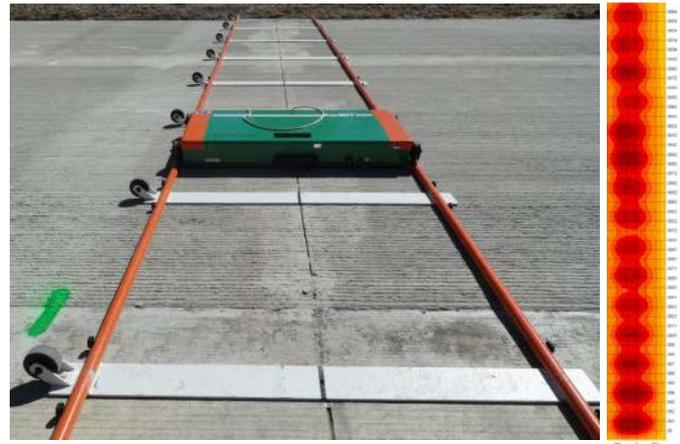
MIT Scan-2 is a state-of-the-art, nondestructive testing device for measuring the position of dowel bars embedded in concrete. The operating principle behind the device is pulse-induction. The equipment emits a weak, pulsating, magnetic signal and detects the transient magnetic response signal induced in metal bars. The response signals are measured with high precision using special receivers in the testing device, permitting the determination of horizontal misalignment, vertical misalignment, side shift and depth of the dowel bar from the top of the pavement.

Proper dowel bar alignment is essential for efficient load transfer between concrete pavement slabs. Until the advent of this device, there was no way of accurately checking alignment of dowel bars other than taking cores (which can be only done on a limited basis). The advantage with MIT Scan 2 is it can be used as soon as the pavement can be walked upon to check the presence and alignment of dowel bars, allowing the contractor to take corrective action immediately. Typically, coring is not conducted unless dowel bar placement issues are suspected. Even in those cases, coring is not a good method to check the presence and alignment of dowel bars, since coring can be performed at only a limited number of joints. In addition, multiple cores have to be taken at each joint, since taking one or two cores will not reveal the overall dowel bar alignment at a joint.

The major benefits of MIT Scan 2 are that it is nondestructive, measurement can be taken extremely quickly (two to five minutes per joint), results can be seen in a graphical display or a tabular format immediately in the field for quality control purposes, and it is not very complicated to operate. Currently North Carolina DOT, Nevada DOT, and the New York Thruway Authority, have specified the use of this technology to check alignment of dowel bars in their specifications.
