# Evaluation of Work Zone Split Traffic Symbol Sign

tech transfer summary

February 2018

Evaluation of Work Zone Split Traffic Symbol Sign

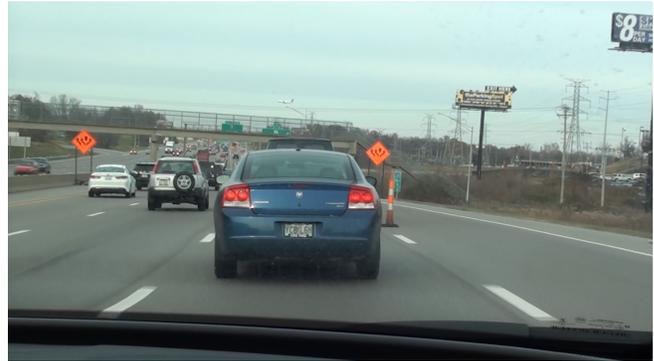
*Screenshot from a drive-through video*

- Collection and analysis of drive-through videos to understand drivers' perspectives and evaluate sign visibility
- Collection and processing of stationary videos to assess driver behavior
- Stakeholder interviews with contractor and Missouri Department of Transportation (MoDOT) personnel to learn their views on the effectiveness of the sign
- Review of survey responses from MoDOT's "Rate our Work Zones" website to determine if drivers provided any feedback regarding the use of the alternative sign
- Analysis of crash data for the work zone period and the period prior to the work zone
- Travel time analysis for the work zone period and the period prior to the work zone
