# Guide to the Prevention and Restoration of Early Joint Deterioration in Concrete Pavements

tech transfer summary

December 2016

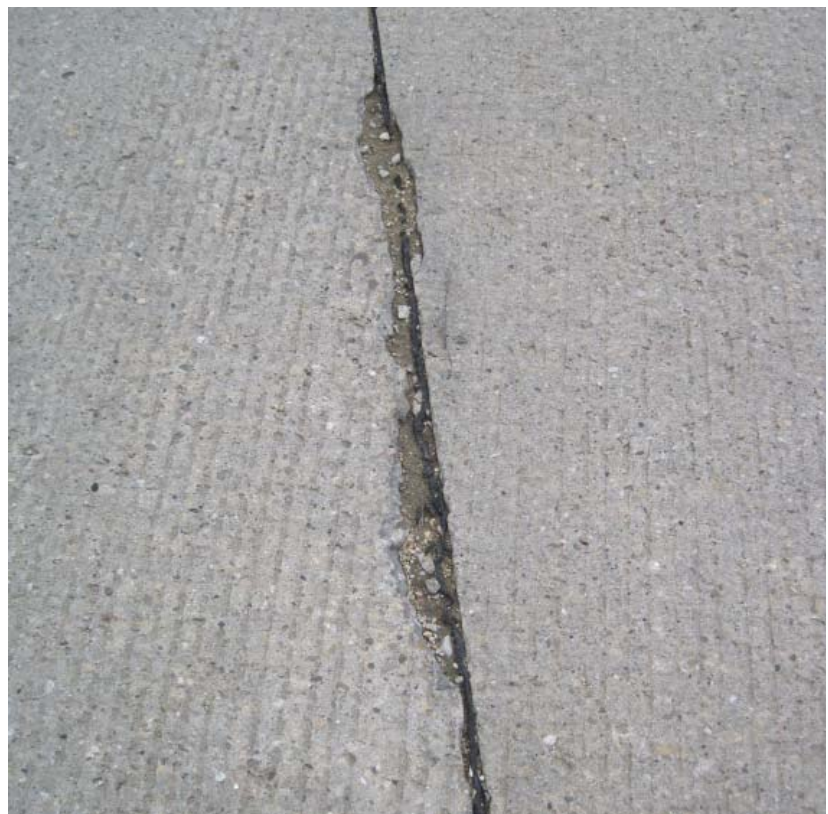
Figure 1. Premature joint distress (photo courtesy of Jim Grove, FHWA)

For more than a century, portland cement concrete pavements have served the traveling public well. During this time, joint design has undergone many changes in regard to spacing, width, depth, and formation, and materials engineers have gained knowledge about the concrete mixture itself related to improving joint performance. In recent years, however, premature concrete pavement joint distresses have occurred, primarily affecting the mortar in the joints, as shown in Figure 1. This premature deterioration has been observed not only in Iowa but in other snowbelt states as well.

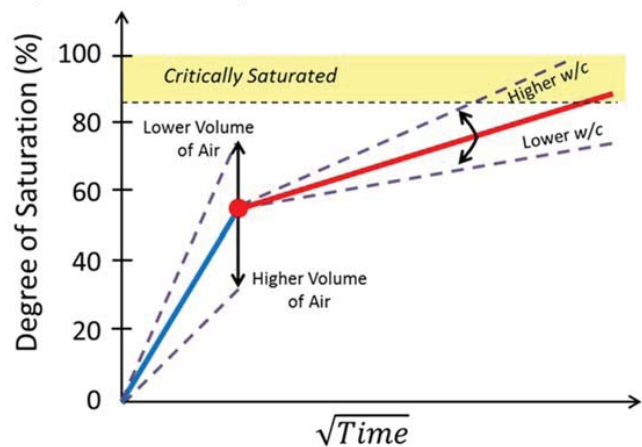
Figure 2. A conceptual illustration of the sorption-based freeze-thaw model

The model reflects the relationship between the DOS in a sample and the critical DOS (shown as the yellow region above the dashed line at about 85 percent DOS) that would result in freeze-thaw damage.

Initial absorption occurs very quickly, during the first 12 to 24 hours for 50 millimeter samples, and is represented by the blue line. This initial absorption includes the filling of the gel and smaller capillary pores. The secondary absorption occurs over a longer time and is represented by the red line. During secondary absorption, the entrained and entrapped pores fill. If the entrained and entrapped voids fill to a point where the concrete exceeds the critical DOS, the concrete will begin to show damage after freeze-thaw cycles.

Sorption-based models have been proposed (Fagerlund 1977; Bentz et al. 2001; Yang et al. 2006; Todak et al. 2015) to predict the time required for a concrete sample to reach critical DOS after being continuously exposed to water. The sorption model is illustrated in Figure 2.

Although more research is needed, the model indicates that, as the water-to-cementitious-materials (c/m) ratio increases and the air content decreases in the concrete mixture, the concrete is closer to critical saturation after only a short time of exposure to water.

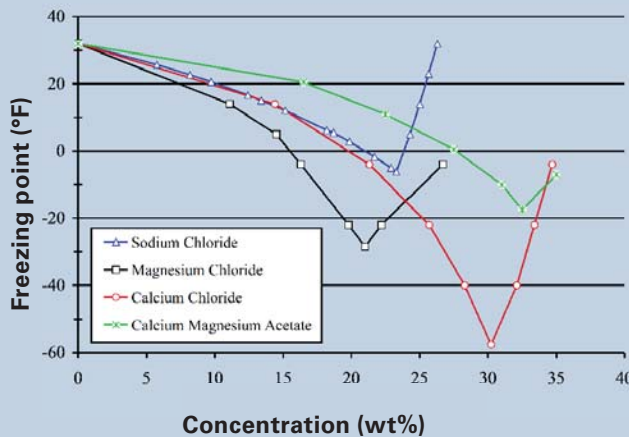
Figure 3. Partial phase diagrams for brines with common deicing/anti-icing salts. The freezing points of the solutions are plotted as a function of the salt concentration in weight percent. For all salts a minimum freezing point is shown (Sutter 2008)

Table 1 shows the freezing point for common deicing salts. The least damaging salt, sodium chloride, has a freezing point of -6 degrees F. Figure 3 shows that the concentrations for the three salts used in Iowa—sodium chloride, magnesium chloride, and calcium chloride—are basically the same for temperatures in the 20-degree F range.
