Impact of Curling and Warping on Concrete Pavement

# Impact of Curling and Warping on Concrete Pavement

tech transfer summary

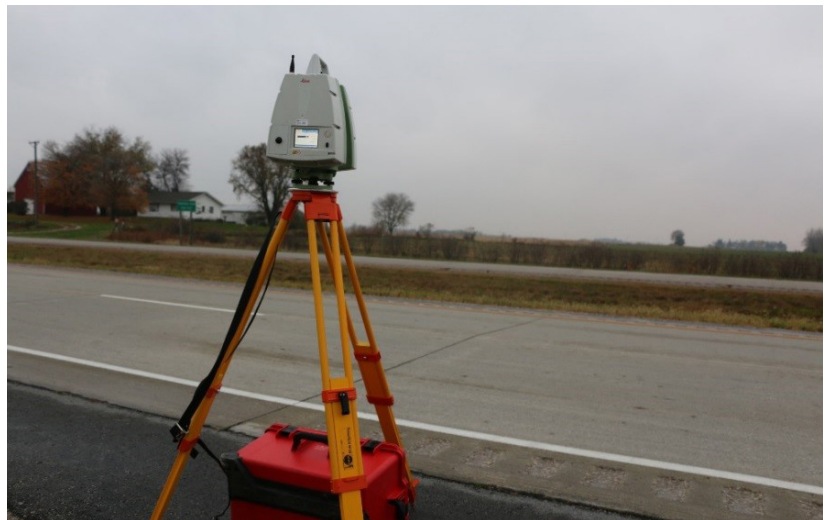
*LiDAR device utilized in this study*

These sites had PCC pavements with various ages, slab shapes, mix design aspects, and environmental conditions during construction. By using the Leica ScanStation C10 LiDAR device, the researchers obtained point clouds for these sites during field investigations.

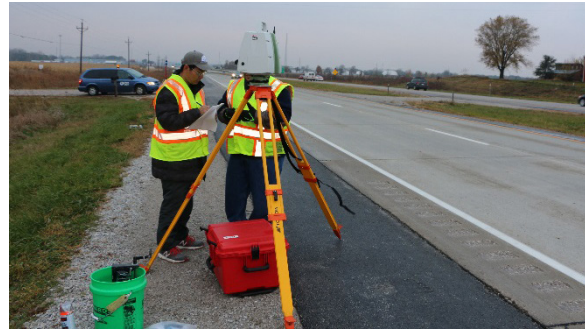
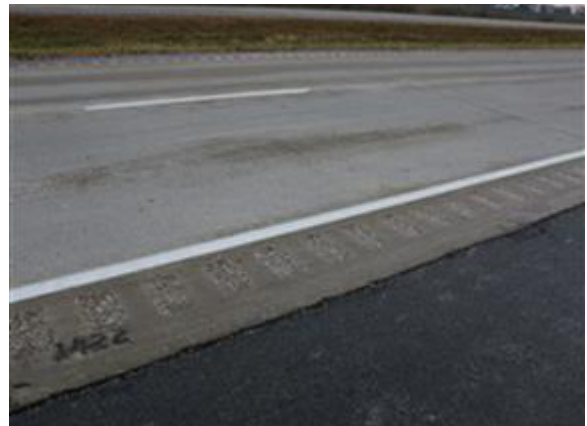
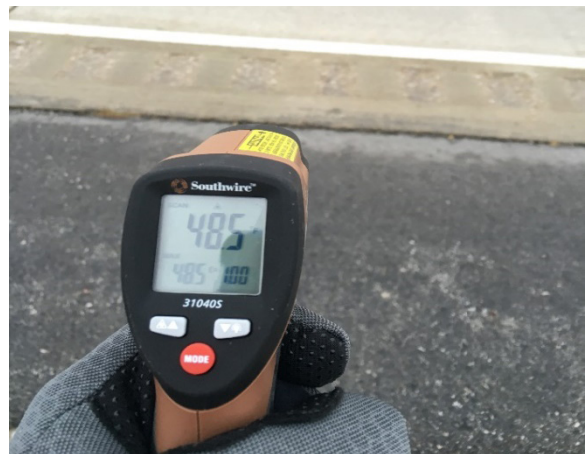
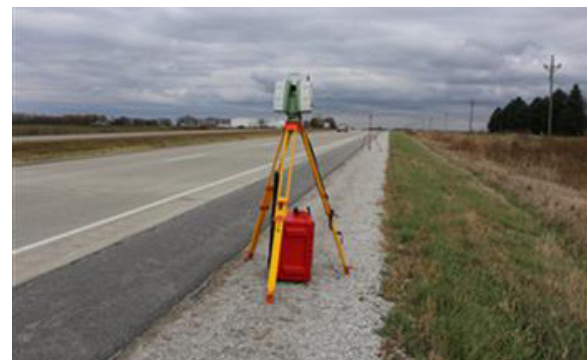
*Field investigation of concrete pavement systems on US 30 near Ames in Story County, Iowa*

This research was directed toward documenting PCC pavement surface profiles by utilizing the light detection and ranging (LiDAR) system and comparing the degree of curling and warping between the concrete pavement systems used on those pavements. Field investigations were performed at six concrete pavement sites in Iowa at different times of the day during the late fall of 2015.

The research team obtained three LiDAR scans at each site. They processed the point clouds for registration and segmentation first. Then, the researchers exported and processed each point cloud for the predetermined slabs in the MATLAB environment by fitting a quadratic equation to the scanned slab surface. They then calculated the degrees of curling and warping along the longitudinal, transverse, and diagonal directions of each concrete slab.

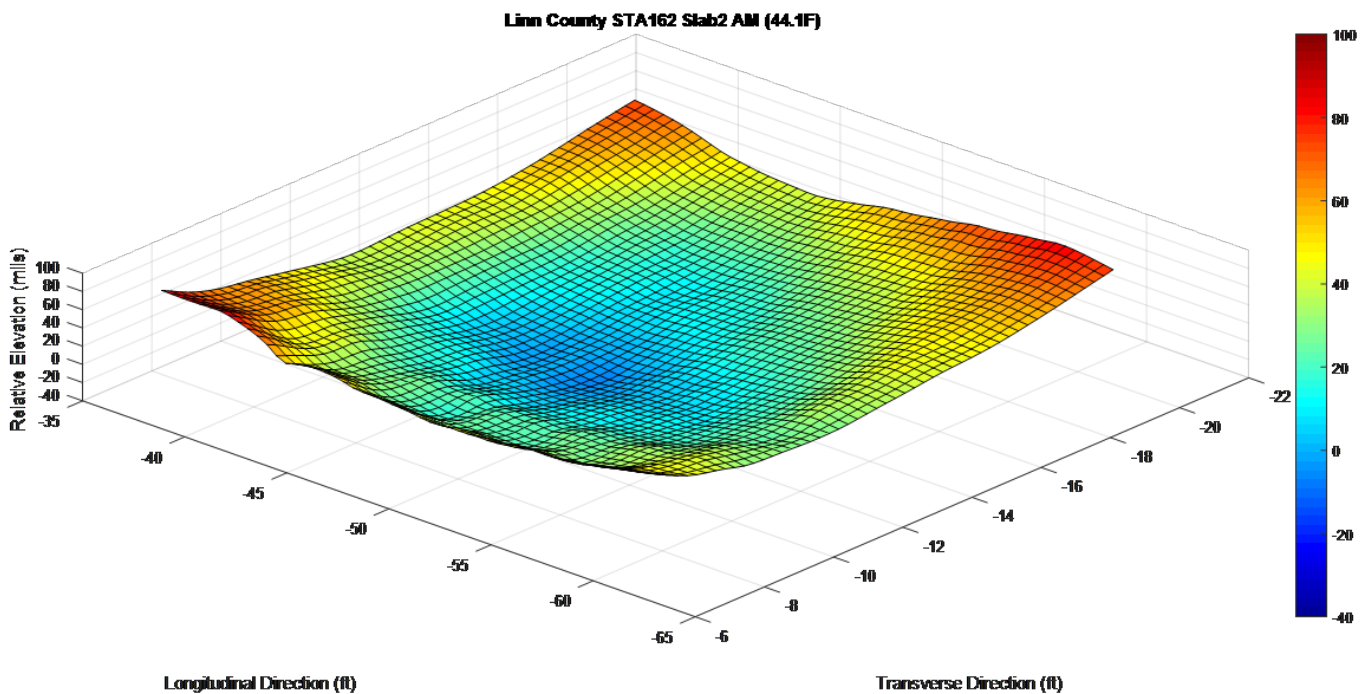
*Computer-generated three-dimensional (3D) shape of an upwardly curled and warped PCC slab in the field under temperature and moisture gradients produced from processing LiDAR point cloud data*

The researchers developed recommendations on how to minimize curling and warping based on literature review findings and field investigations. They also developed some examples of how to use LiDAR point cloud data to build three-dimensional (3D) models for the overall curvature of the slab shape to show the feasibility of using this 3D analysis method for studying the curling and warping behavior of concrete pavements.
