Investigation of Deterioration of Joints in Concrete Pavements: Field Study of Penetrating Sealers

tech transfer summary

March 2016

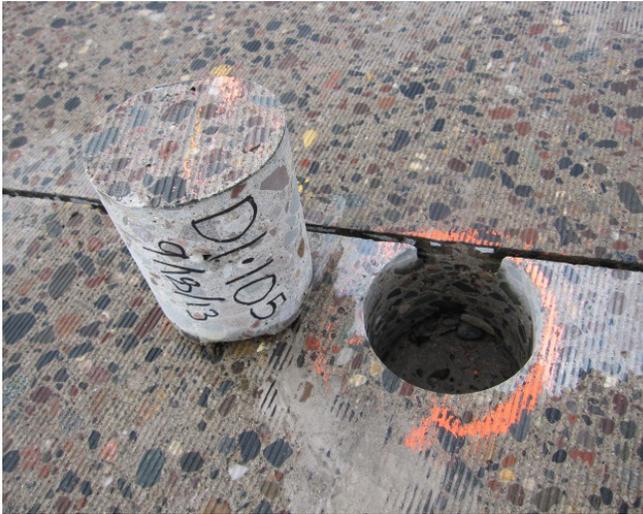
Sample core retrieved in 2013 showing the relationship to Joint 105 Cell 9

Cores were retrieved from pavements to assess the before condition. Six-inch cores were extracted immediately adjacent to the selected joints. All cores were extracted from the approach side of each joint, with respect to traffic. Cores were positioned so the edge of the expansion joint just intersected the perimeter of the core. Five cores were taken from different joints in each cell, with one joint to serve as the control and the other four to have different sealers applied.

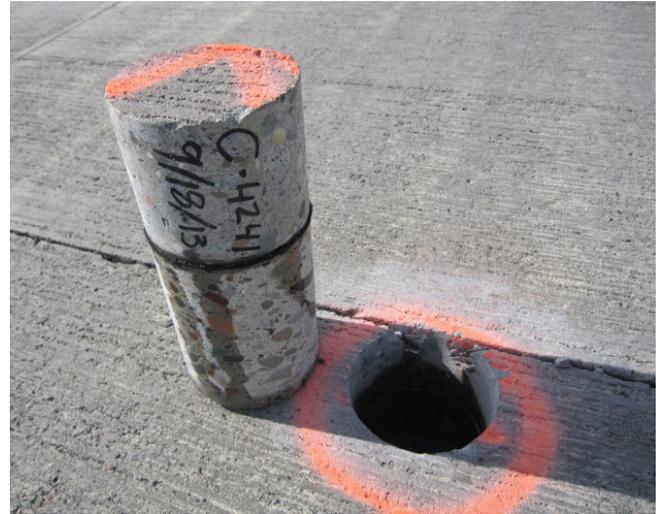
Sample core retrieved in 2013 showing the relationship to Joint 4241 Cell 505 with its fabric bond-breaker

In contrast to the 23 year old pavement, the initial concentration in the horizontal direction of Cell 505 is the same as that found in the vertical direction, suggesting the dilution evident in the older pavements does not take place in Cell 505. The joints in Cell 505 were not sealed with silicone or hot pour asphalt, and the concrete overlay was placed over a separation fabric. The lack of sealing permits free entry of salt solution and debris from the wear surface into the joint.
