CROSSINGS

NEWSLETTER OF THE WOOD IN TRANSPORTATION PROGRAM

CONSIDERATIONS WHEN PAVING TREATED TIMBER BRIDGE DECKS

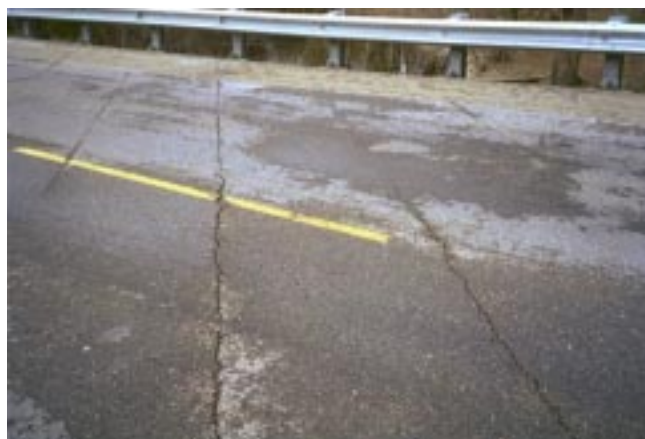
Figure 1. Pavement cracking caused by differential deflection of panels.

Asphalt paving is flexible enough that uniform bridge superstructure deflection seldom causes pavement problems. The most common cause of pavement failure in glued-laminated panel deck systems is differential deflections between adjoining deck panels. This is particularly true of transverse glued-laminated deck panel systems (the panels are installed with the laminations perpendicular to traffic flow). Wheel loads moving from panel to panel cause rapid, repetitive panel movement. When these deflections are greater than .05 inches the pavement will usually crack. When deflections exceed .10 inches the cracks will often ravel, causing impact loadings and increased moisture penetration and retention.

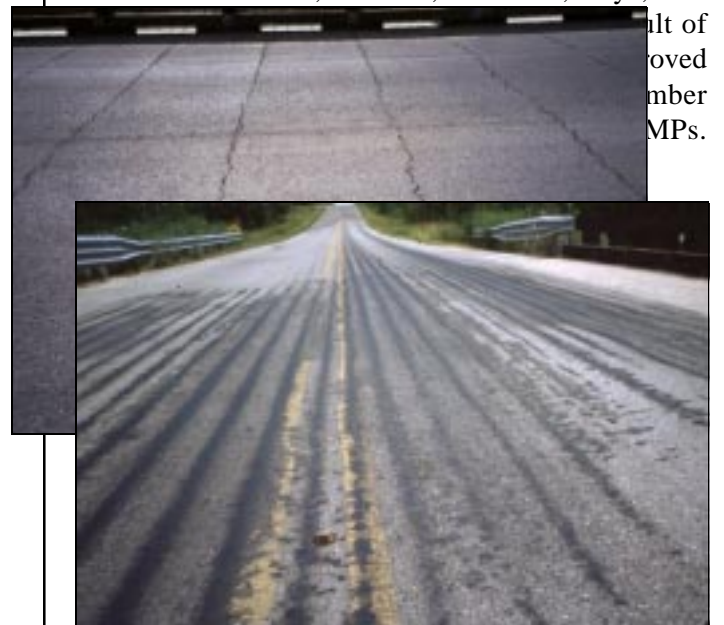
Figure 4. Bleeding caused by over treatment (note tracking from bridge to approach).

chemicals (and/or solvents) will be present at, or may migrate to, timber surfaces. These materials have detrimental effect on asphalt pavement. Excessive creosote or oil solvent reduces pavement to deck adhesion, softens the asphalt in the pavement mix, and causes bleeding and pavement rutting.

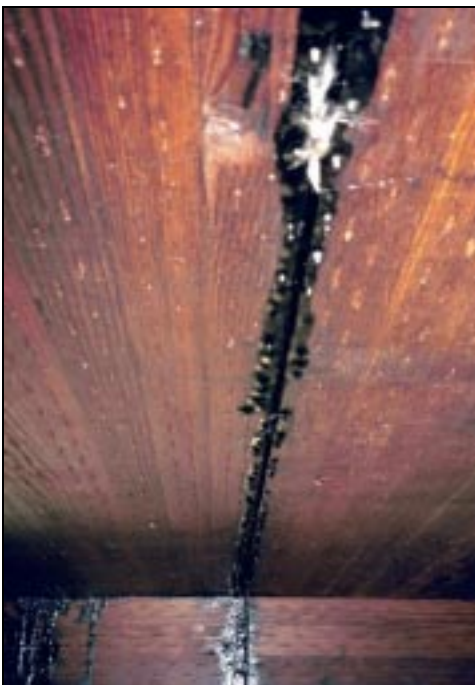
Figure 5. Paving membrane leakage.

Over the past several years, incidents of asphalt material dripping from the underside of treated timber deck panels have been reported in Michigan and Oregon. In July of 2000, a creosote treated transverse glued-laminated timber panel deck bridge in Michigan was inspected and tested. The bridge had been paved in late November of 1998. Immediately after paving, strands of melted paving membrane were observed hanging from the underside of the bridge. The hot asphalt overlay melted the paving membrane causing this initial leakage. However, the membrane continued to leak from the underside of the bridge.

In early 2000, two Forest Service bridges in Oregon were reported to be leaking asphalt material between the deck panels. One bridge had been installed in 1991, the other in 1998. In each case the leakage was not observed until the bridges were inspected in the fall of 1999. Deck panels for the 1991 bridge were treated with pentachlorophenol in a light oil solvent. The deck had been coated with an asphalt primer before installing the paving membrane and asphalt pavement. The deck panels for the 1998 bridge were treated with pentachlorophenol in heavy oil and again coated with a primer before placing the membrane and asphalt pavement.

The creosote and pentachlorophenol treatment solvents in all these bridge decks appear to be dissolving the asphalt in the paving membranes. The Michigan bridge deck panels were not post treatment cleaned, and significant quantities of creosote were present on the panel surfaces. For the Michigan bridge, it appears that the paving membrane began to dissolve almost immediately after placement of the overlay. The Oregon bridges were post treatment cleaned and the dissolved membrane leakage did not appear until
