Maintenance of Drainage Features for Safety

*A Guide for Local Street and Highway
Maintenance Personnel*

FHWA-SA-09-024

U.S. Department of Transportation
Federal Highway Administration

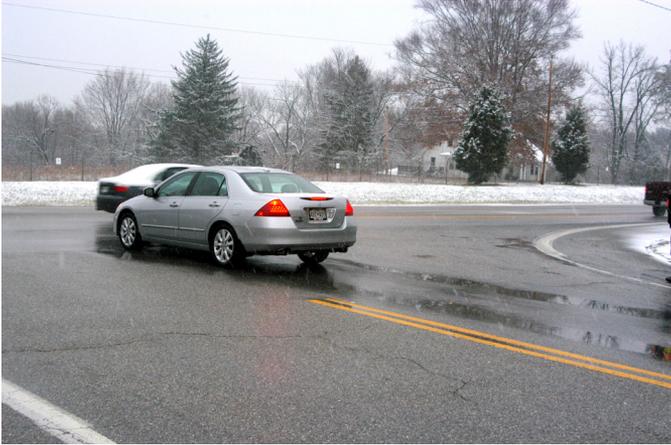
Water ponding in wheel ruts.

Rutting is caused by the wear or movement of the bituminous pavement to the sides of the wheel path. Rutting usually runs parallel to the centerline of the roadway. When wheel ruts are noticeable, they are generally deep enough to pond sufficient water to initiate hydroplaning.

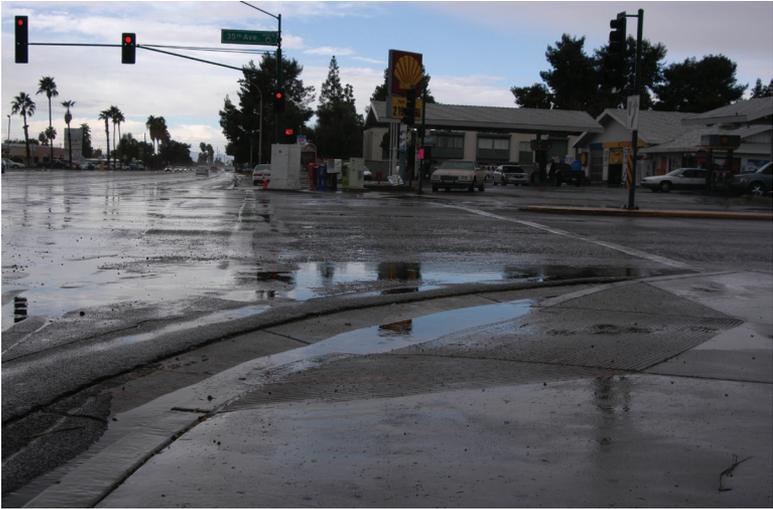
Water standing in the roadway.

Ponding or standing water in the travel way may also cause some drivers, bicyclists, or pedestrians to divert from their desired path. Storm drains or drop inlets that have collected debris, such as leaves, can cause ponding during and after storms. Both motor vehicle and bicycle operators may choose to avoid going through

the water by encroaching on the opposing lane, thus endangering themselves and opposing traffic.

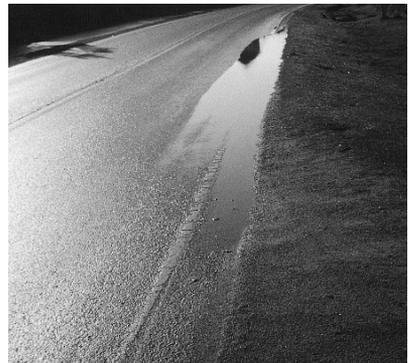
Water ponding at the edge of roadway.

Water can pond on the outside edge of the travel way surface when debris, particularly aggregate and soil on turf shoulders, builds up. As debris accumulates on the shoulder, it raises the level of the edge, and eventually hinders run-off from flowing into side ditches.

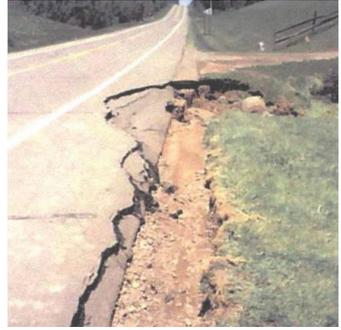
Deterioration of pavement edge and shoulder due to poor drainage.

Water ponding on the edge of the pavement contributes to the deterioration of the pavement edge and the rutting of stabilized soil supporting the pavement edge, which can result in additional safety hazards. Edge drop-offs and shoulder scour are often caused when water is trapped at the pavement edge by the build-up of debris and vegetation growth.

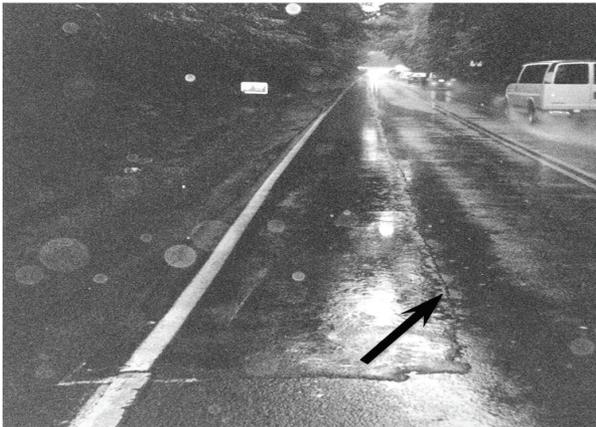
The edge of this partial pavement overlay is causing water to be retained on the travel way surface.

Partial overlays and pavement repairs can result in water being trapped and retained on the travel way surface. Partial overlays, either to correct shoulder deterioration or widen the roadway surface, result in a pavement edge where the overlay stops. Depending on the size of aggregate in the overlay mix and the effort taken to feather the lip into the existing pavement, water can be retained on the travel way. When the lip is along the wheel path, the thin layer of retained water can initiate hydroplaning, reduce braking ability or freeze and contribute to skidding.

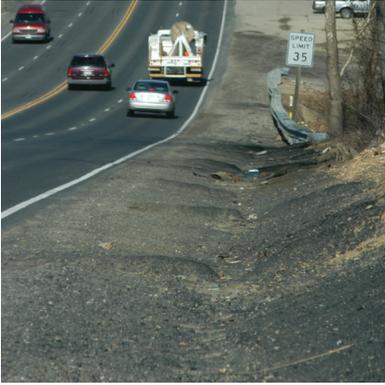
A traversable drainage ditch such as this provides space for vehicle recovery.

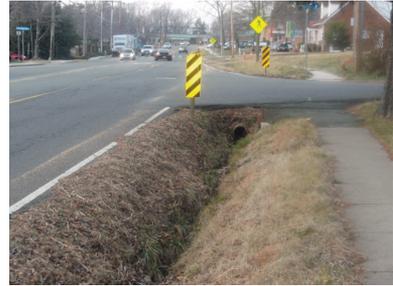
A non-traversable drainage ditch such as this is a safety hazard.

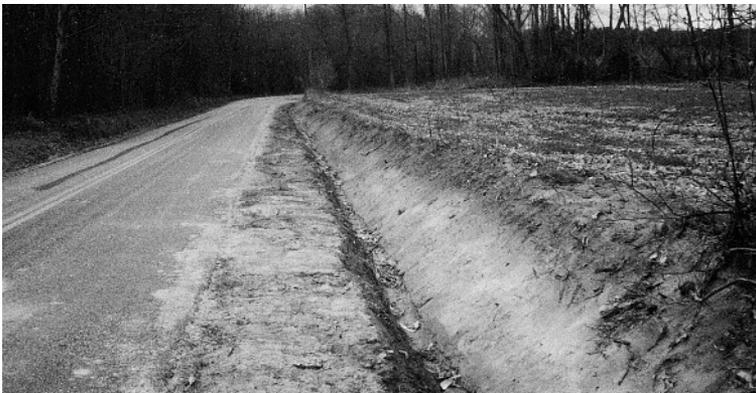
This regraded earth shoulder and ditch has a steep backslope which makes it non-traversable; if right-of-way is available the backslope should be made less steep.

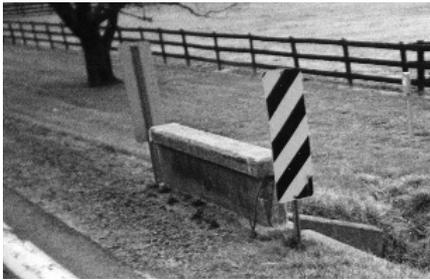
This headwall is a roadside obstacle and should be replaced as soon as possible.

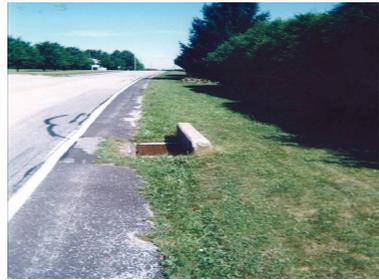
The headwall is sticking up almost a foot in a relatively flat recoverable area. It can snag a vehicle and bring it to an abrupt stop or cause it to overturn.

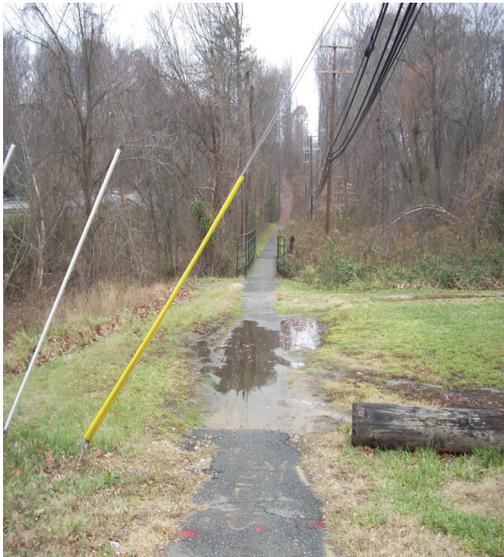
This water ponding on a ped/bike path could have been avoided by proper grading of the path.

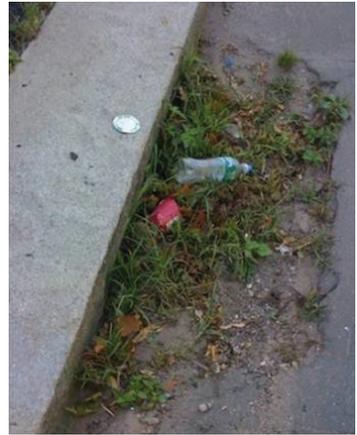
A clogged drain can easily be detected during a field survey.

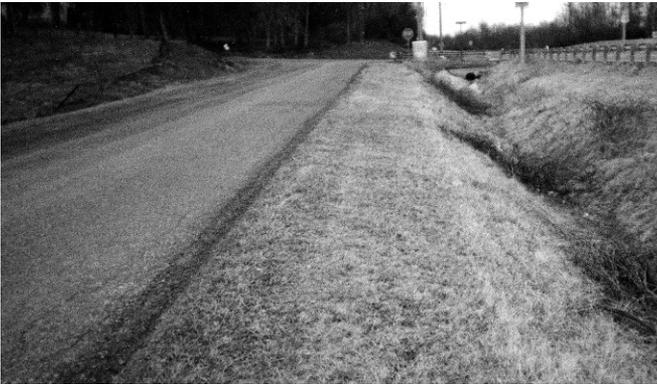
Side slope erosion can cause rollovers.

Erosion scars on a side slope can also initiate vehicle instability by tripping the vehicle's wheels and initiating overturning. Therefore, eroded slopes should be graded and seeded. When rip rap is used to control and spread the flow of water, it should have shallow inverts and be placed flush with the existing ground. Additionally, the roadside conditions should be checked to determine why erosion is taking place and the problems resolved.

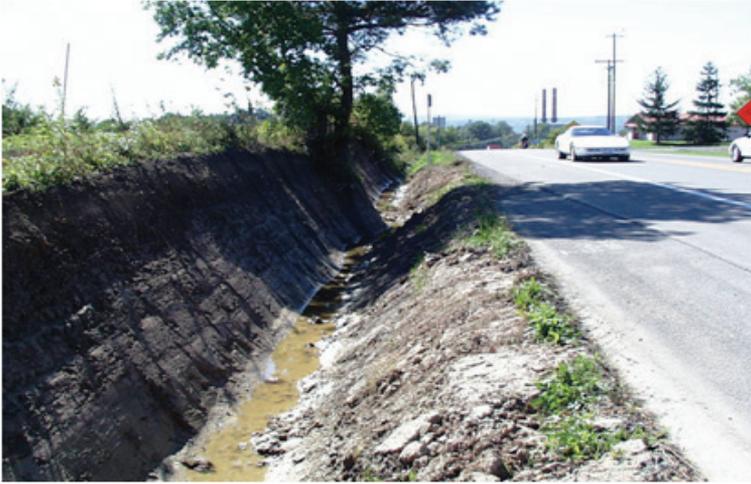
Deep ditches such as this are a safety hazard.

Both earth and lined ditches require maintenance to remove debris and prevent erosion that can create roadside hazards and/or reducing the effectiveness of the drainage system. It is important when repairing eroded earth ditches and shoulders to restore them to their original safety shapes. Ditch side slopes that are too steep and ditches that are too deep can initiate instability in a vehicle causing it to roll over or cause the vehicle to snag against the ditch back slope and abruptly stop or vault the vehicle into the air.

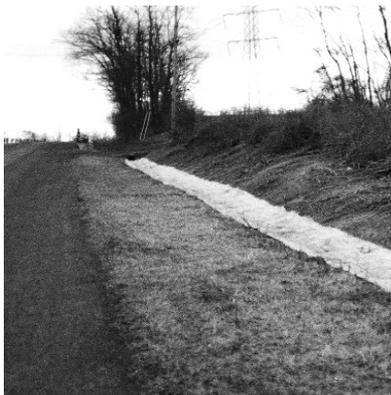
Erosion control measures such as fiber mats shown may be necessary to prevent ditch erosion.

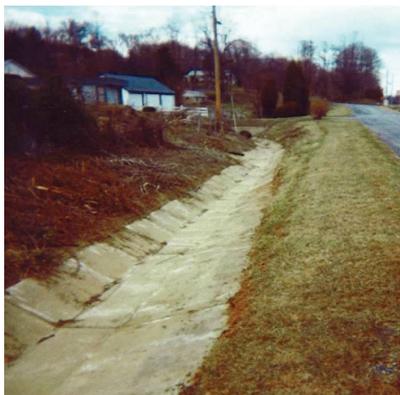
For ditches with heavy runoff, concrete lining may be necessary.

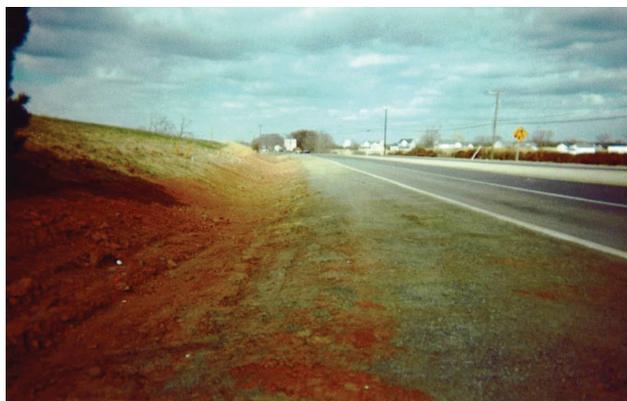
This ditch was reshaped to provide a safe recovery area for errant vehicles.

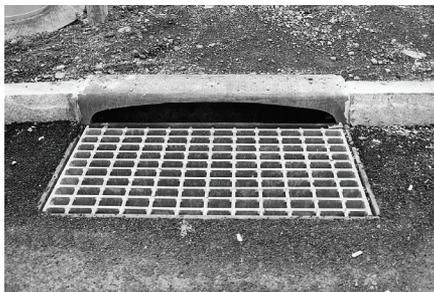
Bicycle safe grate with drop inlet.

Drop inlets located in or adjacent to the path of motor vehicles, pedestrians and bicycles require grates that can accommodate run-off while preventing vehicles, bicycles and pedestrians from falling into the inlet. When bicycle traffic exists, grates should prevent the tires of a bicycle from slipping into and being caught in the grate. Therefore, bicycle safe grates should be used whenever bicycle traffic is expected. The photo below shows a preferred treatment for a drop inlet located on or near a bicycle travel way. With a flush bicycle-safe grate, a bicycle tire cannot get caught in the grate because of the cross pattern of supports which results in only small openings.

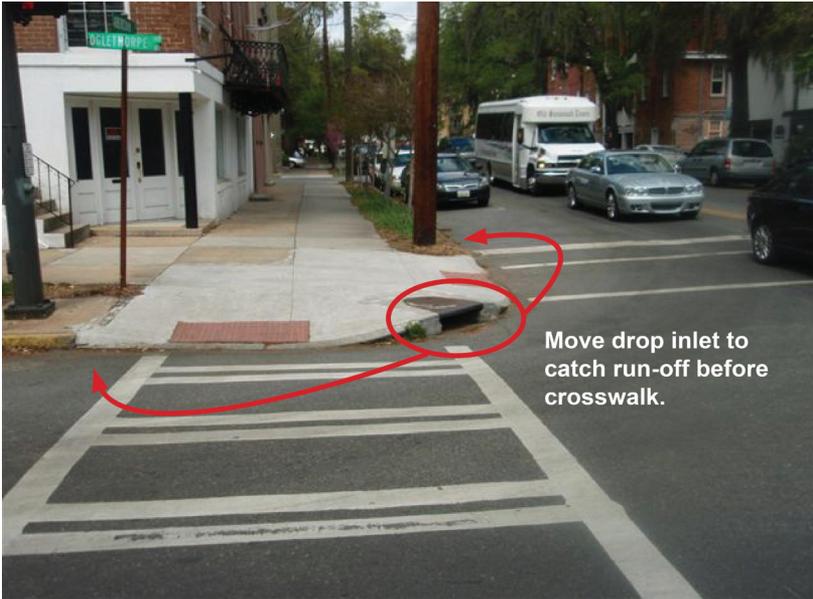
To avoid run-off across the pedestrian path, it is desirable to locate drop inlets before crosswalks.

Drop inlets should not be in the path of pedestrians. To avoid run-off across a pedestrian crosswalk it is desirable to locate the catch basin and inlet before the crosswalk as depicted on next page.

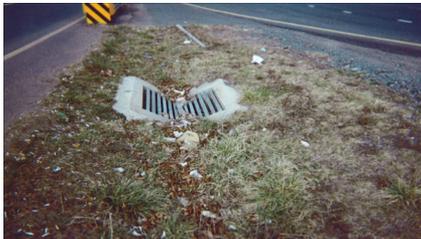
V-shaped grate in median.

Raised roadside drop inlets, sometimes referred to as table top inlets, provide a vertical opening in their sides for large volumes of run-off and debris removal. They are usually located in low-depressed or sump areas. Raised inlets located in areas where an errant vehicle or bicycle can drive into or over them should be no higher than 4 inches above the surrounding ground. Drop inlets that extend more than 4 inches above the surrounding ground can snag the undercarriage of a vehicle in the same way a raised headwall can, causing it to abruptly stop, go out of control, or roll over. A safer drainage treatment is to use a grated inlet that is close to the ground as shown below.

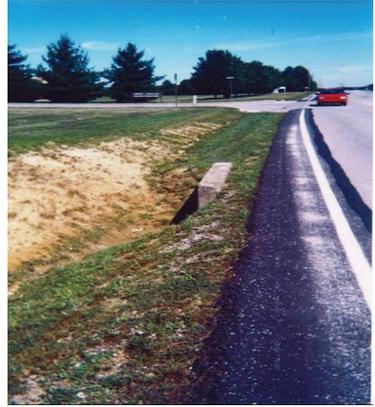
This culvert headwall is a roadside hazard.

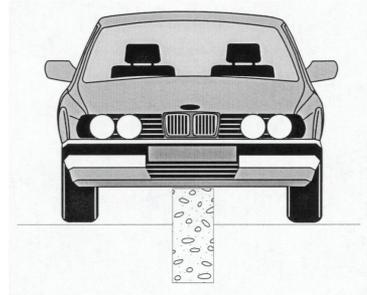
In flat areas the height of the headwall should not exceed 4 inches.

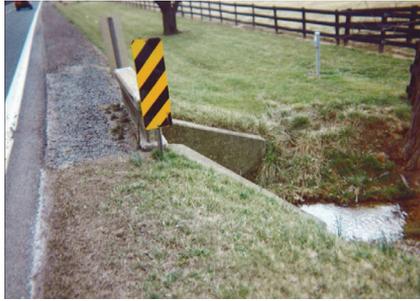
***Rigid headwall delineated with
Type 3 Object Marker.***

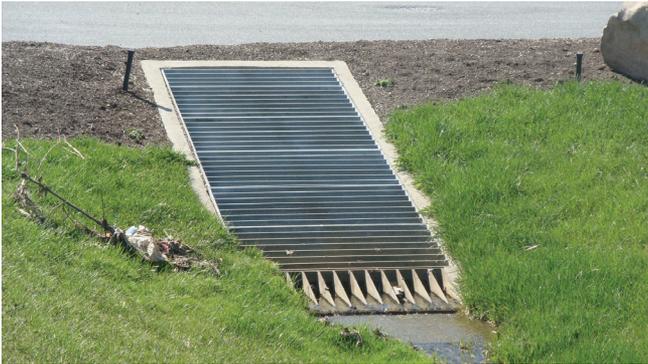
Grated inlet flush with ground over a culvert end.

To minimize the potential of vehicle snagging on the end of a pipe, it is necessary to provide a traversable end section, ensuring that either the pipe end is cut flush with the ground line, or when used, that the steel grating is sloped flush with the surface.

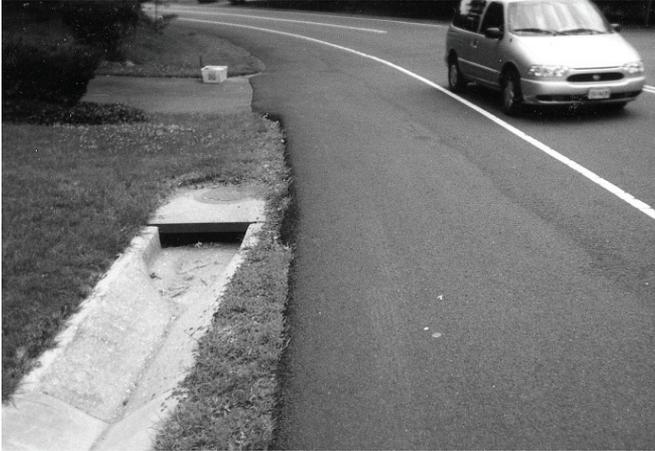
This culvert has a rather large opening which could cause a vehicle that hits it to go out of control.

A second safety consideration, important to all large pipe and culvert ends located in the clear zone, is the size or width of the opening. Pipes and culverts can trap a vehicle wheel if the opening is too large, causing it to stop abruptly or initiate overturning. Generally, openings that are larger than 30 inches are considered potential hazards; however vehicles may safely traverse over openings up to 30 inches. In crash tests of vehicles at normal highway speeds it was demonstrated that vehicle tires

could cross over openings of 30 inches provided that the opening has been cut to match a traversable side slope.

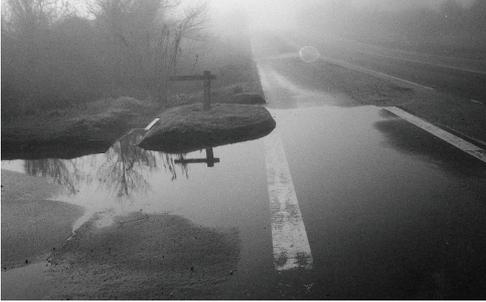
In this photo, water is ponding because the outflow ditch has silted up. Ponded water can cause drivers to leave their lane, reduce braking ability or contribute to pavement deterioration.

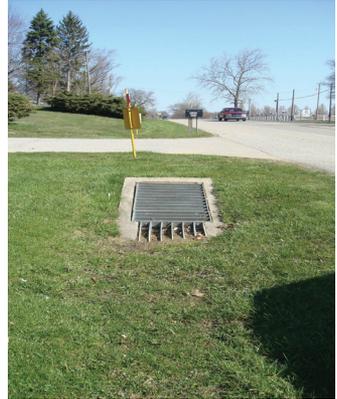
This grated inlet can be used to prevent water ponding at access points.

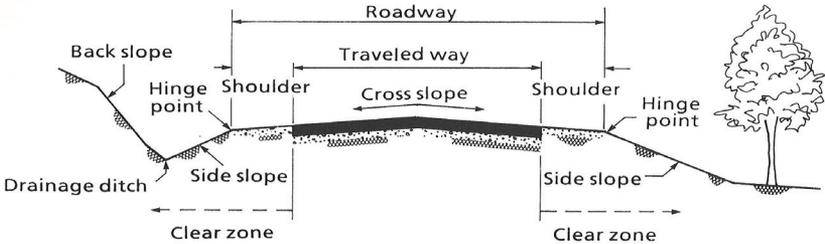
Clear zone illustration

- Hinge Point Point where the slope rate changes.
- Clear Zone That area along the side of the traveled way including the shoulder that is available for recovery of an errant vehicle.

A safe traversable slope can be either a recoverable slope or a non-recoverable slope with a **clear run-out area** at the bottom. A **recoverable slope** is a slope on which a motorist may, to a greater or lesser extent, retain or regain control of a vehicle and recover or stop. Slopes 1:4 (Vertical:Horizontal) or flatter are generally

considered recoverable. A non-recoverable, traversable slope is a slope which is considered traversable but on which an errant vehicle will continue to the bottom. Embankment slopes from 1:3 and 1:4 may be considered traversable but non-recoverable if they are smooth and free of fixed objects. A clear run-out area is the flatter area at the toe of a non-recoverable slope available for safe use by an errant vehicle. Slopes steeper than 1:3 are not considered traversable and should not be found in the clear zone.

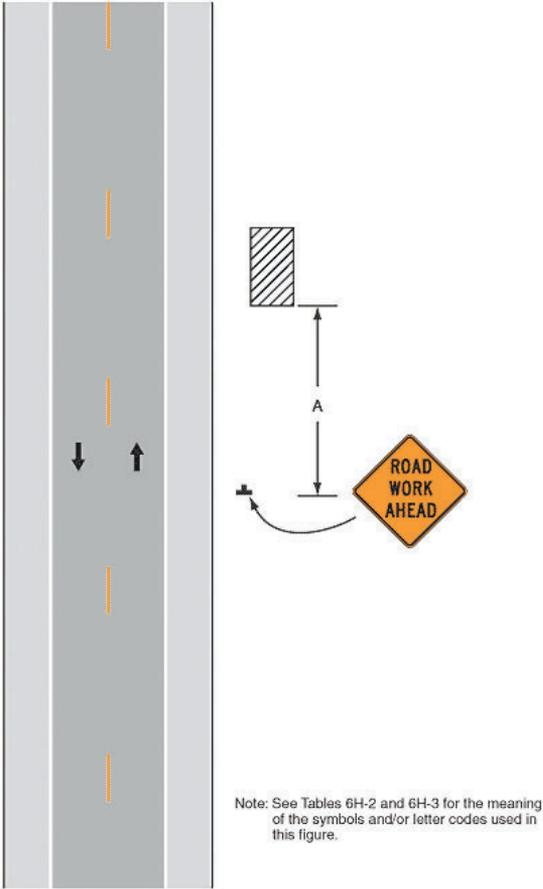
Figure 6H-1. Work Beyond the Shoulder (TA-1)

1. Typical Traffic Control Layout for Work Beyond the Shoulder

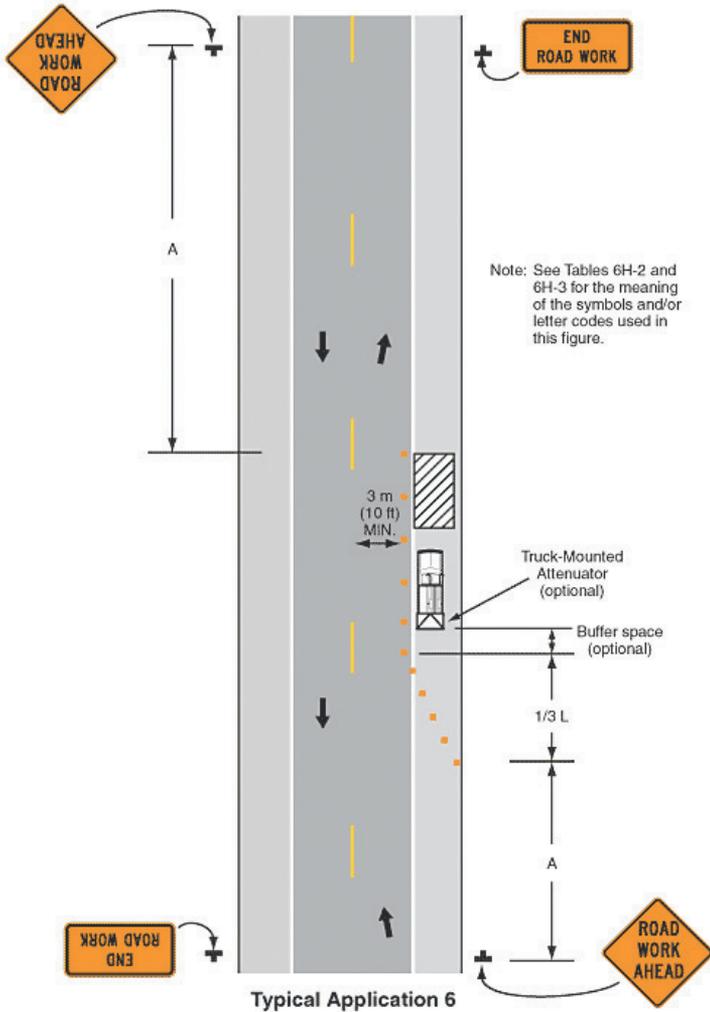
Figure 6H-6. Shoulder Work with Minor Encroachment (TA-6)

2. Typical Traffic Control Layout for Shoulder Work with Minor Encroachment

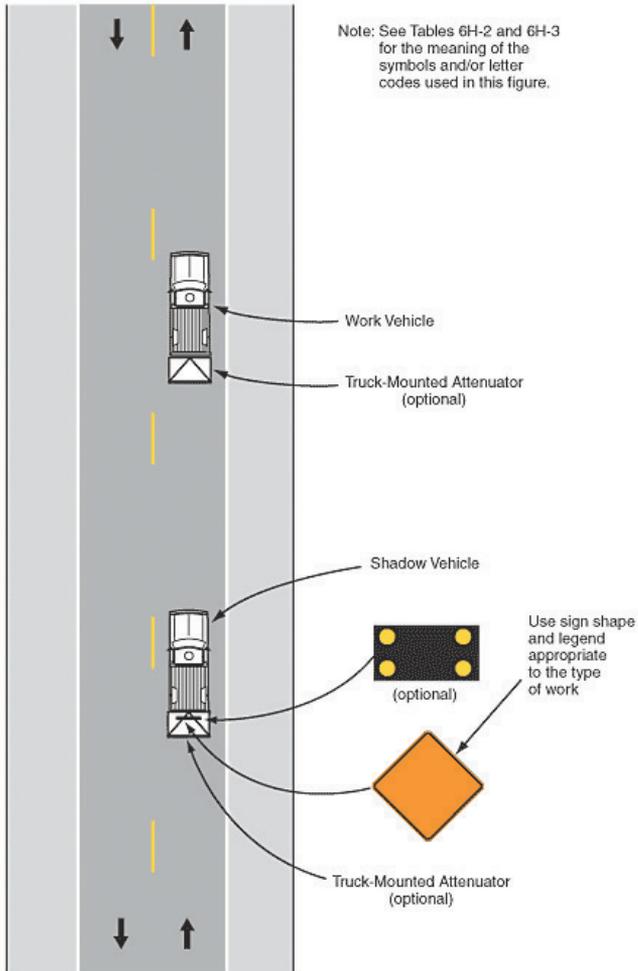
Figure 6H-17. Mobile Operations on Two-Lane Road (TA-17)

3. Typical Traffic Control Layout for Mobile Operations on Two-Lane Road
