CMP Banding Tool

Agency: Marion County Road Department

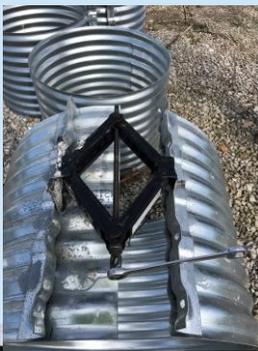
It was determined we needed a tool to spread the bands apart to get them over the pipe sections, but also to help pull them back together to begin bolting the band flanges. Someone suggested a scissor jack, so we purchased one RV style scissor jack to test the operation. It was successful, but needed modification. To safely push the flanges apart we welded bolts to secure it in place, but this also double as a way to pull the flanges back together.

After purchasing 4 RV jacks at a local hardware store, the crews grabbed a few bolts out of the bin in the shop, welded them to the top and bottom plates of the jacks. Another bolt was welded to the threaded rod of the jack for an impact wrench and socket to aid in quick expansion and retraction. For smaller diameter bands a piece of angle iron was welded on the top and bottom plates of the jack to keep the jack out from in between the band flanges, as it was too large.
