# Utility Cut Restoration

## A. General

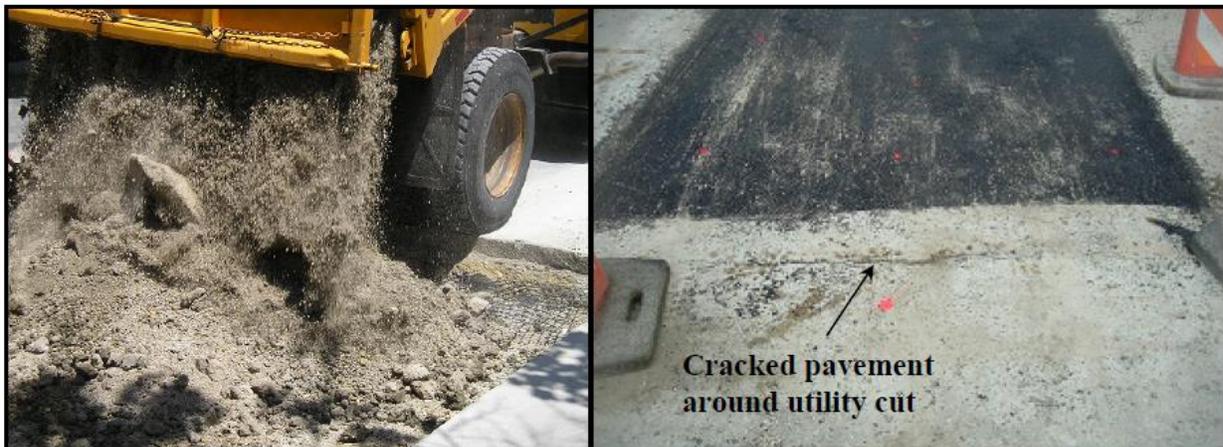
**Figure 9D-1.01:** Cracking Pavement Surrounding the Utility Cut Area Because of Construction Equipment Getting Too Close to the Edge of the Open Cut

Backfill materials are often compacted using large compaction equipment, which is placed close to the edges of the cut, resulting in damage to pavement surfaces around the perimeter of the excavation. Note Figure 9D-1.01. It is important to keep equipment away from the edges of the trench.

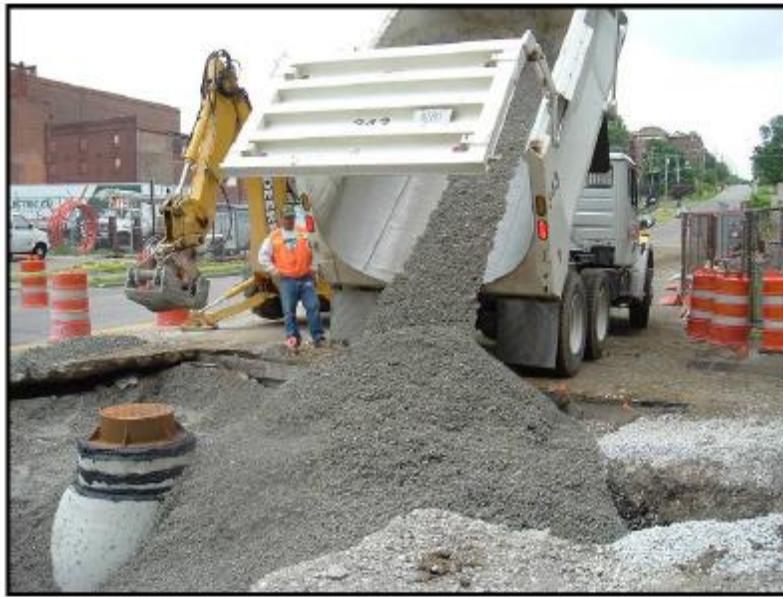
**Figure 9D-1.02:** Large Lift Thicknesses Used in Utility Cut Trench Backfill Material Placement

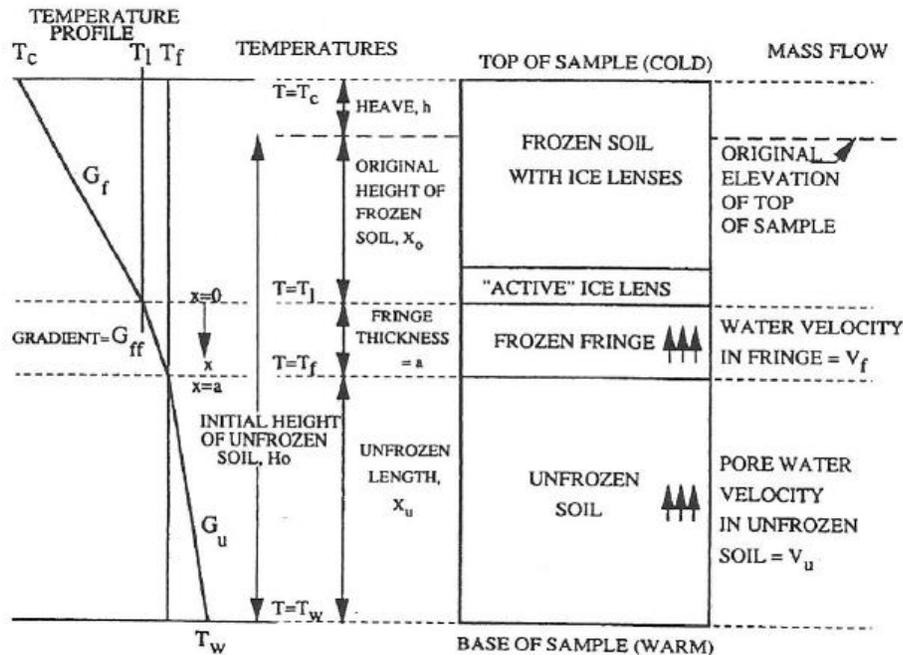
**Figure 9D-1.03:** Frost Heave in Idealized One-Dimensional Soil Column

As frost forms in a soil, a frozen fringe develops (see Figure 9D-1.03). This fringe develops at freezing temperatures and extends downward. The frozen fringe forms below where an active ice lens is forming. As freezing temperatures penetrate deeper in a soil, the frozen fringe and zone of active lens formation also migrate downward. The active ice lens layer in the soil is also a boundary where the permeability of the soil decreases because the pores begin filling with ice. This boundary prevents water from traveling upward beyond the active lens zone. Because of this, no additional ice lens will form above the active ice lens zone. The downward movement of the frozen fringe affects the size of the ice lens. When the front advances rapidly through a soil, the lens will be thin; however, when the frozen fringe remains at a stationary point because of the heat flow balance, a larger lens will form.

As ice lenses form, they exert an outward pressure on the pore. When the pressures are greater than the overburden pressures, the soil will heave. The heave (expansion of soil) occurs at the

frost line, which is assumed to be at freezing. Frozen soils above the frost line do not expand because there is no influx of moisture.

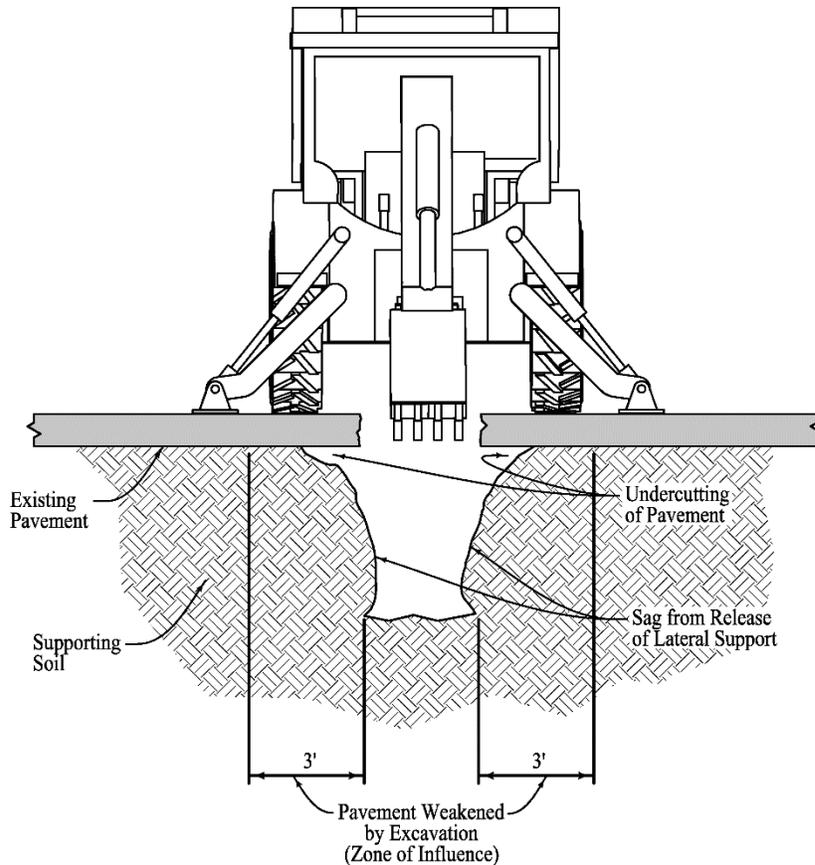
**Figure 9D-1.04:** Overstressing of the Pavement and Natural Materials Adjacent to the Trench

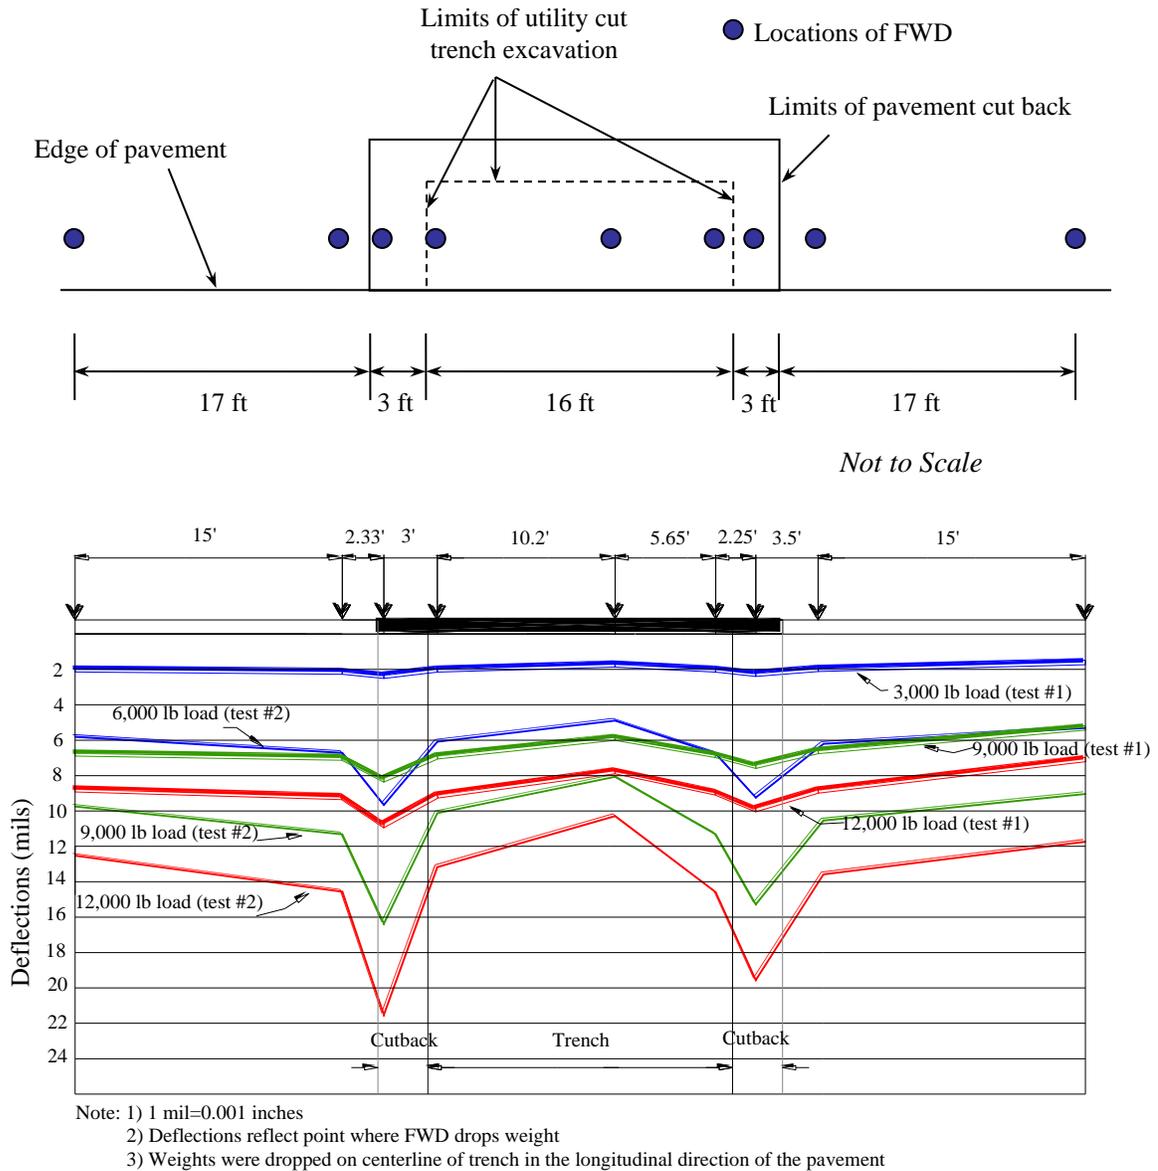
**Figure 9D-1.05:** Locations and Results of FWD Tests Performed at a Utility Cut Location Showing Deflection Within the Zone of Influence

As can be seen in Figure 9D-1.05, the zone of influence, in this case approximately five to six feet in width, performed significantly poorer than both the existing, undisturbed pavement section, and the properly constructed trench backfill. This increased deflection implies that the pavement is moving relative to the surrounding pavement, increasing the likelihood of crack formation and premature pavement deterioration.

The charts above were recorded using a Falling Weight Deflectometer (FWD). This tool, providing a non-destructive measurement, drops a weight from a controlled height and measures the resulting pavement deflection using an array of sensors placed along a line. This line is usually orientated along the direction of travel for the roadway. Figure 9D-1.07 shows the Iowa DOT's FWD.

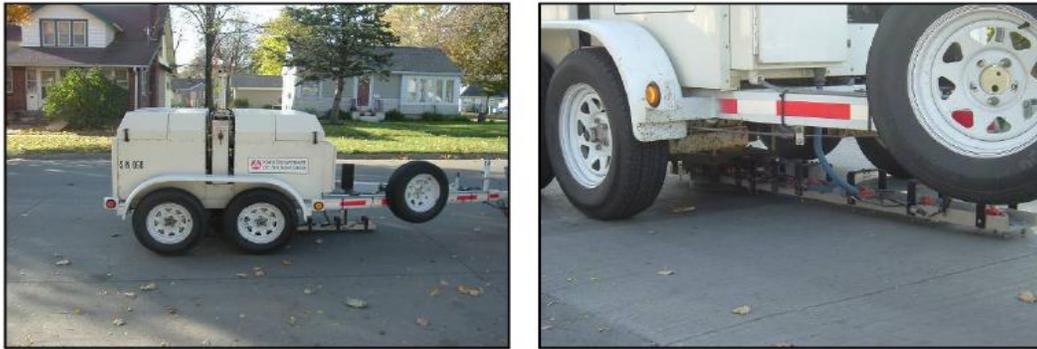
**Figure 9D-1.06:** Iowa DOT FWD Equipment Showing Sensor Configuration

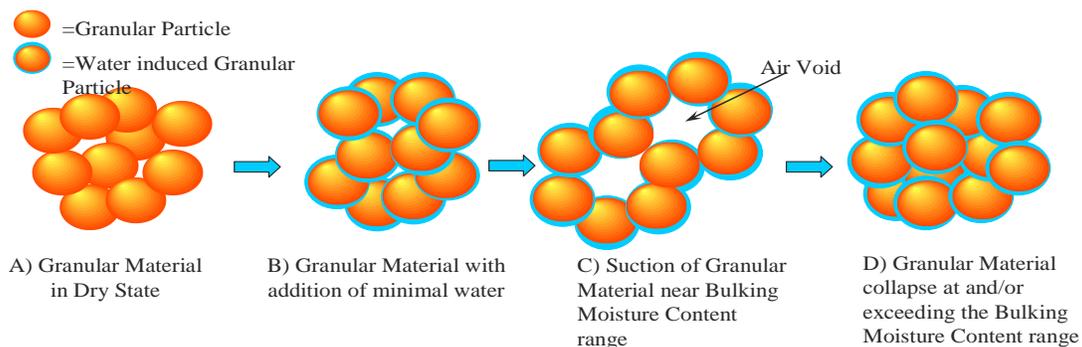
**Figure 9D-1.07:** Bulking Moisture Content

- 5. Moisture Content of Backfill Material and Collapse Potential:** It is critical that the bulking moisture content of the granular material be exceeded in order to achieve a dense backfill condition. Bulking is a phenomena that occurs in most granular materials in which the capillary action between soil particles that are surrounded by water hold the particles together in a honeycombed structure as noted below. The material starts out dry. With the addition of some water, the soil particles are surrounded. As more water is introduced, generally to a moisture content of approximately 6% to 10%, suction forms between the soil particles that creates tension and air voids. With the addition of more water, generally above 10%, the tension is released. This rearrangement of particles is referred to as collapse of granular materials. This phenomena is shown in Figure 9D-1.07.

When the tension releases, the collapse occurs, leading to a denser material, and reduced trench settling. Thus, it is very important that the granular backfill materials be placed in the trench above the bulking moisture content. The bulking moisture content range (i.e., the range of moisture contents to avoid can be determined in the laboratory and the range is defined as the moisture content for the maximum collapse potential plus or minus 2%.

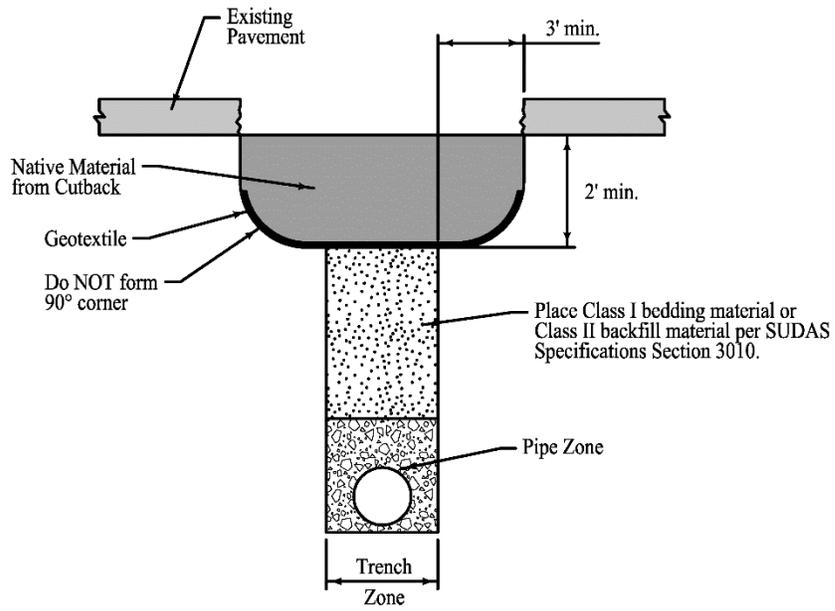
Figure 9D-1.08: Recommended Trench Reconstruction

- Reduce lift thickness to 8 inches to 12 inches for backfill materials
- The standard vertical-walled cross-section with 1 inch clean limestone is recommended as a construction practice.
- Quality control measures should be implemented in the field. These should include methods to ensure compaction and moisture requirements are met. This includes achieving at least medium relative density with moisture contents above the bulking moisture content for cohesionless soils and above 95% of Standard Proctor and  $\pm 2\%$  of optimum moisture content for cohesive soils.
- Place geotextiles in the bottom of the cutback area prior to placement of subgrade/subbase material.

- Saw the pavement full depth to create the cutback area three feet from edge of the original trench.
- Recompact the top 12 inches of trench backfill material after removal of cutback materials.
- PCC patches seem to perform better regardless of the existing pavement type. This is due in part to the difficulties in completing uniform compaction of HMA in relatively small areas.
