# PCC Rehabilitation US 30 Denison, Iowa

- Iowa Civil Contracting Inc.
- Contactor's Perspective

Mark Rhinehart lowa Civil Contracting

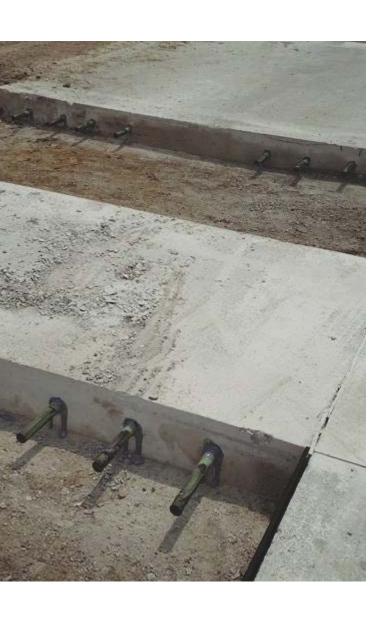
## Full & Partial Depth Patching

- Performed by Ten Point Construction
- Large quantity overruns
- The contractor would have liked to consider more FD as opposed to more PD. This was debated with IDOT.

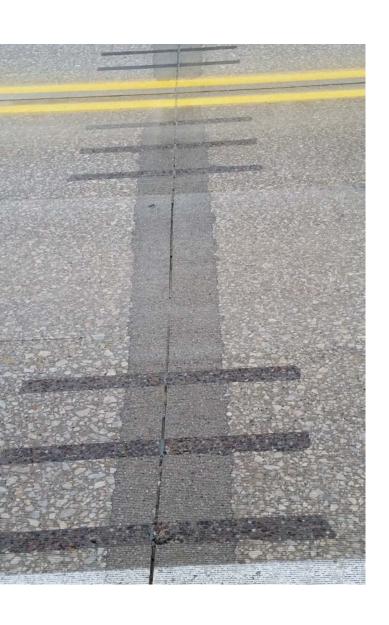
#### Dowel Bar Retrofit

- Some of the DBR were located in a Partial Depth Patch
- Accurate sawing of DBR removals 1. To protect the instances where PD patches are. 2. Help insure the DBR grout is able to be diamond ground uniform.
- Extra Care with removals (all removals done by hand)
- Any damage can be repaired with DBR mix
- Existing pavement was solid. There was little to no deterioration below DBR removals. We have seen this issue on past projects. Never severe.

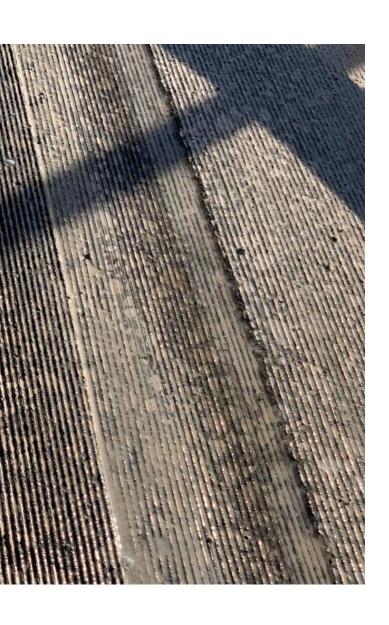
### Diamond Grinding

- Performed by West Fork Grinding
- Different aggregates separated by bid items at time of bid. (GRAVEL) (LIMESTONE) this is a benefit to contractors at time of bid.
- 4 foot head diamond grinding machines can only grind within 18"-20" of curb face. This created a delay on this project.
- Communication of final product is key.
- Feather pass was achieved with a smaller machine on this project.
- Discussion of options, and things to consider.

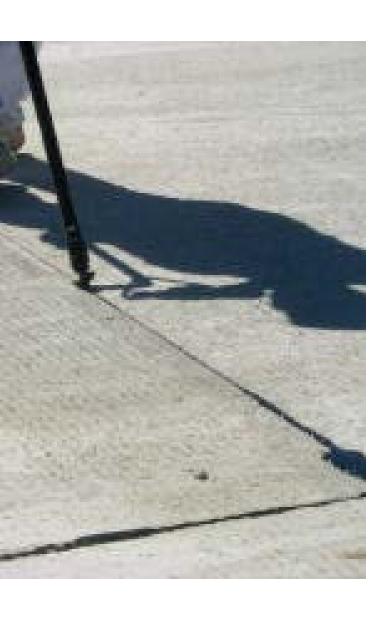
## Joint & Crack Cleaning and Filling

- Performed by Midwest Coatings
- Large joints and cracks to fill
- Majority to be performed in 2019 resulting from weather delays.
