Smart Work Zone Deployment Initiative

Freeway Work Zone Lane Capacity

Prepared for the Smart Work Zone Deployment Initiative Pooled Fund Study Contract # 08591

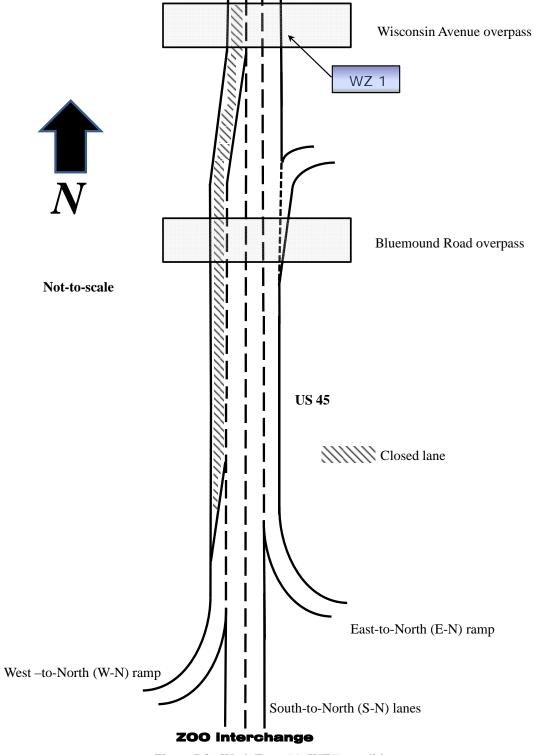
Figure B2. Work Zone #1 (WZ1) conditions.

Continuous 12-foot shoulders were present on either side of the freeway at the **Bluemound Road** overpass, with four 12-ft wide lanes. A 670-foot left-hand taper was used upstream of the overpass to close the median lane, leaving three lanes open for traffic. A 1,050-foot left-hand taper upstream of the **Wisconsin Avenue** overpass eliminated the left-most open lane, leaving two lanes open at **Wisconsin Avenue**. The two-lane cross section at **Wisconsin Avenue** created the most restrictive conditions for the entire work zone area.

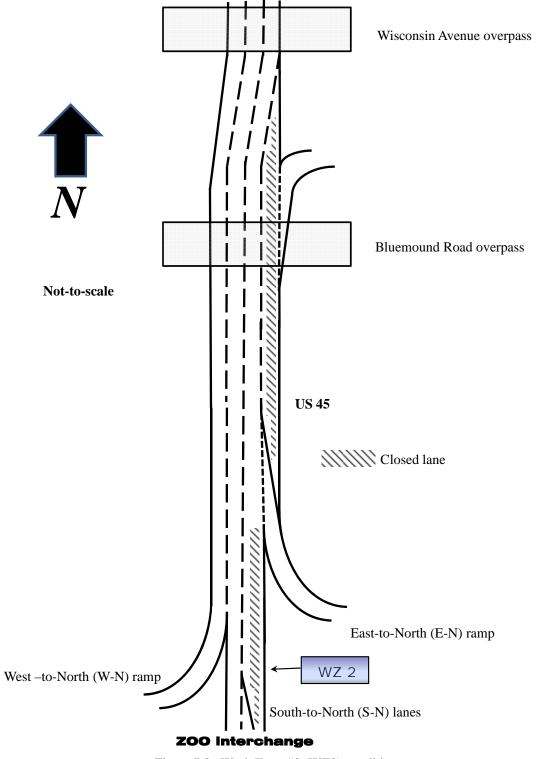
Figure B3. Work Zone #2 (WZ2) conditions.

The second work zone was established between April 27, and May 10, 2006 in order to perform maintenance on bridge piers located on the freeway right shoulder at the **Bluemound Road** overpass. As part of the traffic management plans for this work zone, a taper was established that reduced the two through South-to-North (S-N) lanes at the Zoo interchange to one lane (the left lane was kept open-**Figure B3**). The taper was established near **milepoint 0.0**, on a bridge structure. The one-lane cross section on the ramp structure created the most restrictive conditions for the entire **WZ** area.

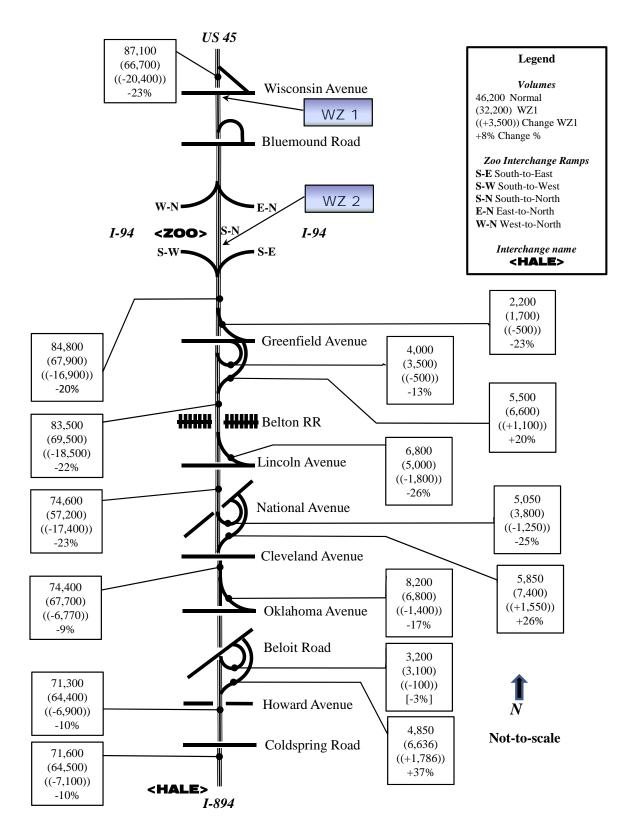
Figure C5. I-894 corridor NB direction, 24-hour detector counts-changes during WZ1.

Figure C5 presents corridor-wide traffic volume changes during **WZ1**. Less traffic entered the South end of the corridor (-10%); the impact was much more noticeable at the **WZ1** location (Wisconsin Avenue) where traffic reduction was 23%. Off ramps showed a 20% to 37% volume increase and on-ramps a 3% to 26% volume decrease.

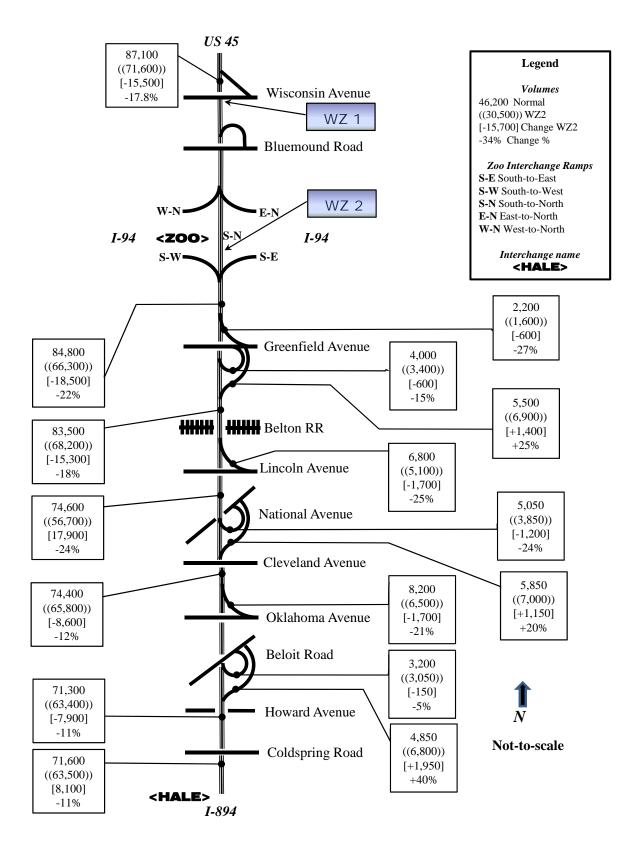
Figure C6. I-894 corridor NB direction, 24-hour detector counts-changes during WZ2.

Figure C6 presents corridor-wide traffic volume changes during **WZ2**. Less traffic entered the South end of the corridor (-11%); the impact was much more noticeable near the **WZ2** location (South-to-North ramp) where traffic reduction was 22%. Off ramps showed a 20% to 40% volume increase and on-ramps a 5% to 27% volume decrease.
