Rehabilitation of Concrete Pavements Utilizing Rubblization and Crack-and-Seat Methods: Phase II - Performance Evaluation of Rubblized Pavements in Iowa

National Concrete Pavement
Technology Center

Final Report
April 2008

Sponsored by
the Iowa Highway Research Board (IHRB Project TR-550)

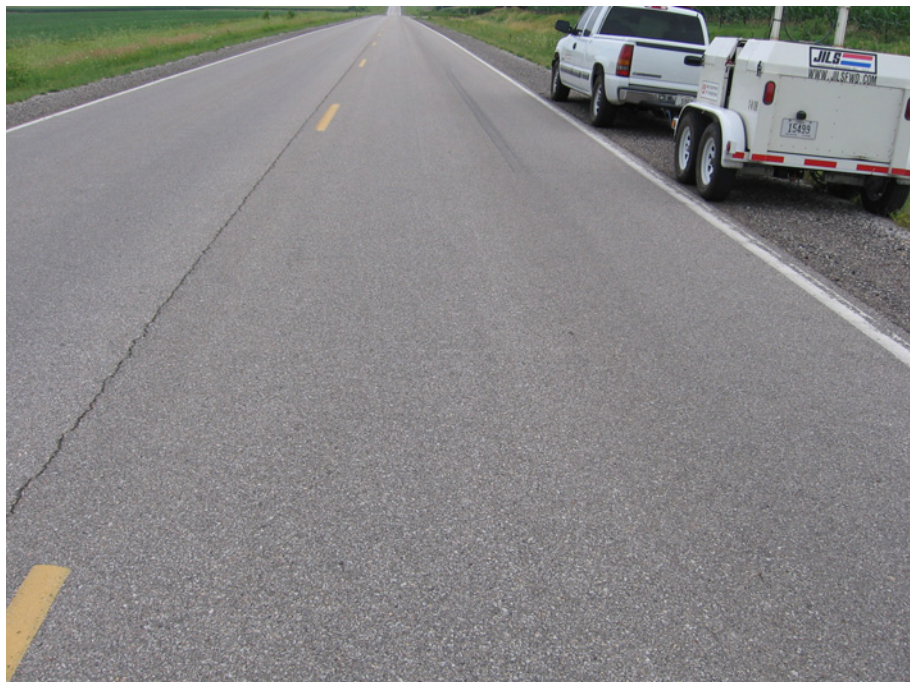
Figure C.2. Pavement Condition on A (Start) of D16 in Black Hawk County, IA (I.D. No. 12): Rubblization

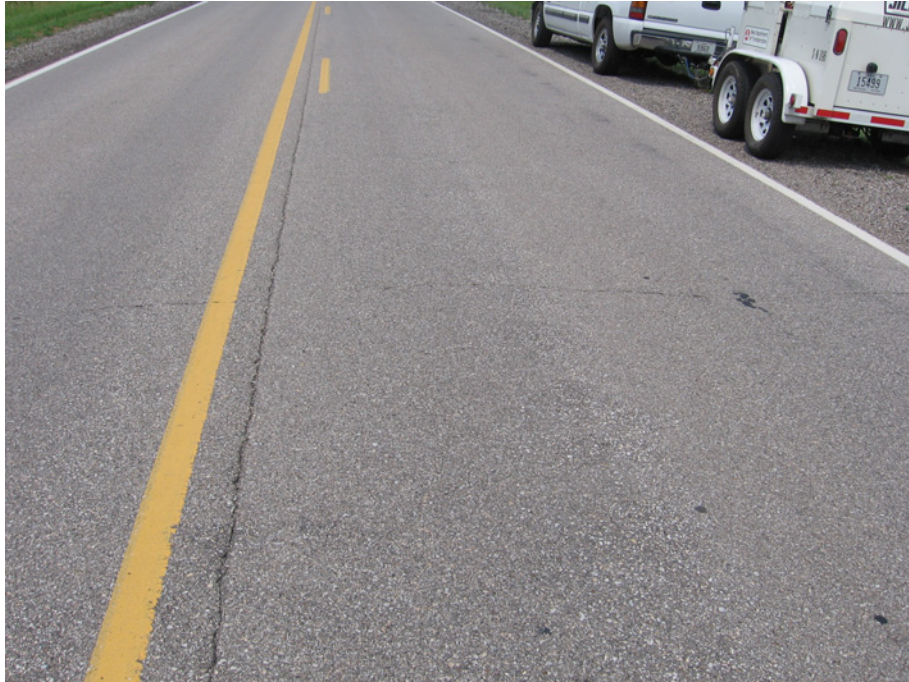
Figure C.9. Pavement Condition on C (End) of V43 in Black Hawk County, IA (I.D. No. 13): Rubblization

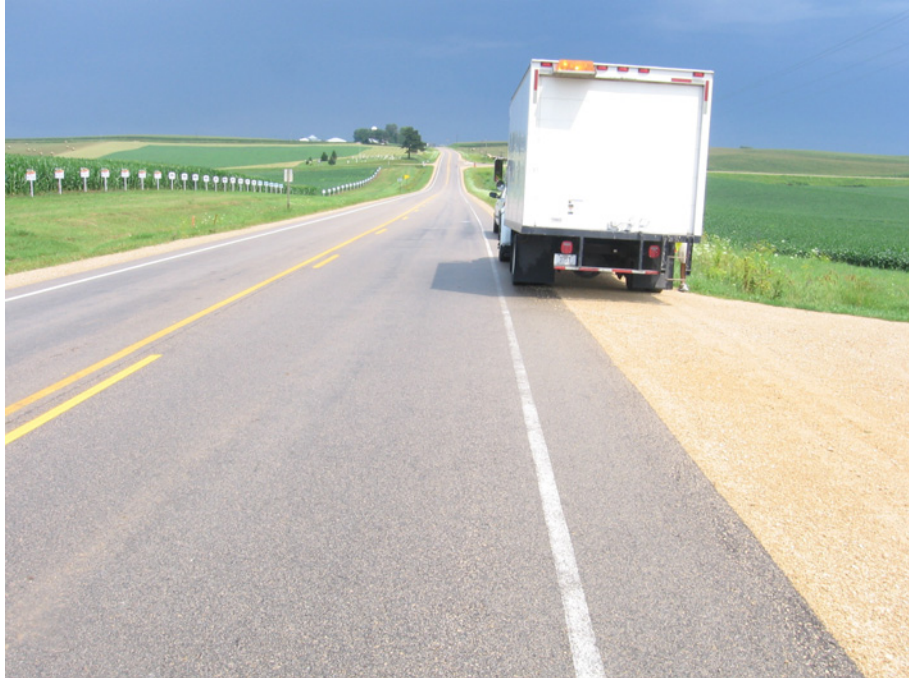
**Figure C.12. Overall Pavement Condition on IA3 in Delaware County, IA (I.D. No. 21):
Rubblelization**

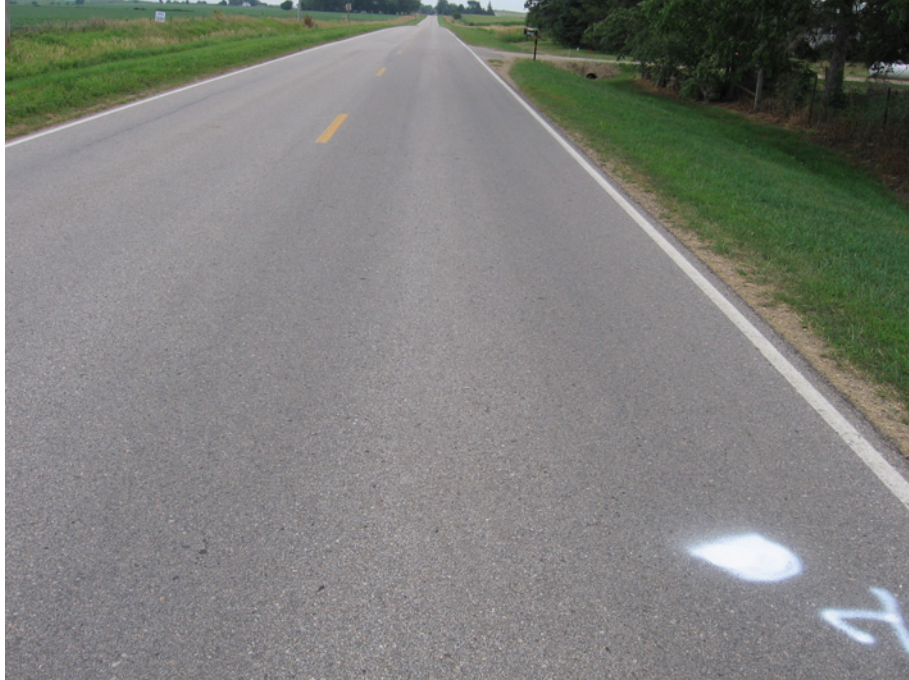
Figure C.19. Pavement Condition on A (Start) of C23 in Franklin County, IA (I.D. No. 26): Rubblization

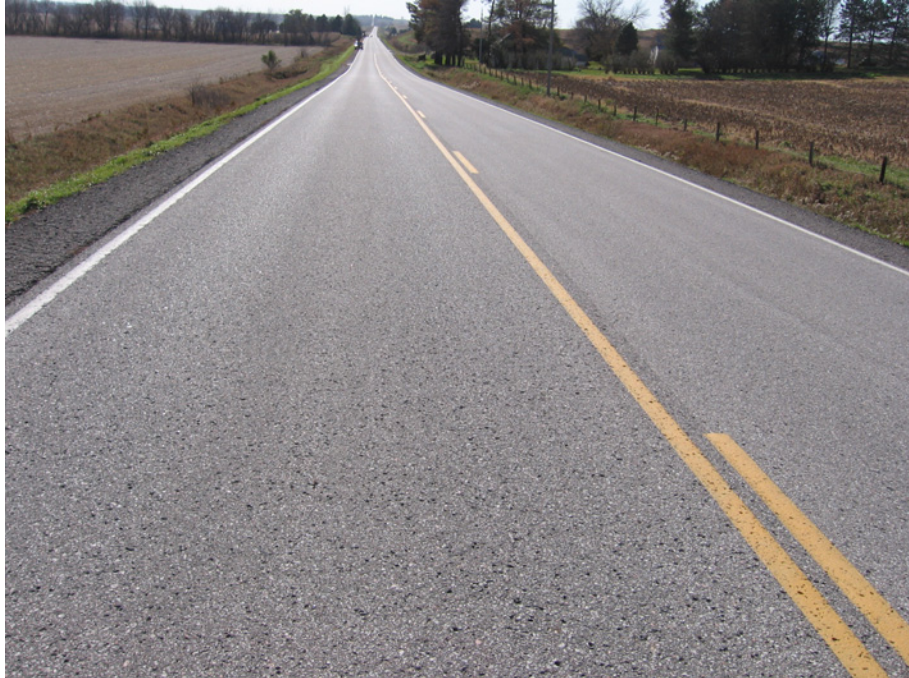
**Figure C.22. Overall Pavement Condition on L55 in Mills County, IA (I.D. No. 32):
Rubblelization**

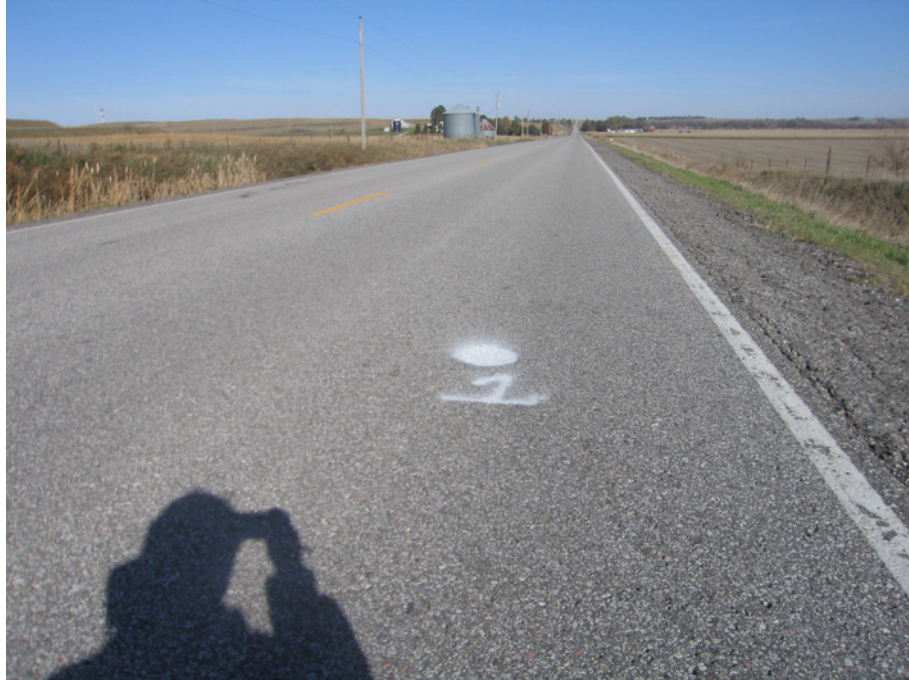
Figure C.23. Pavement Condition on A (Start) of L55 in Mills County, IA (I.D. No. 32): Rubblization

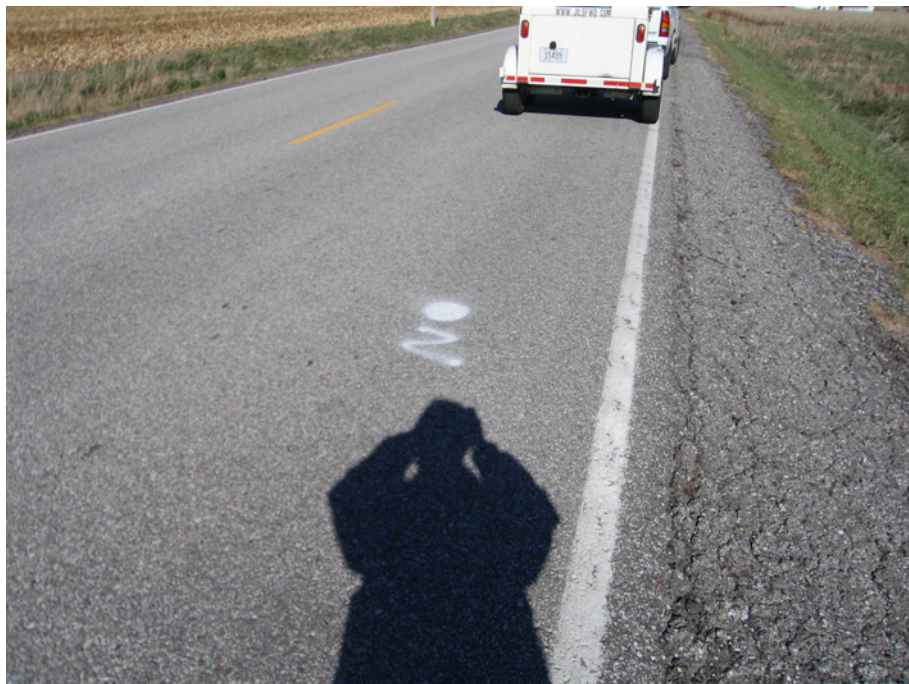
Figure C.24. Pavement Condition on B (Middle) of L55 in Mills County, IA (I.D. No. 32): Rubblization

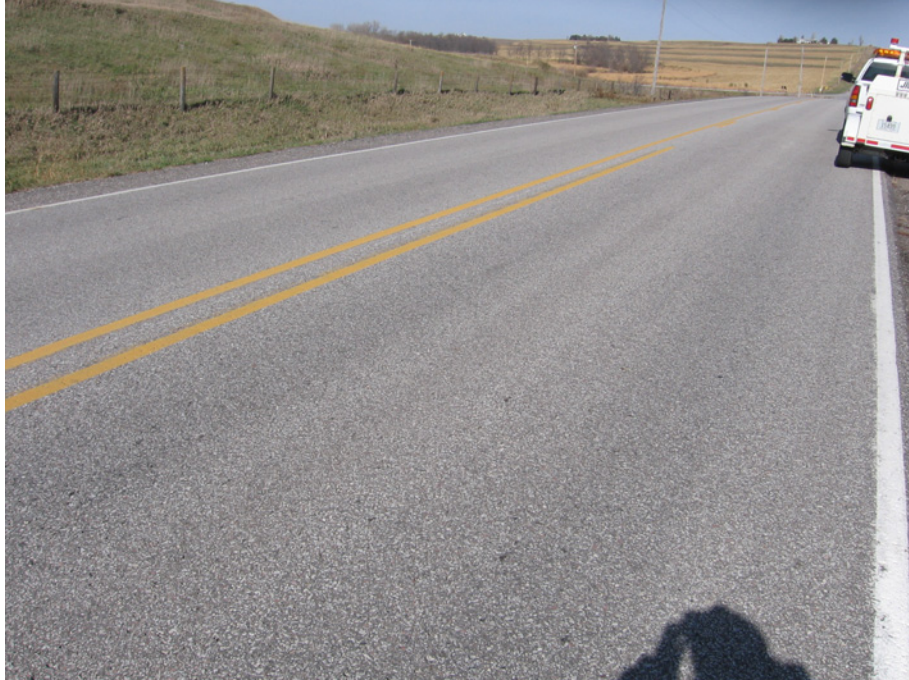
**Figure C.25. Pavement Condition on C (End) of L55 in Mills County, IA (I.D. No. 32):
Rubblization**

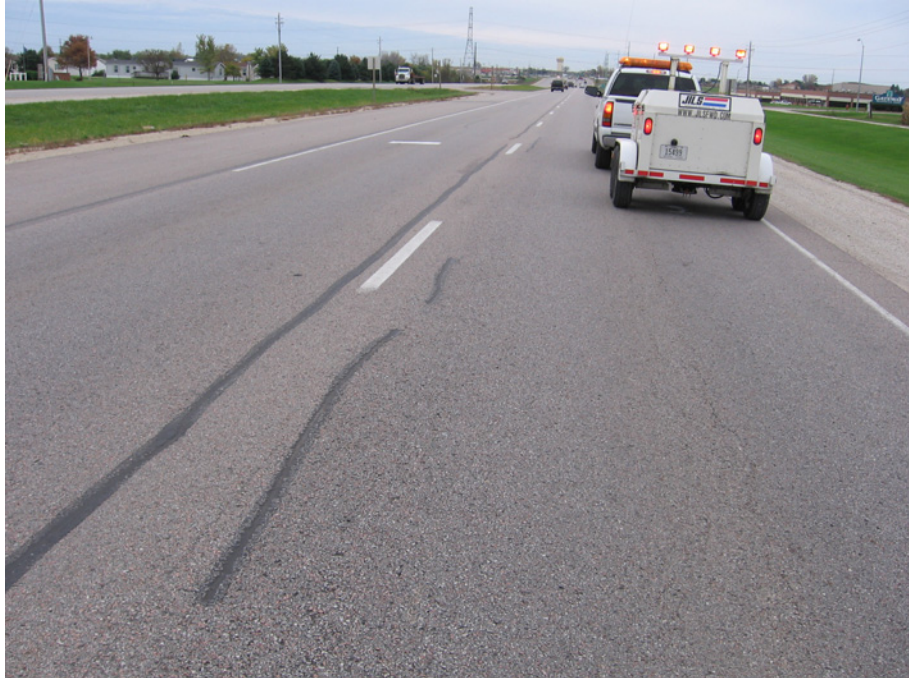
**Figure C.28. Pavement Condition on A (Start) of IA141 in Polk County, IA (I.D. No. 33-1):
Rubblization**

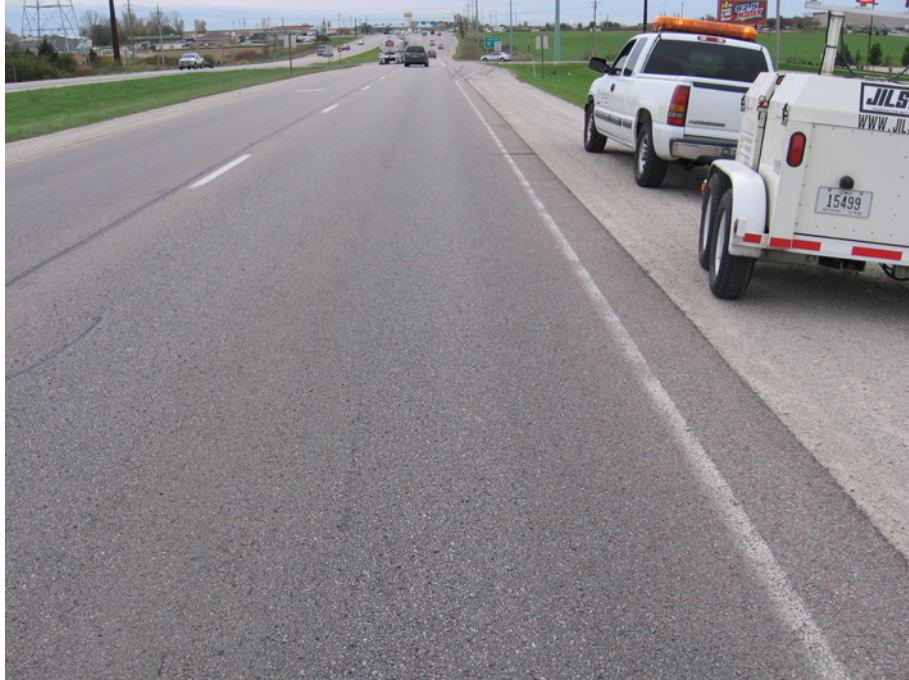
**Figure C.31. Overall Pavement Condition on IA141 in Polk County, IA (I.D. No. 33-2):
Rubblelization**

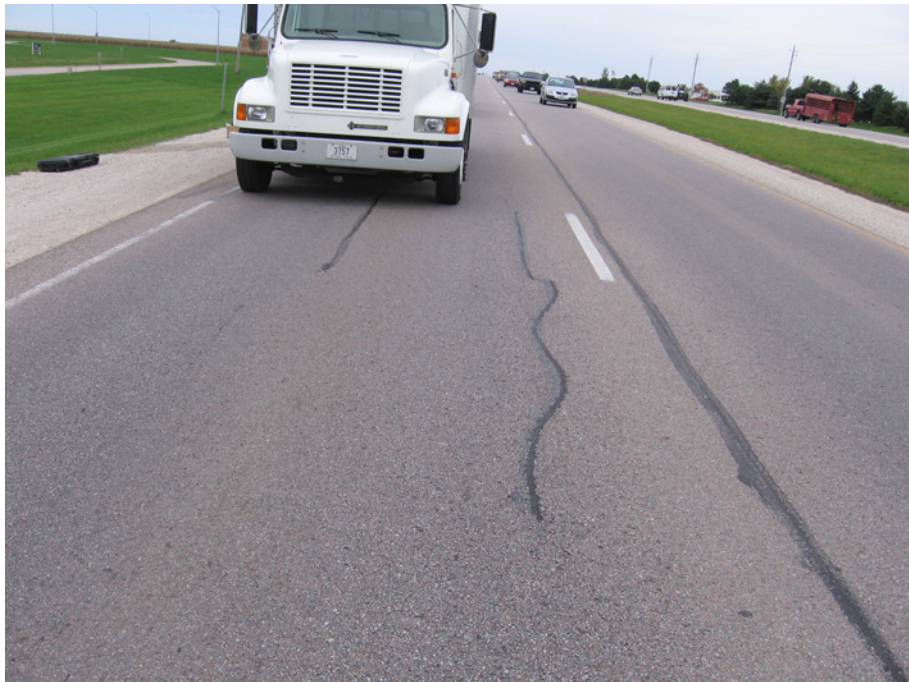
**Figure C.32. Pavement Condition on A (Start) of IA141 in Polk County, IA (I.D. No. 33-2):
Rubblelization**
